THE DUTCH
SAFETY BOARD

**Accident involving
a rail grinding train in Stavoren,
the Netherlands,
on 25 July 2010**

The Hague, September 2011

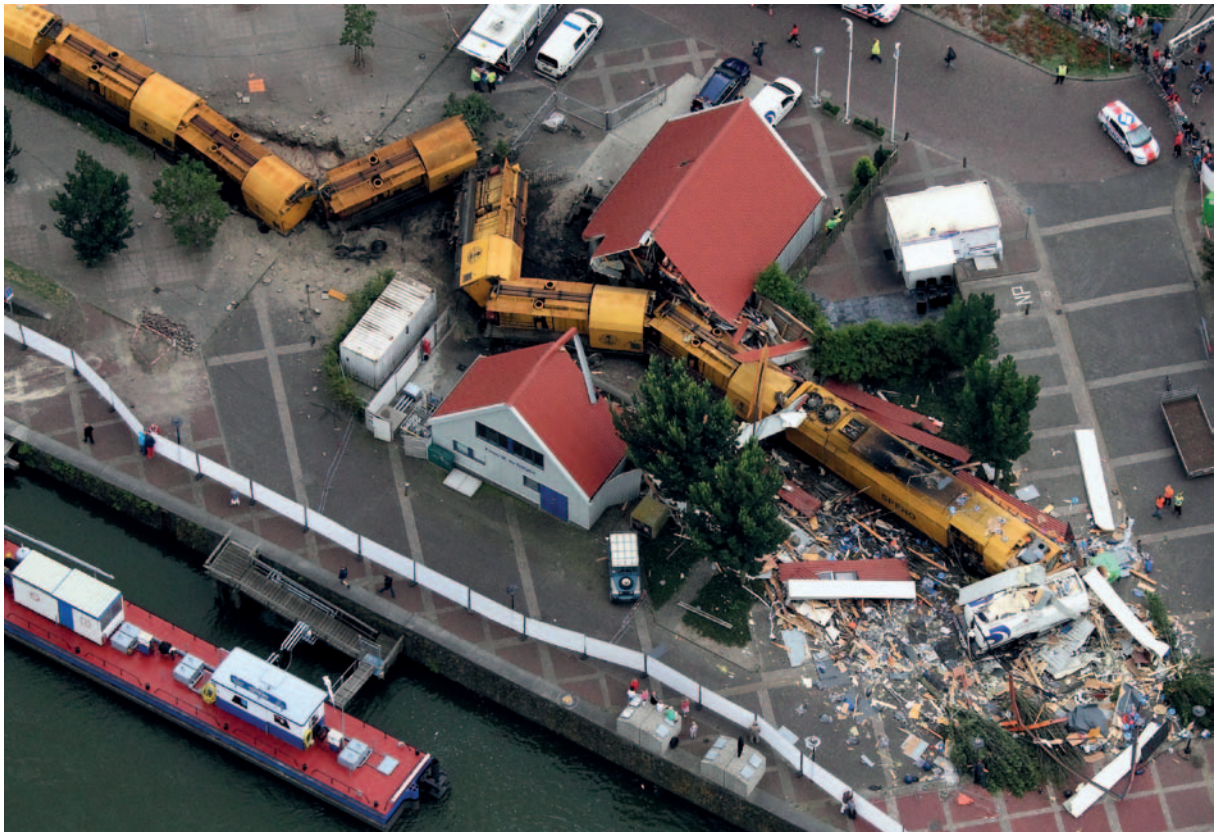
The accident occurred when the rail grinding train arrived at Stavoren Station at around 23.30 hours. Due to the fact that the rail grinding train braked too late, it drove at a speed of approximately 80km/h through a buffer stop located at the end of the line. On account of its high speed the train only came to a halt approximately 70 metres further on. After colliding with the buffer stop, the train first crashed into a parked tanker, which was empty, and then shot straight through the premises of a shop.

Figure 1: This photograph shows the situation shortly after the accident. The train was driving from left to right. The railway terminus is located just outside the left frame of the photograph. The photograph shows that the train, with the tanker in front of it, has ploughed straight through the shop premises. (Source: National Police Services Agency, KLPD).

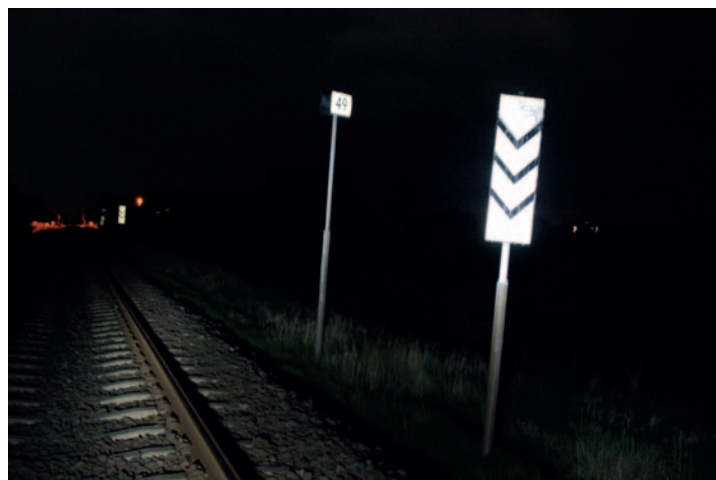
- Stavoren Station does not have the usual light signal entering a railway station. However, a series of approach markers (*keperbaken*) are located alongside the railway track at a distance of approximately twelve hundred metres from the end of the railway track (see figures 4 and 5). These approach markers consist of three signs located alongside the railway track spaced at an intermediate distance of approximately 70 metres from each other. These markers have the same meaning as an amber light signal ('limit speed to 40km/h, or reduce speed as much as is necessary in order to be able to stop at the next signal commanding the train to stop').

Figure 5: Photograph of the approach marker near Stavoren (photographed during darkness using a flashlight).

Ensure that the rules relating to the application of uncommon signals and signs (such as the approach markers) are tightened.

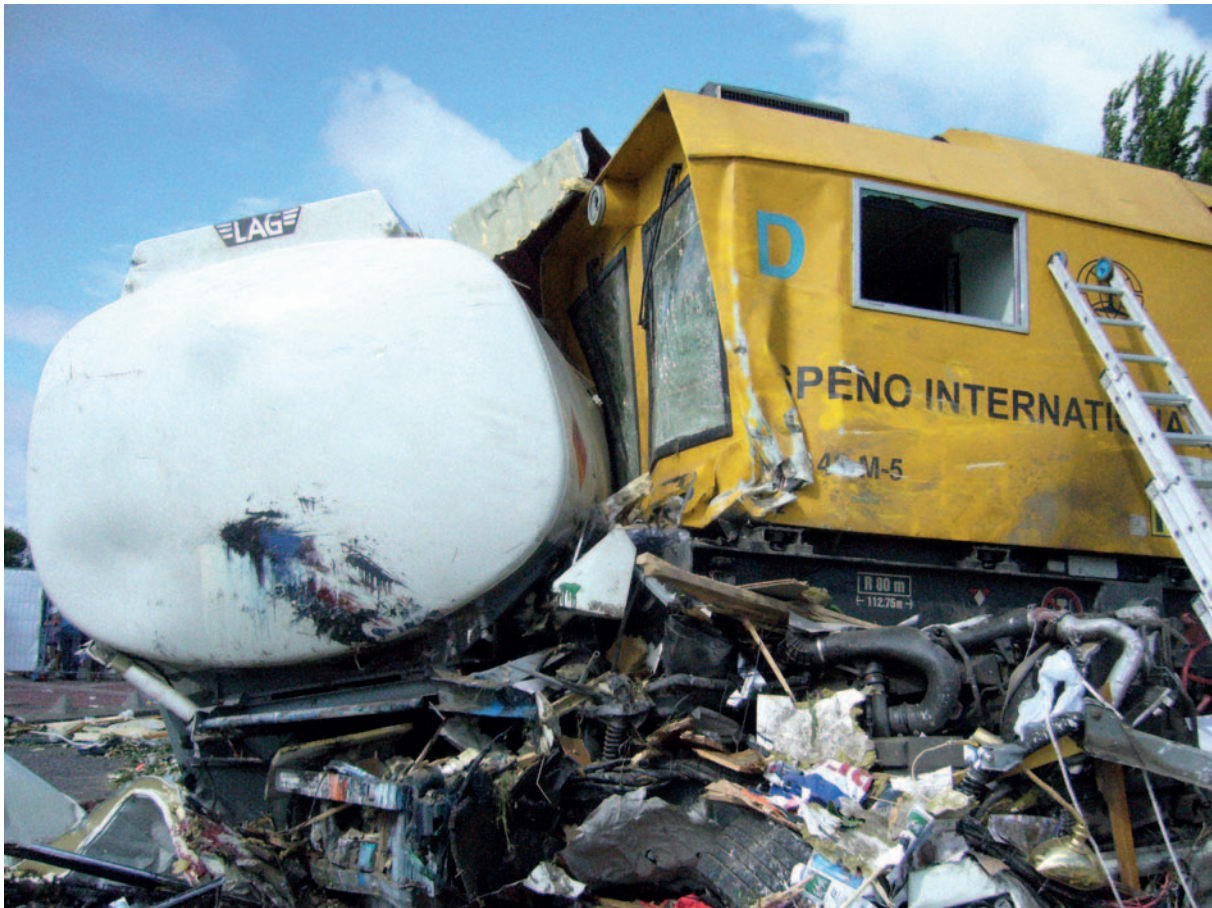
None of the four people on board the rail grinding train were seriously injured. Two of the Italian employees on the rail grinding train sustained mild injuries. No one outside the train was injured thanks to the fact that no one was in the relevant zone, the shop premises or the tanker at that time. However, the rail grinding train was severely damaged and the tanker and shop premises were completely destroyed. The material damage is roughly estimated to be more than EUR 20 million.

Figure 7: Front of rail grinding train RR48M-5 after the crash with the tanker in front that had been pushed through the shop.

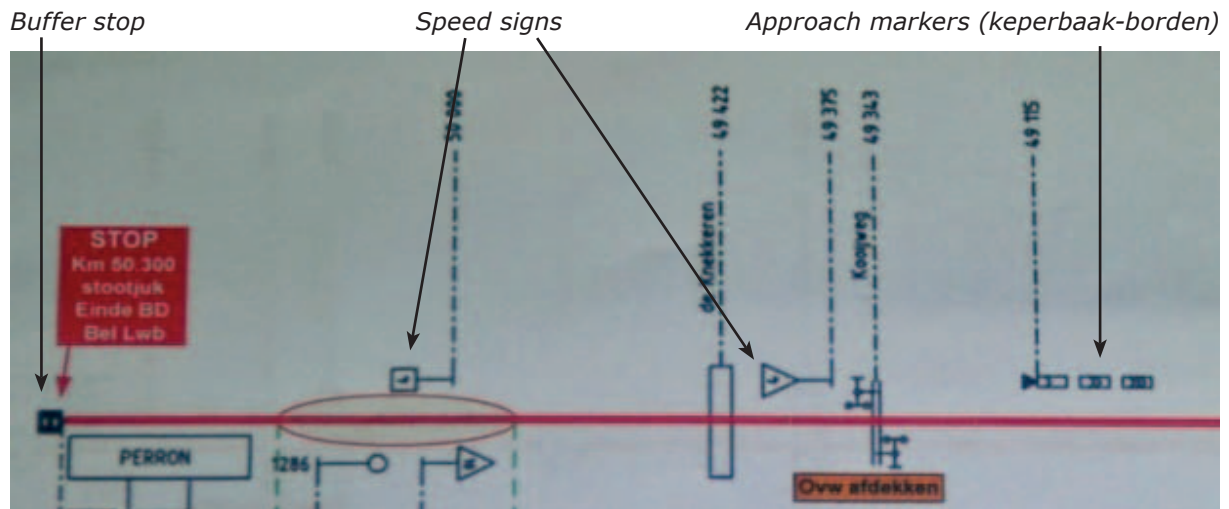
Figure 9: Part of the visual instructions (track layout plan) used by the train driver. The track layout plan shows the speed limit signs that were no longer present. It also shows the approach marker (keperbaak). The track layout plan furthermore states that it must not be used as a safety document.

- The speed restriction signs (313 and 314) indicated on the track layout plan were not present.
- Location markers:
 - A kilometre sign mounted on a high post was located at 49.0km; the sign was placed a short distance after the first approach marker and was turned at an angle of 45 degrees (see figure 21). No kilometre sign was present at 49.5km. However, a kilometre sign was present at 50.0km but had been turned at an angle of 90 degrees (as a result of which it was not readable from the train cabin).
 - A hectometre sign (49.2) was located at 49.343km (at the level crossing shortly before Stavoren), and another hectometre sign (50.3) was located next to the platform.

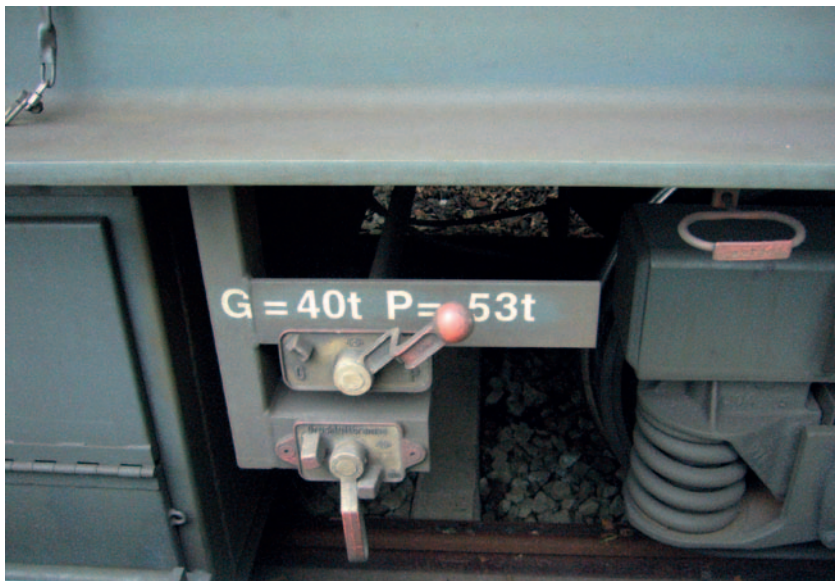
Figure 16: This photograph shows the two brake levers that feature on the units of the rail grinding train (in their correct position).

After the accident, all nine units of the rail grinding train were examined to find out whether the brake levers were in the correct position. The levers on five train units were found to be in the correct position. The levers on three train units were found to have broken off after the accident, making it impossible to determine their position; the remaining part of one of the levers was found in position G, whereby it should be noted that the position of this particular lever is likely to have changed during or as a result of the accident. The front unit of the train had sustained such severe damage that it was not possible to determine the position of the brake levers.

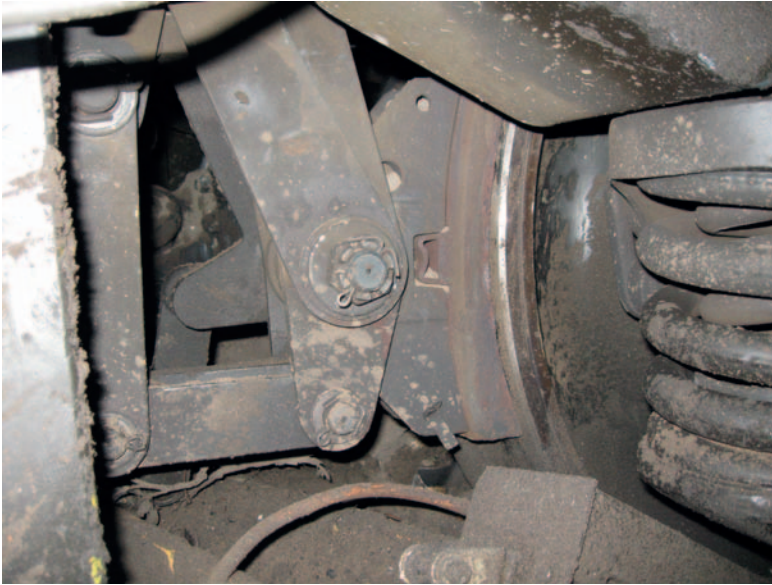
The two rear units of the rail grinding train were virtually undamaged, which allowed the Safety Board to perform a thorough inspection of these units. It was established that the brakes on two of these units were in good condition. As a result of the damage sustained by the train it was difficult to inspect the brakes on the other units, however there was no evidence to suggest that the brakes on these particular units were not in good condition.

It was established that the brakes on the wheel sets that had not sustained damage or had sustained limited damage had been 'pulled' (see figure 17).

Figure 17: This photograph shows that the brakes on the front train unit had been 'pulled'.

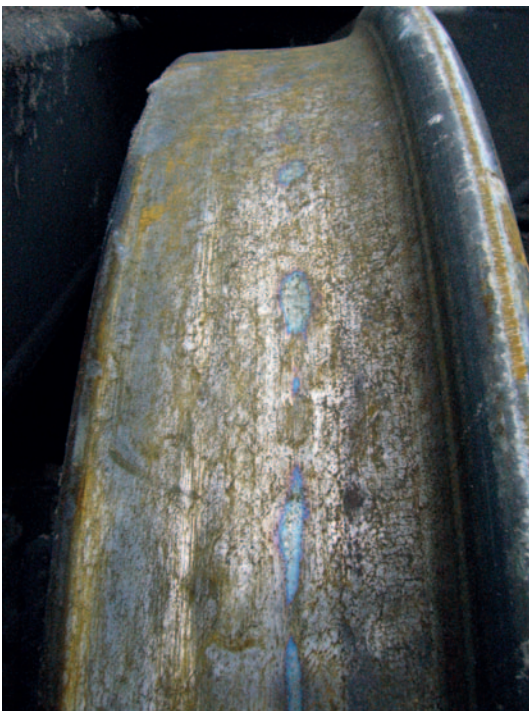
Skid marks were found on the wheel treads. There were hotspots on a number of wheels (see figure 18); these are created by excessive overheating and indicate that the train braked heavily.

Figure 18: Hotspots on the wheel treads

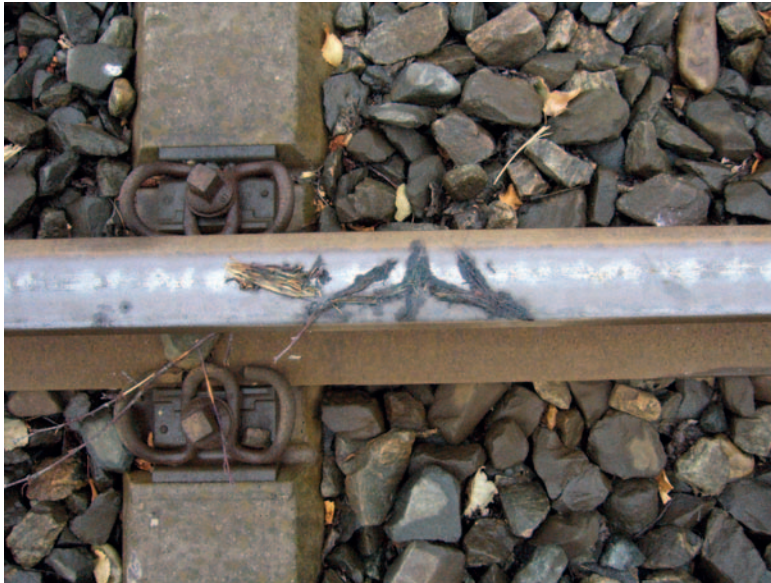
The remains of leaves were found on and alongside the rails (see figure 19). These leaves were from trees (which had shed their leaves because of the dry weather) in the surrounding area, and from trees that had been pruned near the platform. The remains of the leaves on top of the rails were found to have been compacted; they were partly charred, which was caused by the high temperatures that occurred during braking.

Figure 19: This photograph shows part of the skid marks and the remains of leaves found.

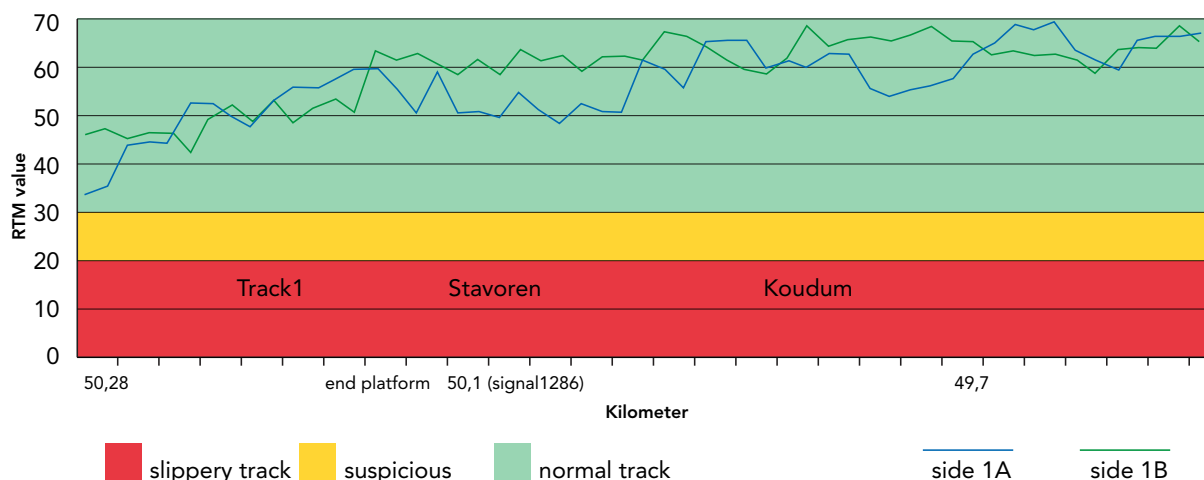
Figure 20: Results of the skid measurement

The measurements revealed that level of skid resistance of the rails was normal and that the rails were not 'slippery'. The skid resistance level of the rails on the last 20 metres of the track section was also measured in wet conditions; normal values were also established on this section.

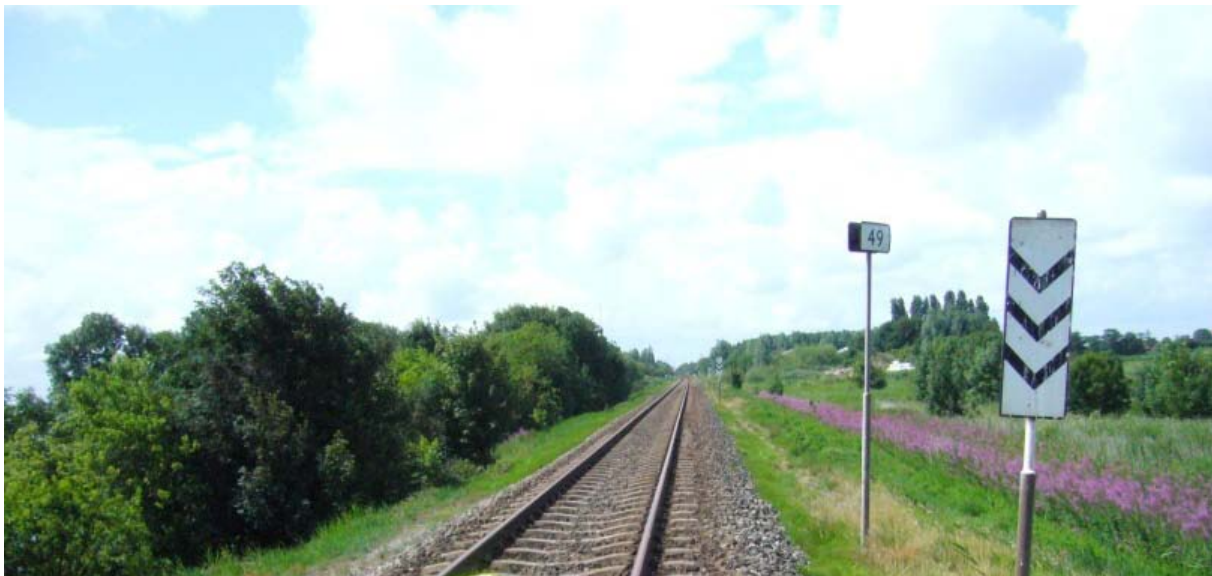
Figure 21: This photograph shows the small 49.0 km sign.
