DUTCH  
SAFETY BOARD

# Explosions MSPO2 Shell Moerdijk

*The Hague, July 2015*

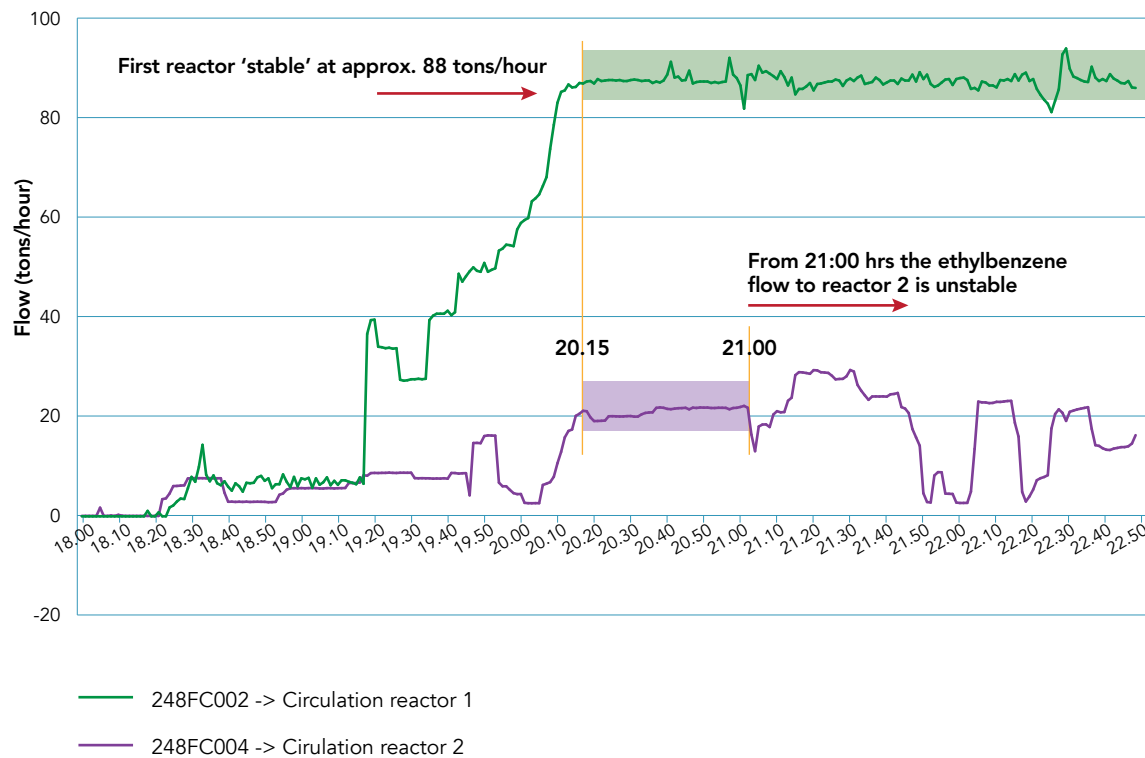
During the evening of 3 June 2014, at around 20:15 hrs the Panel Operator began circulating ethylbenzene through the unit. When the ethylbenzene flow through the unit had been stable for approximately 45 minutes (see the purple highlighting in Figure 2.10), the Panel Operator decided to begin heating the unit at 20:56 hrs. From that moment on, the level of ethylbenzene in the separation vessels<sup>22</sup> and of the flow of ethylbenzene towards reactor 2 fluctuated and was unstable (see the purple line in Figure 2.10, from 21:00 hrs onwards).<sup>23</sup>

Figure 2.10: Circulation flows of ethylbenzene in both reactors.

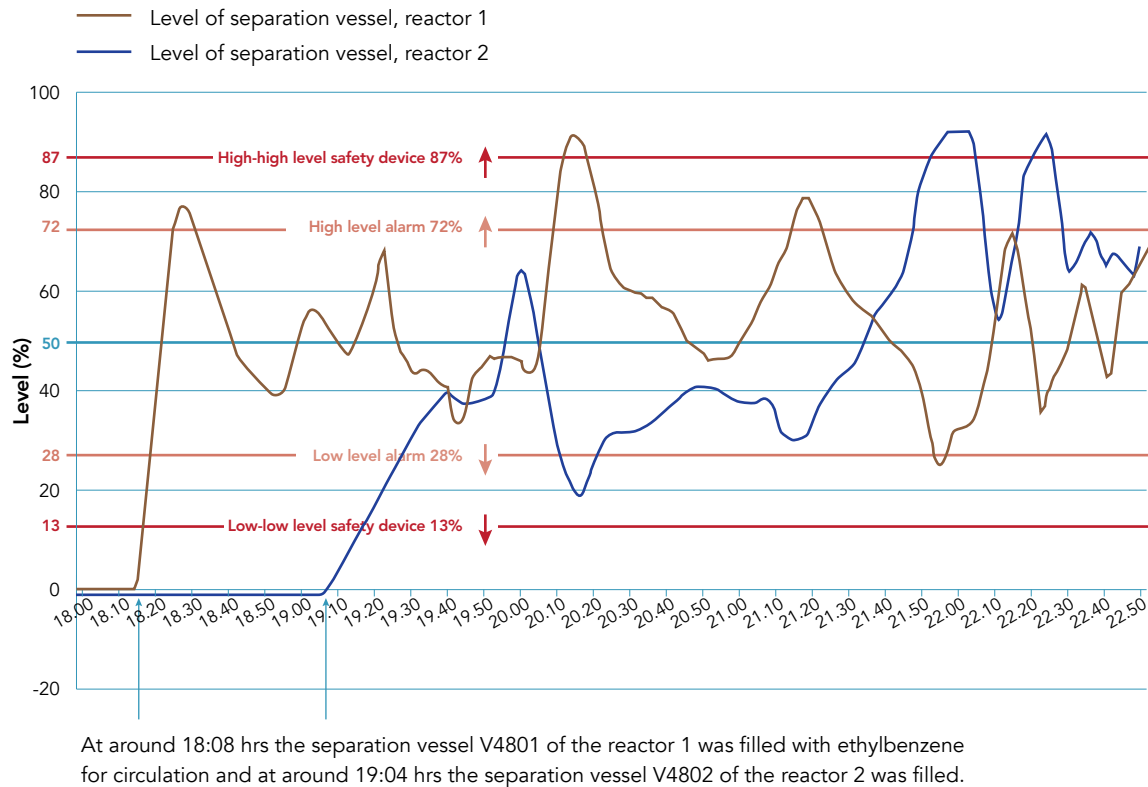
For the duration of the Panel Operator's shift, alarms sounded regularly, including the liquid level alarm in the separation vessel.<sup>26</sup> The level control for the separation vessels was set on manual mode. The Panel Operator was aware that the liquid level was difficult to regulate. The alternating liquid level in the separation vessels is shown clearly in Figure 2.13. Figure 2.13 also shows that the liquid level was regularly above the set limit and was therefore in the 'abnormal' process zone, in this case the zone above the orange line.

Figure 2.13: Liquid levels in the separation vessels.

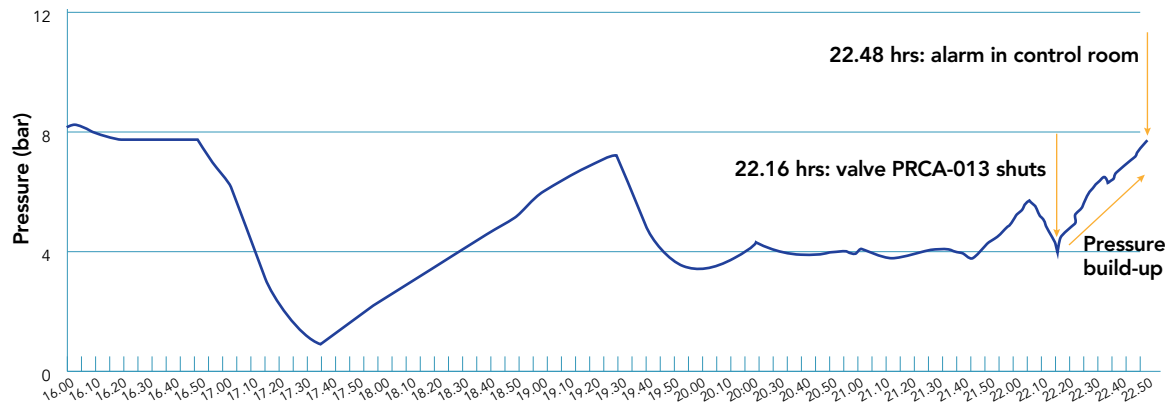
that the temperature in the reactors had exceeded the set alarm limits also sounded. The reason temperature and the pressure were able to rise so fast was because ethylbenzene and the catalyst were reacting inside the reactors. Within the space of a few minutes, the pressure in the unit had risen sharply.<sup>29</sup> This pressure could no longer be released via the pressure release valves on the separation vessels (see Figure 2.14). The other way the pressure could have escaped was by means of the gas discharge system. However, it had been unintentionally left closed which no one noticed.

Figure 2.14: Pressure in gas discharge system to the flare.

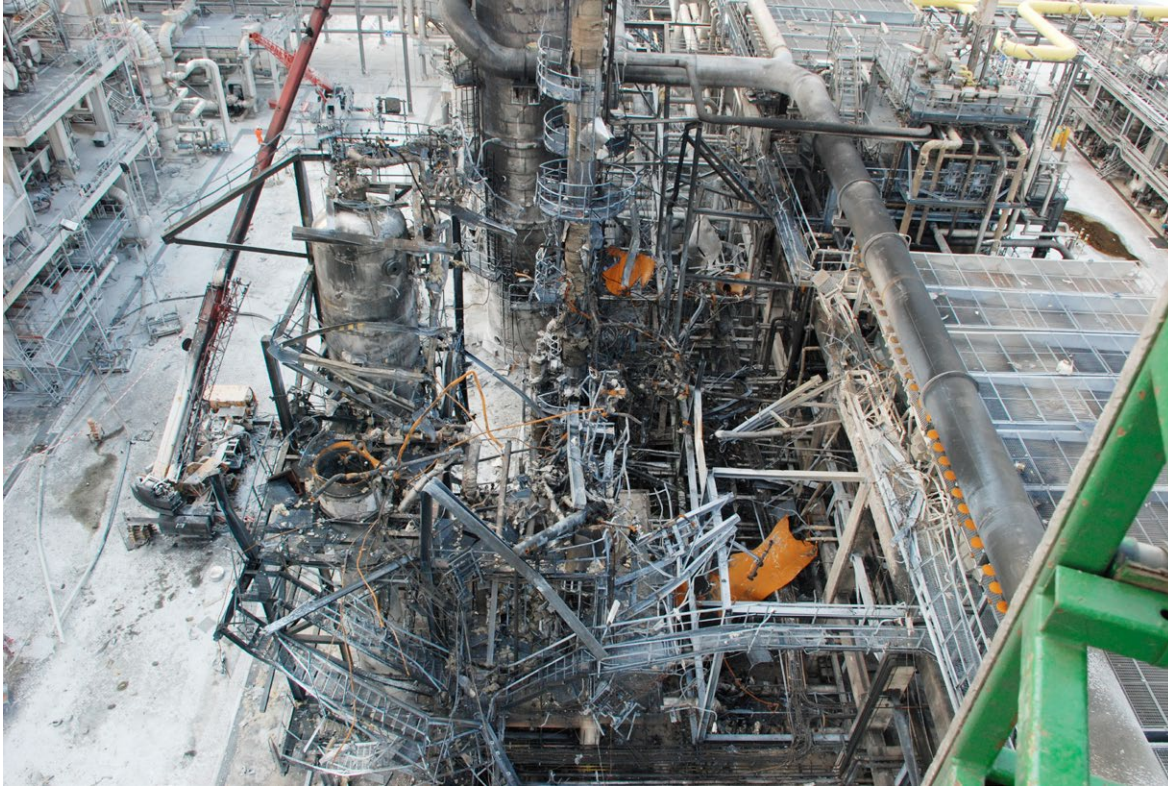
Figure 2.15: U4800 after the explosion. (Source: Police/LTFO)

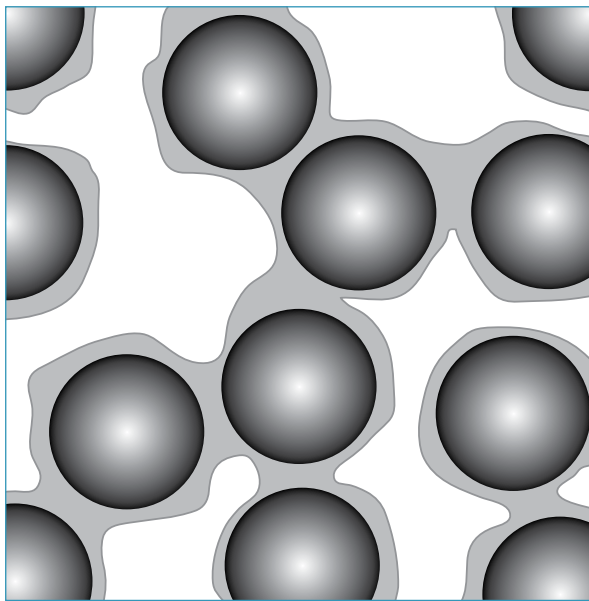
The catalyst pellets had not been adequately wetted prior to the incident. To wet the catalyst pellets properly, enough ethylbenzene and nitrogen had to pass through a distribution plate into the reactors in the correct ratio. It was established in the design phase that a nitrogen flow of 475 kilograms per hour was required to achieve this. At 240 kilograms per hour, the nitrogen flow on 3 June was not only too low, it was significantly lower. After the incident, Shell Moerdijk determined that a significantly higher nitrogen flow is necessary - of approximately 1700 kilograms per hour<sup>30</sup> - to enable the distribution plate to function properly.

Figure 2.17: Liquid film around catalyst pellet.<sup>31</sup>

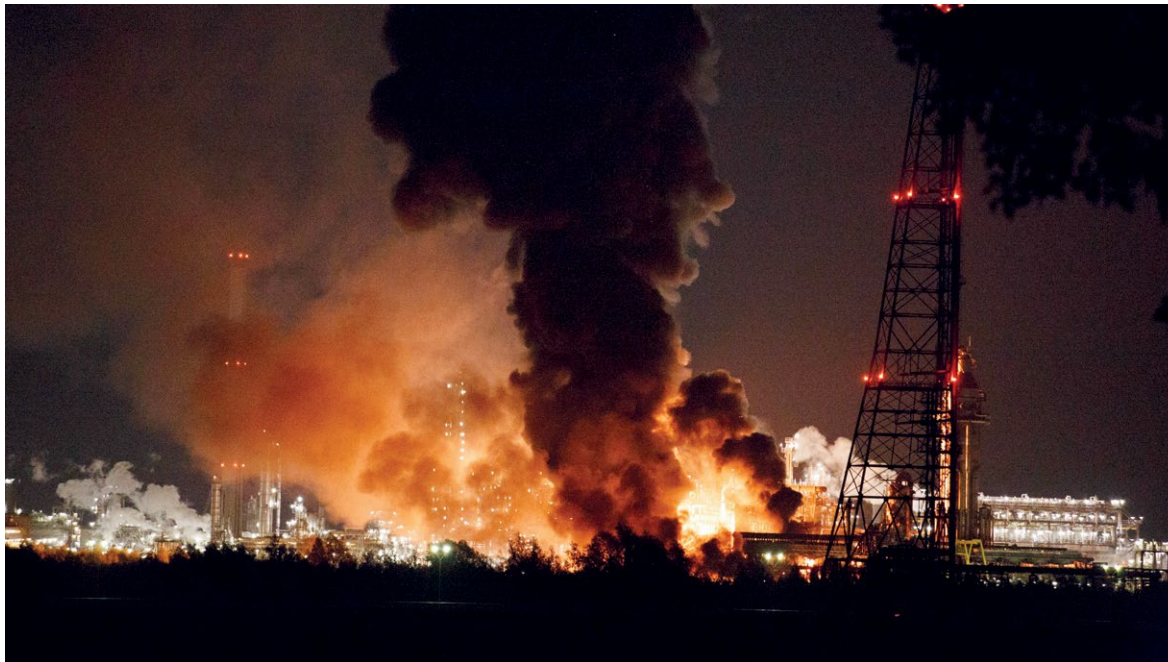
At 23:18 hrs a large fireball formed near at unit 4600 with flames measuring 40 to 50 metres high. At that moment it was not clear what had caused the explosions and whether there was still a significant risk of explosion. The company fire brigade focused its efforts on preventing escalation. The First Commander of the company fire brigade decided that deployment was required in order to screen off unit 4800 and to cool the surrounding installations.

Figure 4.4: High flames from unit 4800. (Source: Marcel Otterspeer)/het fotobureau/Hollandse Hoogte)

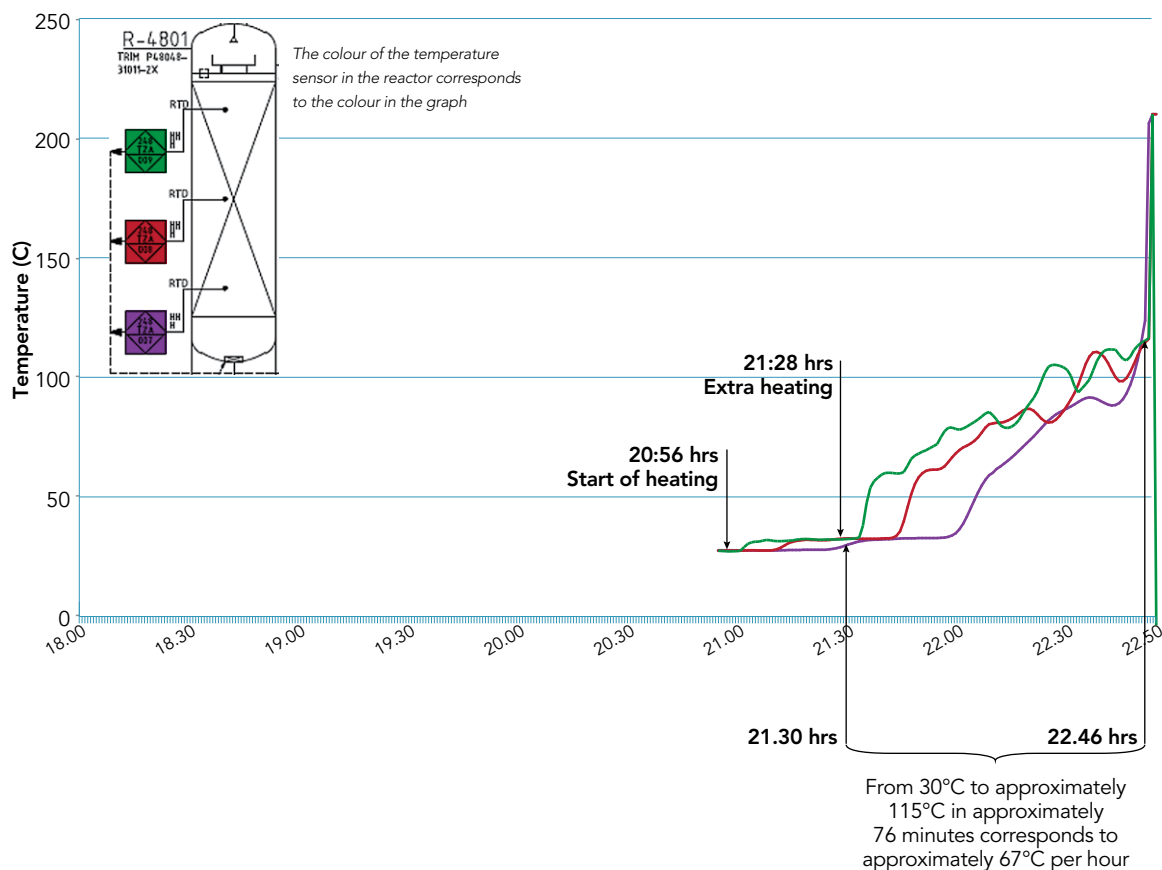
Figure B6.8: Temperature development in reactor 1 during 2014 start-up.
