DUTCH
SAFETY BOARD

Aborted takeoff from taxiway, Boeing 737-800, Amsterdam Airport Schiphol

The Hague, May 2022

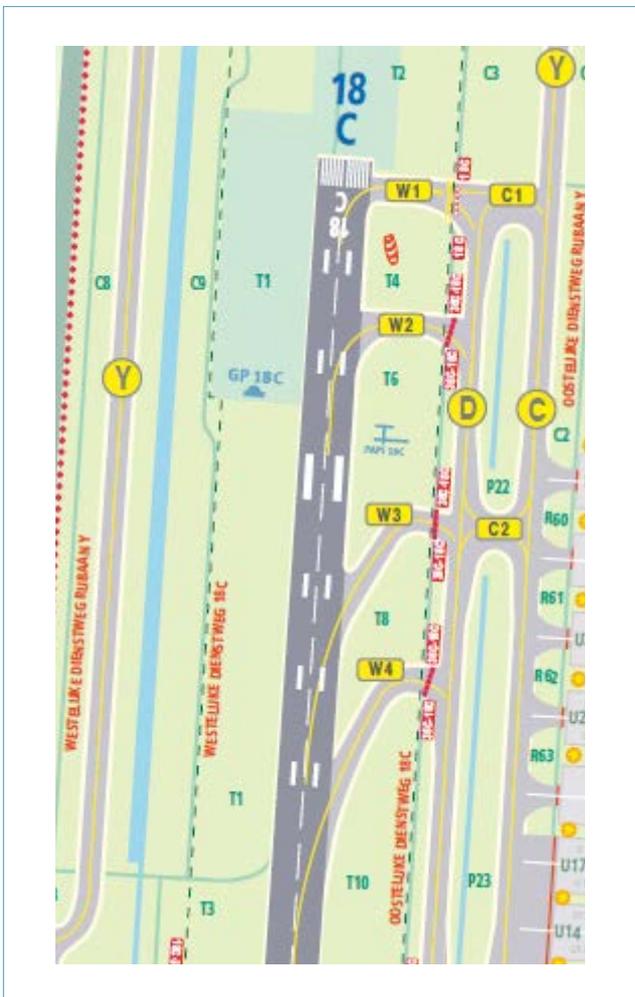
Figure 1: Lay-out of the infrastructure, surrounding the location of the occurrence. (Source: Amsterdam Airport Schiphol)

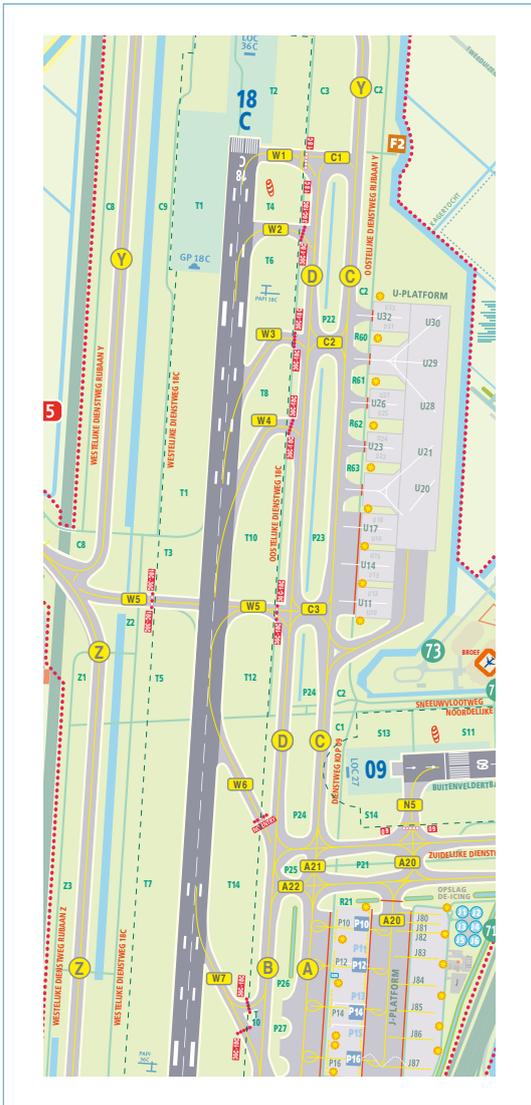
Figure 3: Lay-out of the infrastructure, east of Runway 18C/36C. (Source: Amsterdam Airport Schiphol)

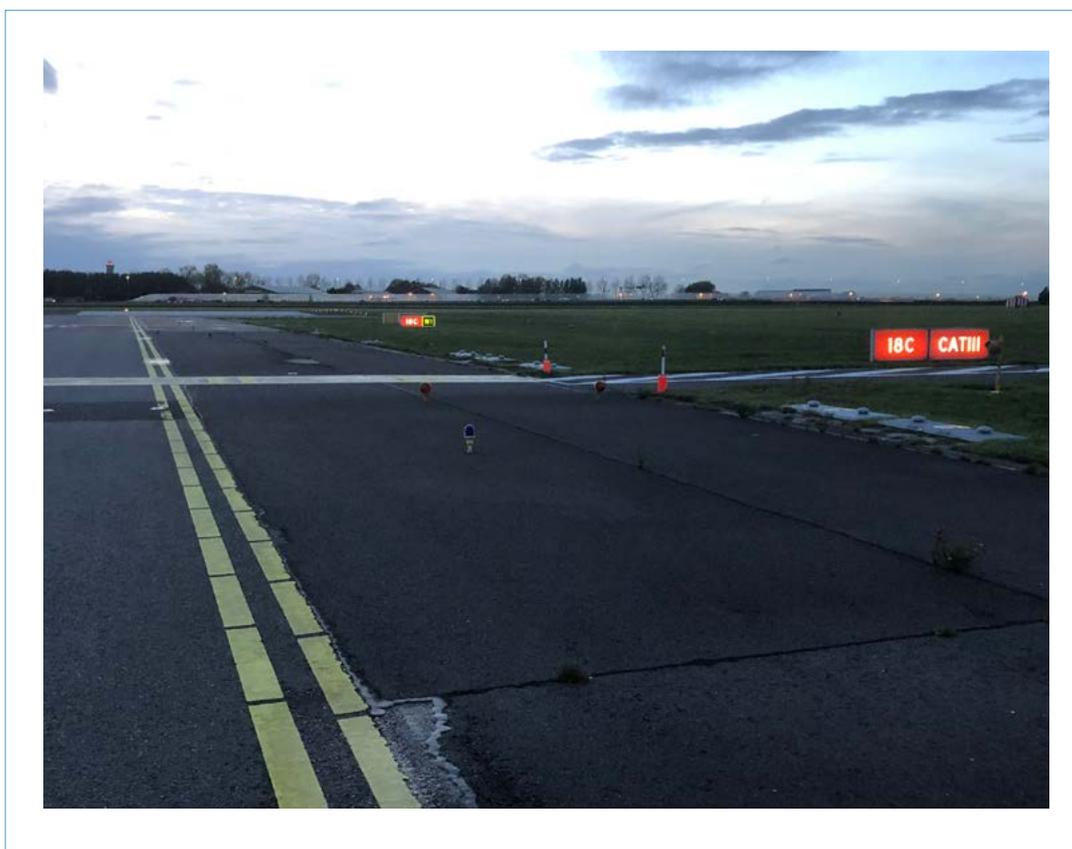
Figure 4: Signs and marking, designating the CAT III holding point of Runway 18C. (Source: Dutch Safety Board)

There are signs on and near the location indicating that intersection W1 leads to a runway. These include the signs designating the runway, the runway entry and the runway holding position marking on the tarmac (see Figure 4).

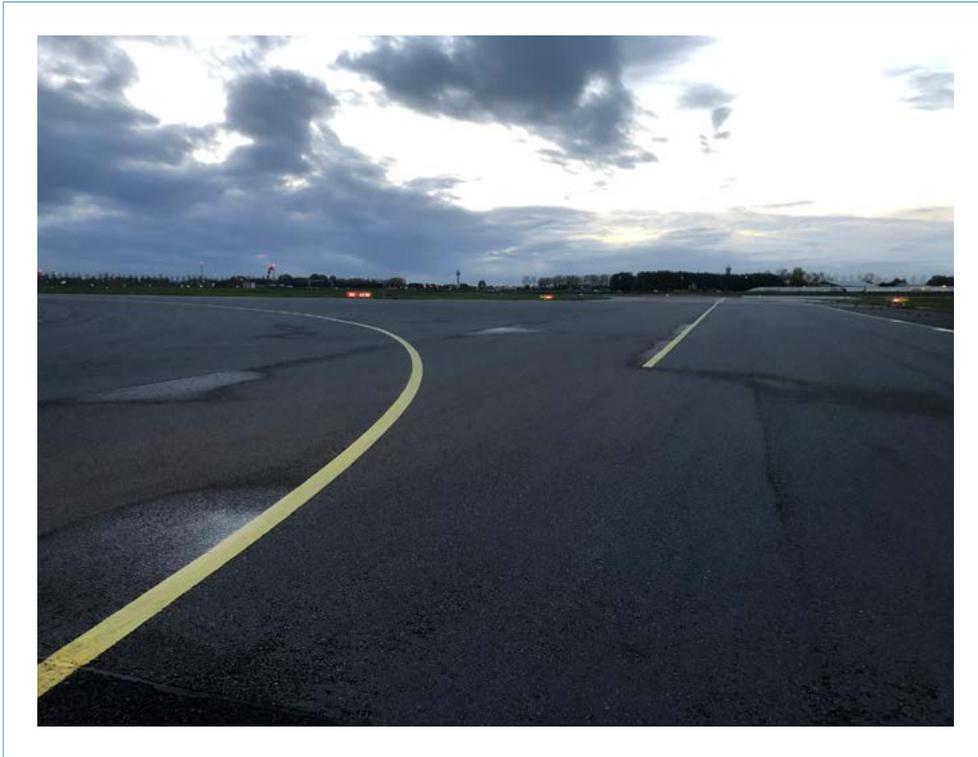
At the junction of Taxiway C and Intersection C1, the taxiway continues northbound as Taxiway Y. At that point, the green centre line lights continue northbound. Turning to the west, there are no green centre line lights towards C1. There is an interruption of the yellow centre line marking towards W1. The yellow line continues in a turn to the south onto Taxiway D (see Figures 5 and 6). At C1, another yellow centre line marking starts towards W1. This line is not connected to the curved line towards Taxiway D (see Figures 5 and 6). Taxiway D has green centre line lights that continue northbound towards W1 (see Figure 7).

Figure 5: Interruption of the yellow centre line marking (from C1 towards W1) and continuing turn of the line to the left towards Taxiway D. (Source: Dutch Safety Board)

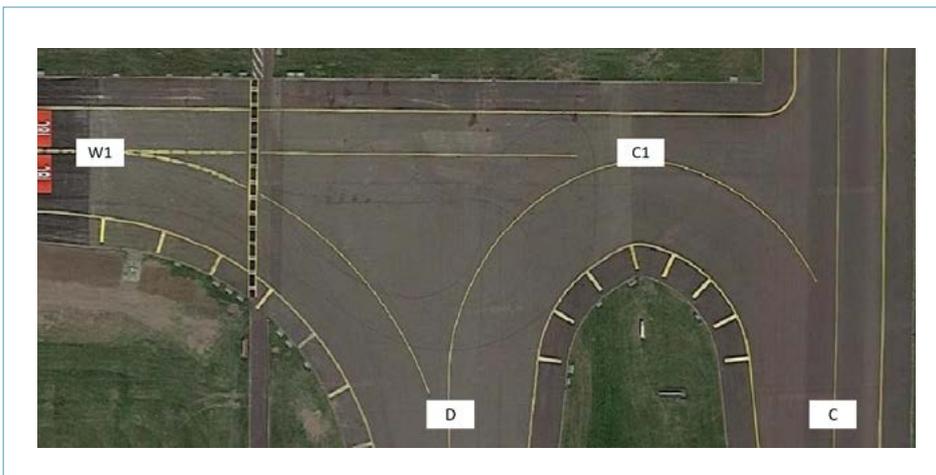
Figure 6: Broken taxiway centre line markings. (Source: Google Maps, modified by the Dutch Safety Board)

The centre line marking from C1 towards the beginning of Runway 18C was broken and therefore did not comply with CS ADR-DSN.L.555 (see Paragraph 2.9.3).

The broken centre line marking from C1 towards the beginning of Runway 18C did not comply with CS ADR-DSN.L.555, but it was included in the Deviation Acceptance and Action Document and therefore accepted by the Human Environment and Transport Inspectorate.

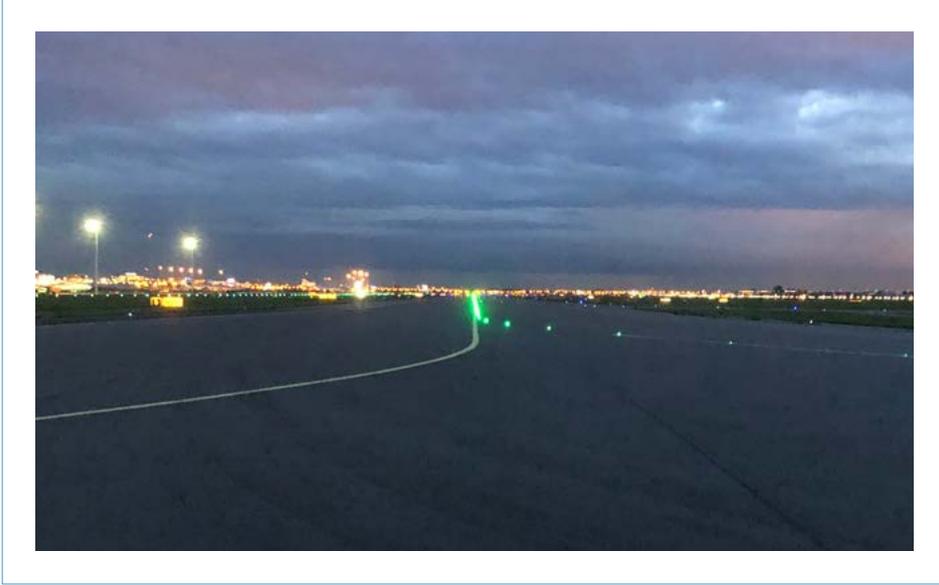
Figure 7: Looking south on taxiway D with its green centre line lights that continue in the northwest towards W1. (Source: Dutch Safety Board)

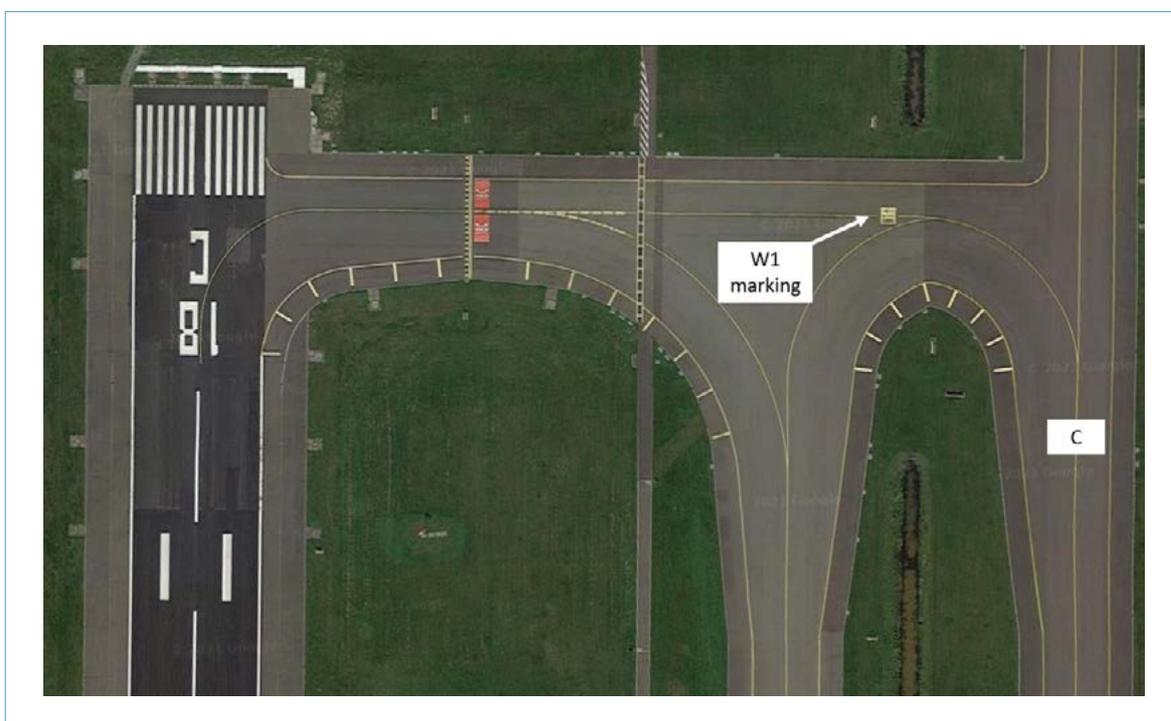
Figure 8: Continuous centre line markings from Taxiway C to Runway 18C and W1 marking at C1. (Source: Google Maps, modified by Dutch Safety Board)

- Standard taxi routing for outbound traffic to Runway 18C via Taxiway D with the following preconditions:
 - outside the uniform daylight period;
 - deviations from this standard remain possible, but only in exceptional circumstances (taxiway damage, work in progress, other incidents or obstructions);
 - no publication in Aeronautical Information Publication (change in air traffic control procedures only).
- Continuous centre line markings from Taxiway C to Runway 18C (see Figure 8);
- Directional marking on Taxiway C1 to Runway 18C, Intersection W1;

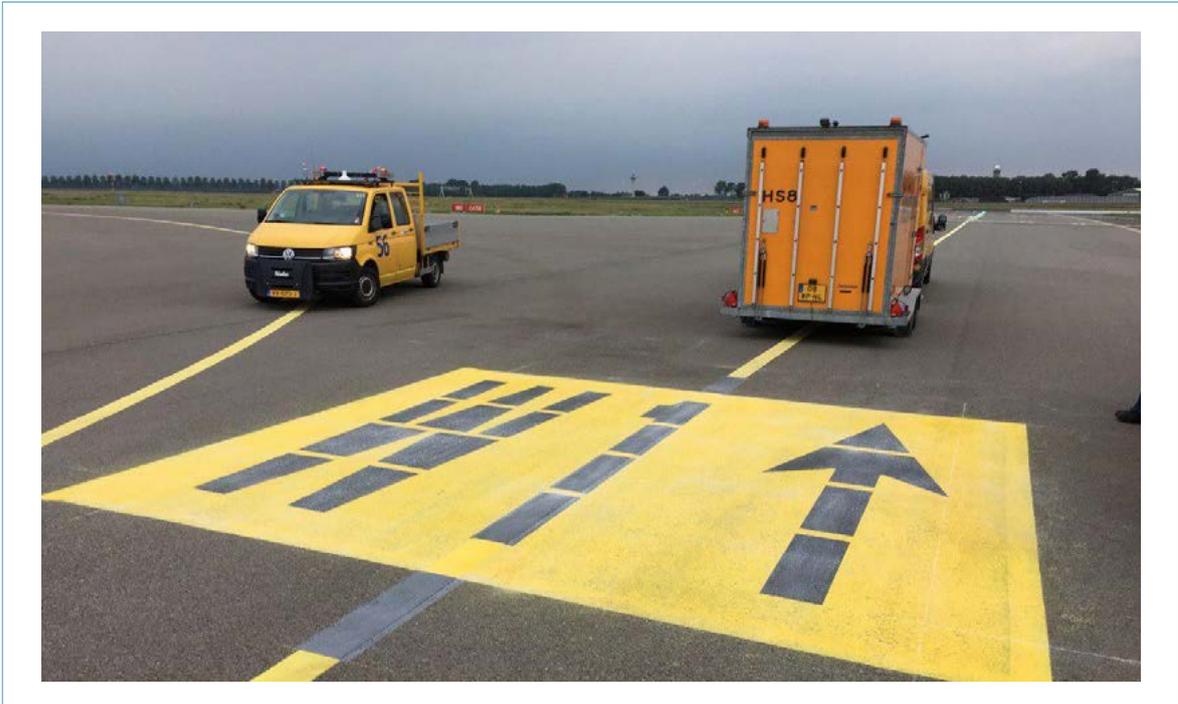
Figure 9: W1 marking at C1. (Source: Amsterdam Airport Schiphol)
