APPENDICES

APPENDIX I: JUSTIFICATION OF THE INVESTIGATION

In the night of 26/27 October 2005, the Safety Board received reports from the media of a major fire at the Detention Centre Schiphol-Oost. During the night, a Safety Board investigator went to the site. In view of the criminal investigation being carried out by the Public Prosecutions Department (OM), the site was originally designated as a 'Crime Scene'. During this time, the Safety Board cooperated closely with the OM in investigating the site. When, in January 2006, the 'Crime Scene' status was lifted, and the site was allocated the status 'Incident Scene'. The Safety Board had sole access to the part of the detention centre where the fire had broken out up until the period in which the draft report was sent for comment to parties en persons involved in July 2006.

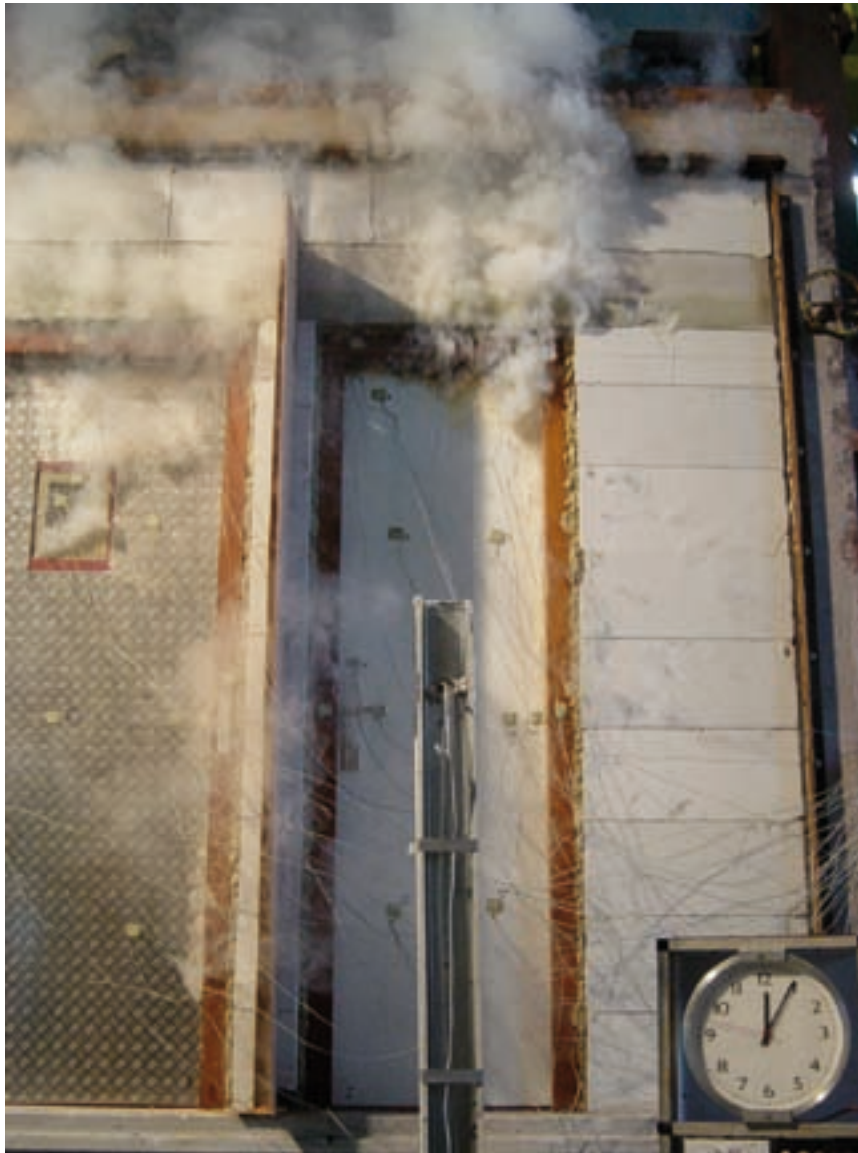
Figure 2: Smoke passing through the cell door and the door of the technical shaft, five minutes after the start of the test

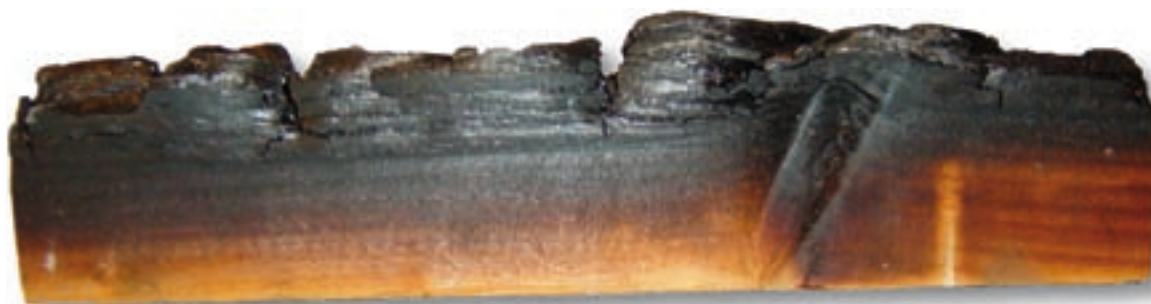
A sample was taken from the pinewood from the ceiling construction in cell 9, which the fire had penetrated relatively intact but in which nevertheless two people died, in order to determine if this process truly did occur. It appeared that several centimetres at the top of the pinewood were charred (see Figure 3).

This type of carbonization was also even found in cell rows 20 to 26, which were exposed to the heat from the ceiling for a shorter period of time.

Figure 3: Sample from the pinewood frame from the ceiling construction of cell 9. Carbonization of the wood through radiation from above.

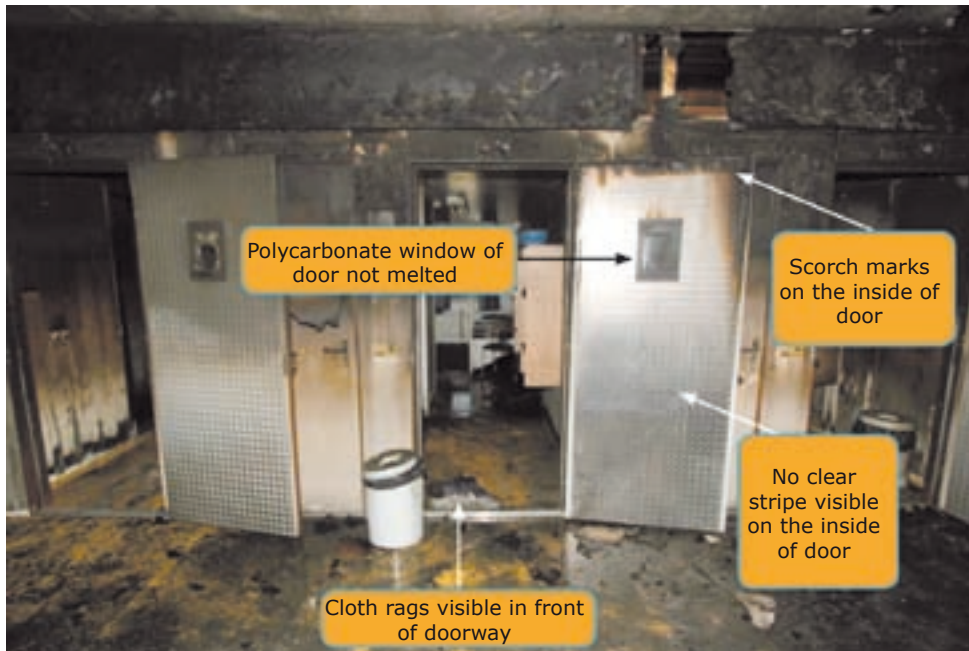
Figure 1: View of cell 5

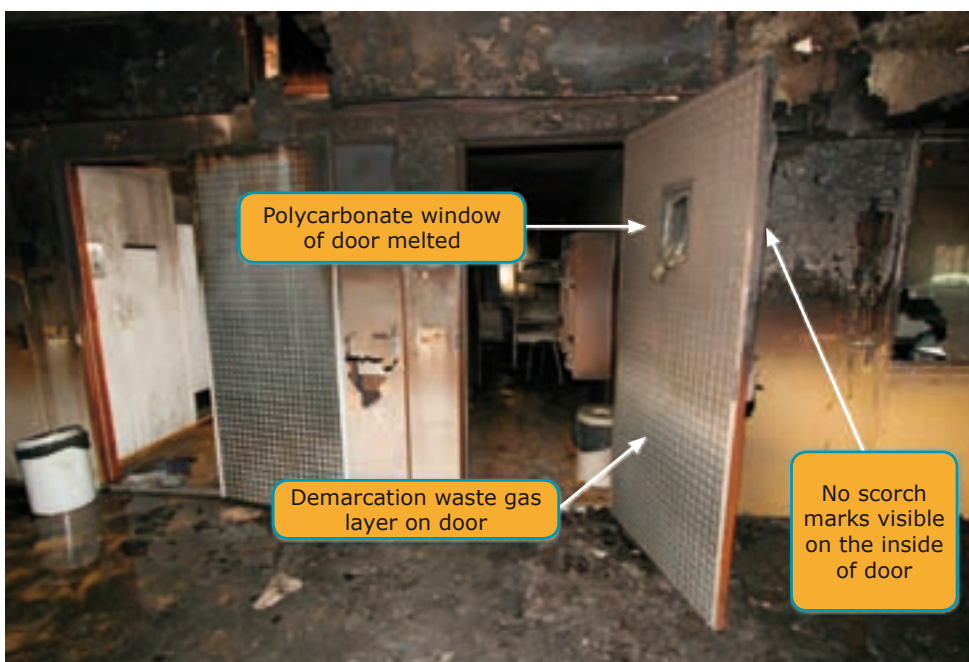
Figure 2: View of cell 6

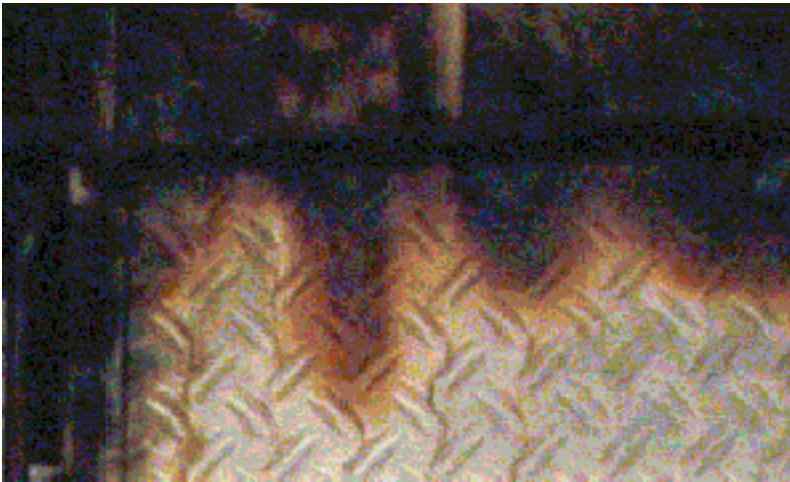
Figure 3: Finger-shaped scorch pattern on the interior of the door to cell 5

On 27 October 2005, the criminal investigation department took photographs of the cells on K Wing. This appendix includes several of these photos. These are photographs of the doors to cell 5 and cell 6 (see figures 1 and 2). A careful study of these photographs showed that the marks on the door of cell 5 are different from those found on the door of cell 6 and the other doors of the neighbouring cells. First of all, it may be seen that the interior of the door to cell 5 is charred at the top. These scorch marks are finger-shaped in the upper left corner, and these 'fingers' are pointing downwards (see figure 3). There were no scorch marks found on the door to cell 6. On the door to cell 6 however, a horizontal demarcation of the combustion gas layer was visible. This demarcation was not visible on the door to cell 5. Finally, it may be observed that the polycarbonate inspection window on the inside of cell 6 are melted as well as the small windows on the inside of the other doors. The inspection window on the interior of cell 5 did not melt however.

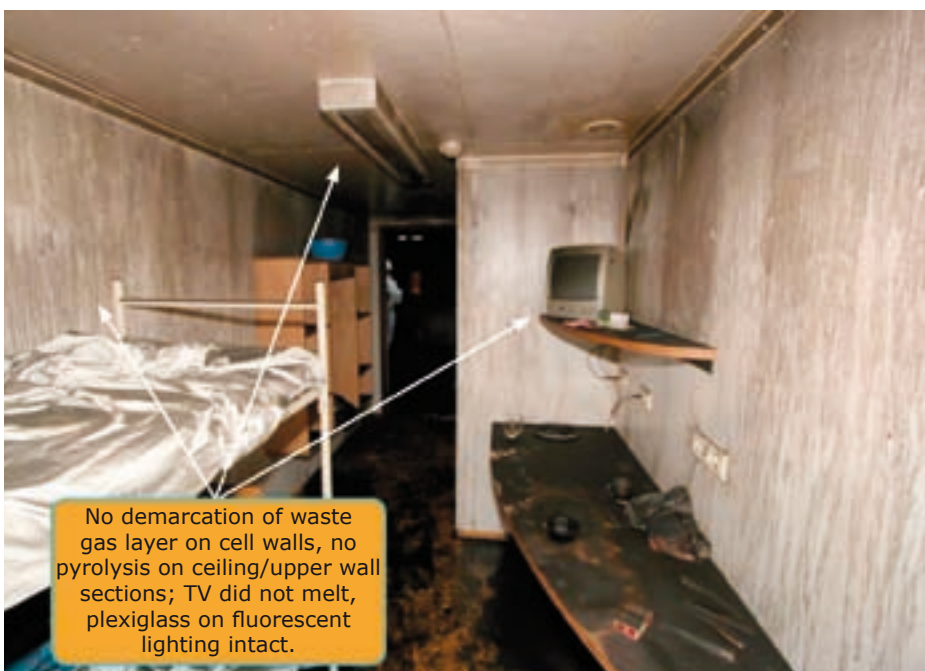
Figure 4: Interior of cell 5

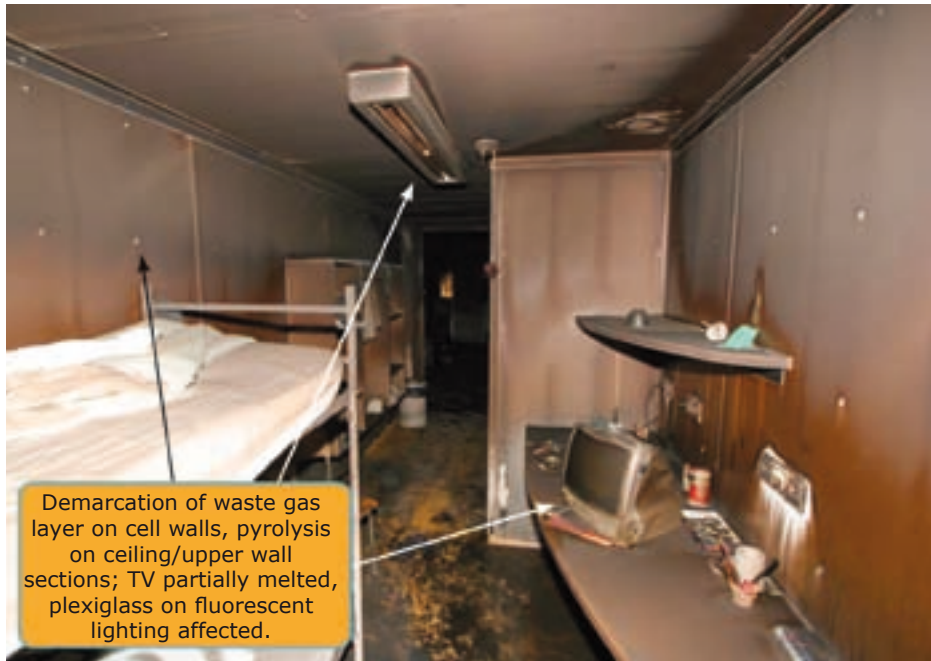
Figure 5: Interior of cell 6

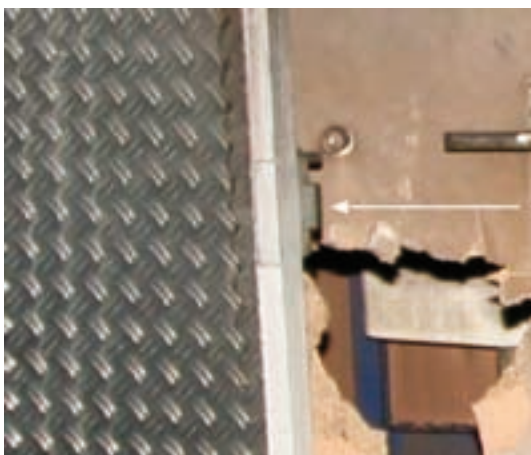
Figure 6: Bolt on the door to cell 5 turned outwards

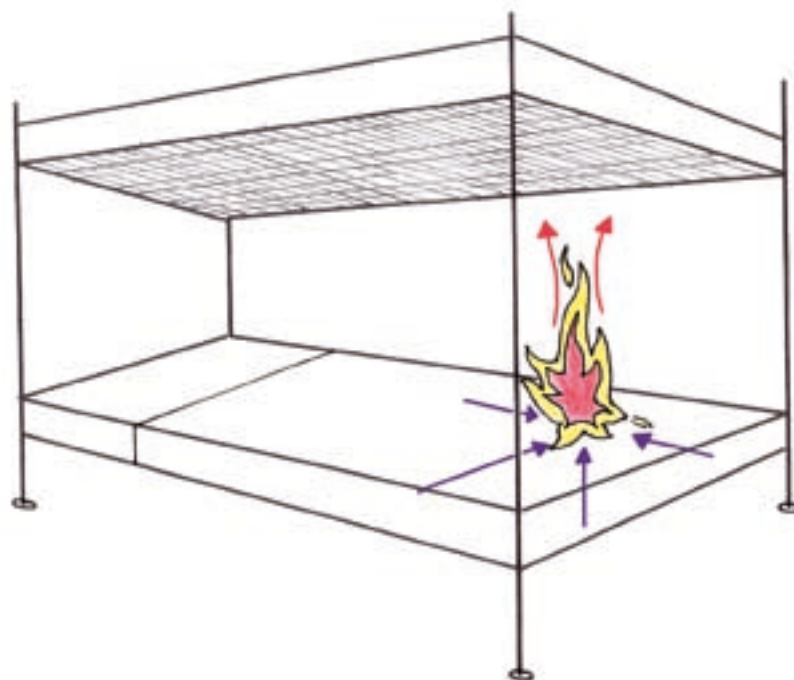
Figure 3 illustrates the initial seat of the fire on the lower mattress. The seat of the fire draws in fresh air from below; heated air rises upwards towards the upper mattress. Because the flames are small and have not yet reached the upper mattress, the seat of the fire can only spread in a lateral direction at the surface of the lower mattress. However, the spread of the fire is opposed by the direction from which the fresh (i.e. cold) air is drawn in, and as such is impeded. It takes relatively a long time before the seat of the fire spreads to such an extent and the flames get higher.

Figure 3: Initial seat of the fire on the lower mattress. The direction of the fire's development is opposed by the supply of fresh, relatively cold air (blue arrows).

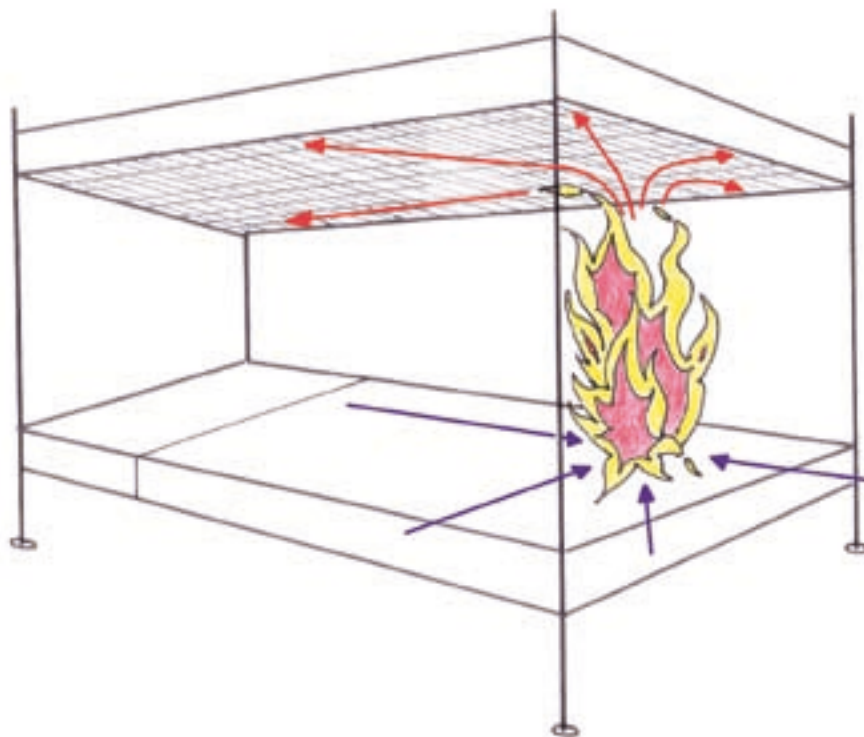
Eventually, the flames reach the underside of the upper mattress (see figure 4). Here, they come into contact with the steel springs which are under the mattress. The springs absorb the combustion heat, and this is spread across the underside of the upper mattress. It takes some time therefore before the ignition temperature of the mattress is attained. Likewise, this phase of the development of the fire takes a relatively long time.

Figure 4: Flames reach the underside of the upper mattress. The heat is spread across a large surface by the bed springs (red arrows).

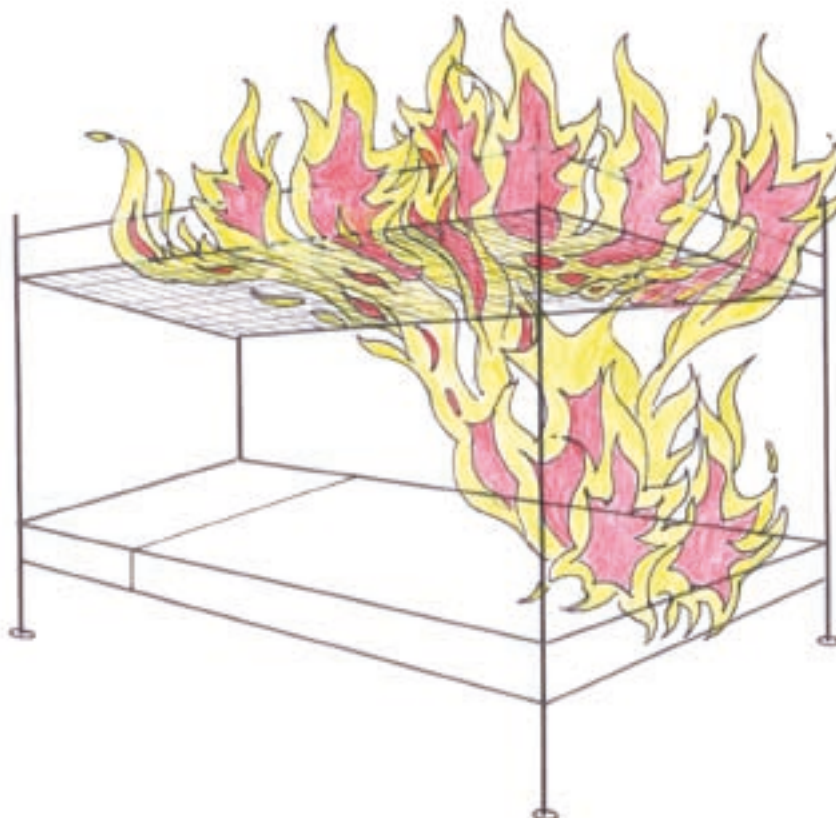
Figure 5: Fire takes hold of the upper mattress in full.

Because the steel bed spring spreads the combustion heat across the underside of the upper mattress, the mattress does heat up slowly, but across an extensive surface. At the point when the mattress eventually attains its ignition temperature, it starts to burn all over almost immediately (figure 5). From that point onwards, the heat released by the fire develops extremely rapidly (see figures 1 and 2). Situated in a space the same size as cell 11, the burning bunk bed now reaches enough capacity for flashover. Finally, the flashover causes a rapid increase in the production of smoke (see appendix 5)²⁸.

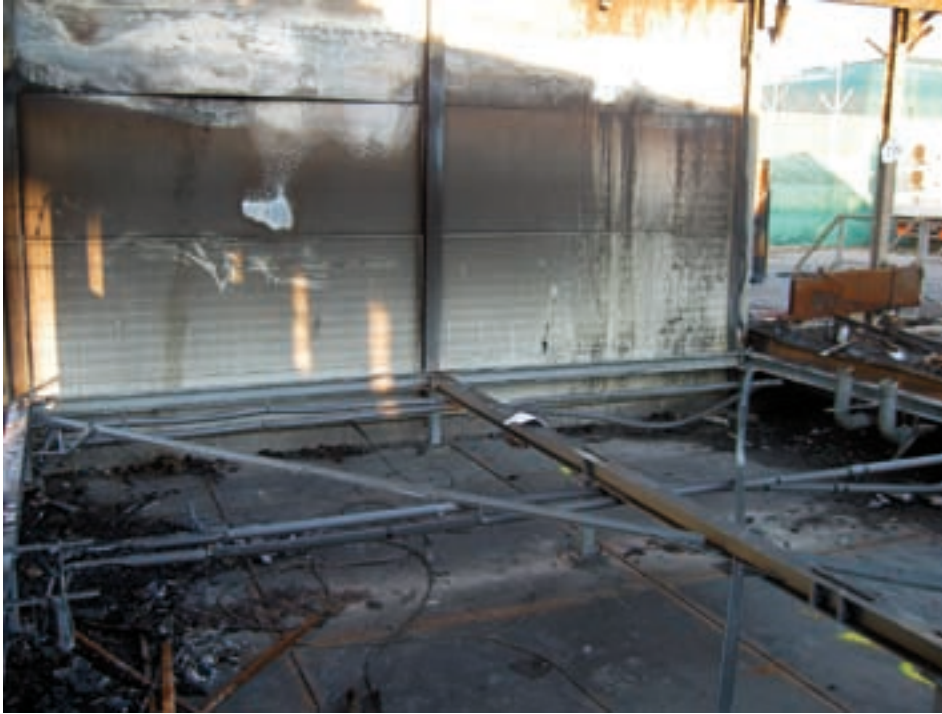
Figure 11: Far wall on the inside, where cell 11 was situated. The cell has been removed in this picture. To the left of the centre of the picture, the intense burn imprint, which formed next to the bunk bed in the cell, is visible.

To summarize, we can conclude that no relationship with the primary seat of fire can be demonstrated from any of the fire traces in cell 11. The fire traces therefore do not provide any information about how the fire in cell 11 was caused.

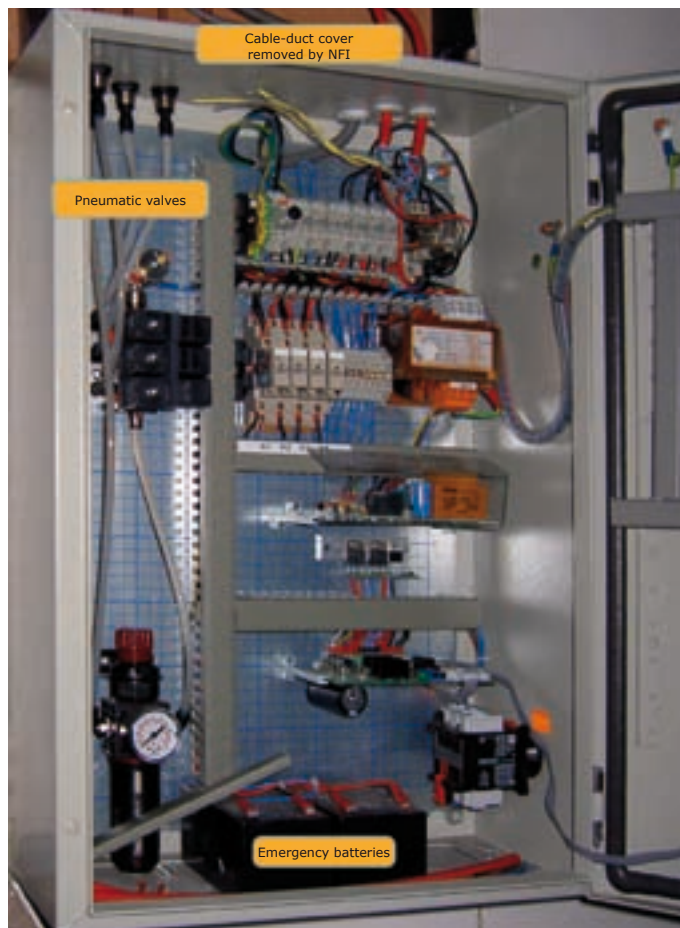
The technical components of the SHE (control box, compressor and air receiver) were located in a technical area in the central connecting corridor close to J and K Wing. This technical area was not affected by the fire. A photograph of the SHE (figure 1) may be found below.

Figure 1: SHE control box
