DUTCH
SAFETY BOARD

Capsizing and sinking of fishing vessels

Lessons learned from the occurrences
involving the UK-165 Lummetje and
the UK-171 Spes Salutis

The Hague, June 2021

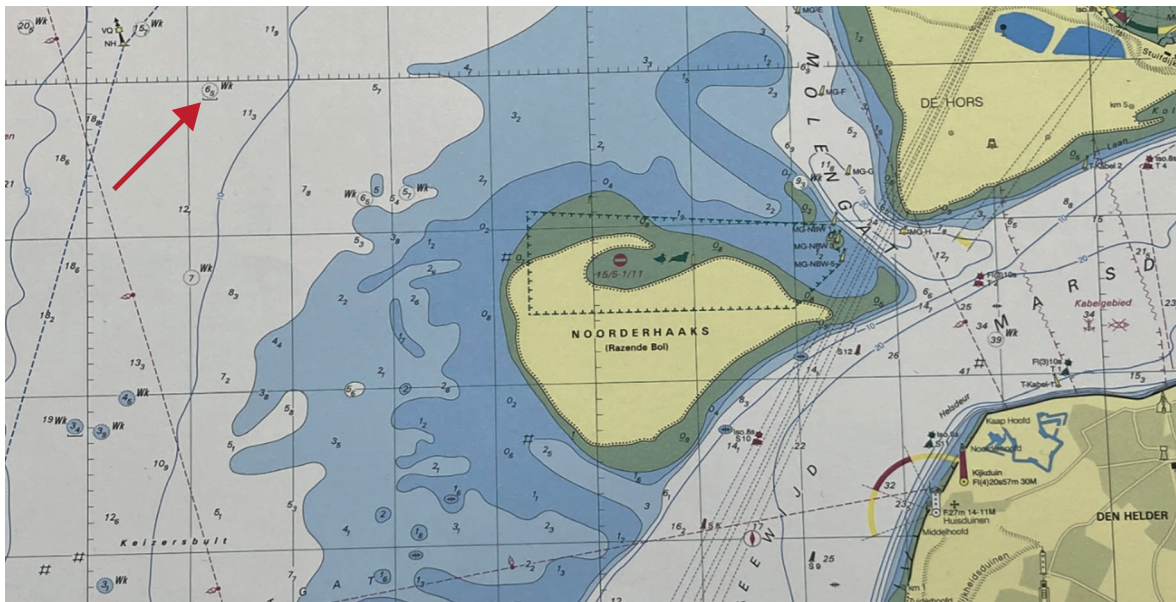
The occurrence involving the UK-165 took place on 28 November 2019 at around 05.42 hours³ (Dutch time). It was dark, with a strong west-southwesterly wind force of 5 to 6 Beaufort. In the run-up to the occurrence, the beam trawler UK-165, with its bow pointed roughly in a northerly direction, was following a north-northeasterly course over the ground⁴ approximately 4 nautical miles⁵ to the west of Texel. At this point, the current was flowing at a rate of 1.2 knots in a north-northeasterly direction (030°). The investigation revealed that the waves were running in the same direction as the wind and the current. Witness statements revealed that there was considerable swell. The trawler disappeared from the radar at the location shown in Figure 1.

Figure 1: Section of sea chart showing the position in which the UK-165 disappeared from the radar. (Source: Hydrographic chart 1801.10)

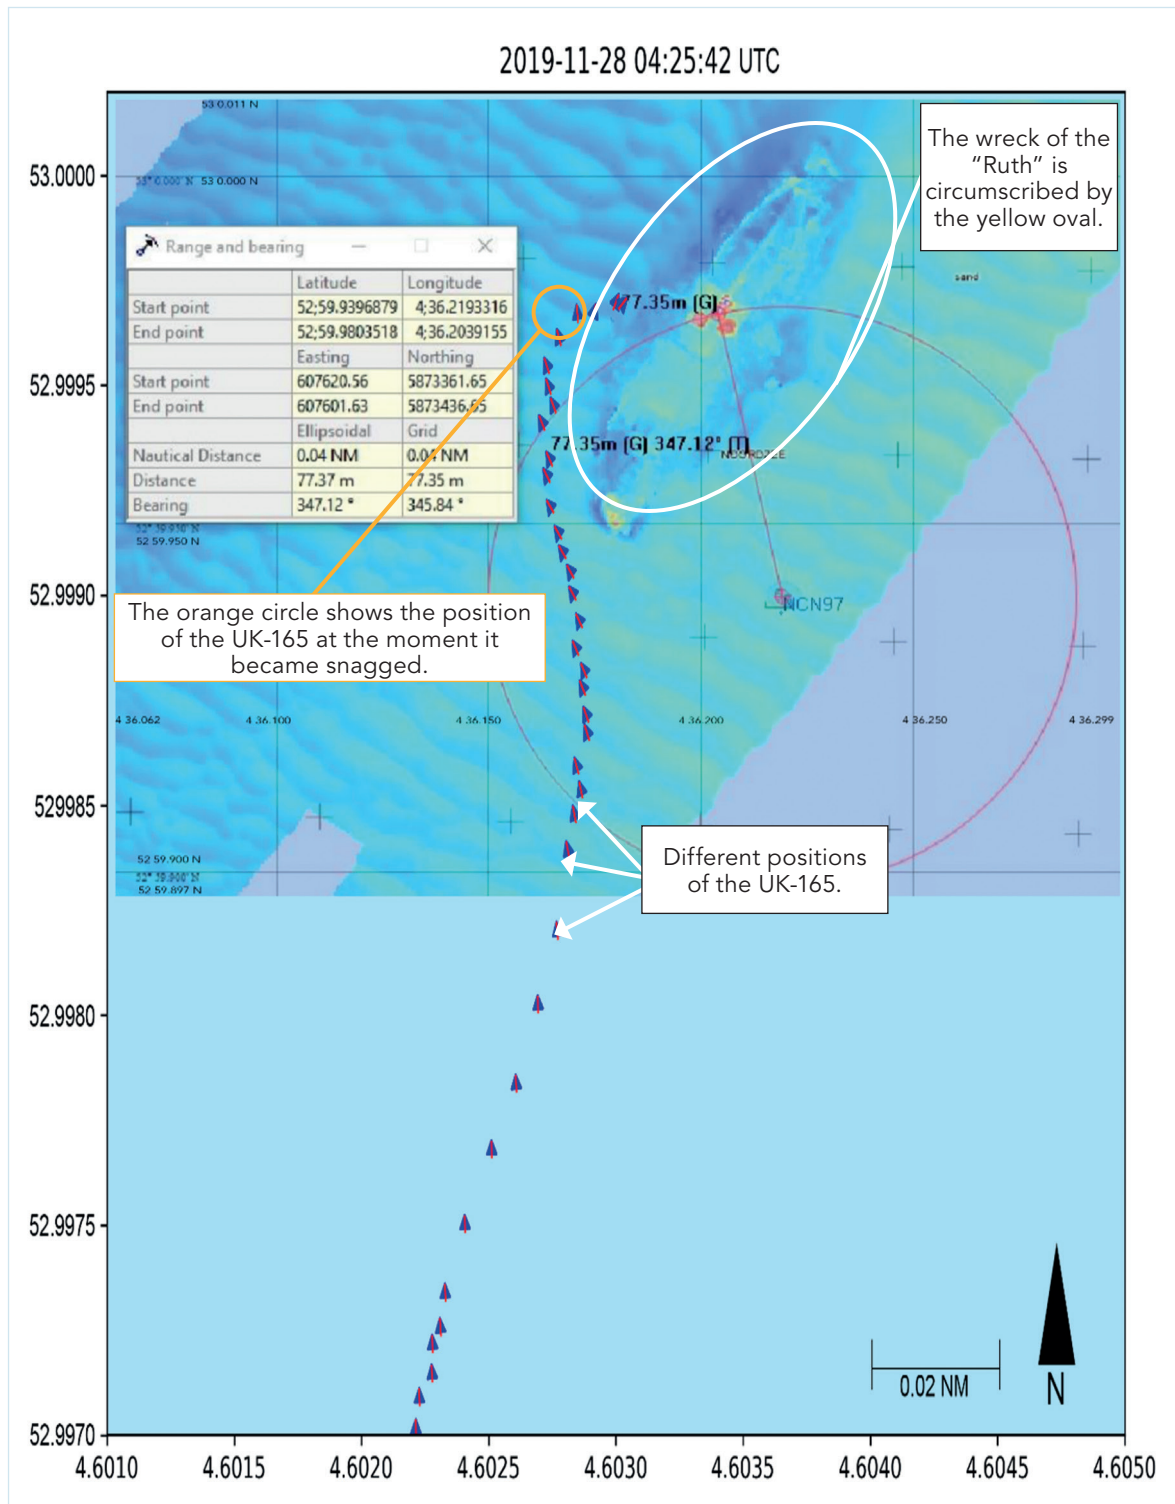
Figure 2: Track of the UK-165 up to the moment of becoming snagged. (Source: RWS and Dutch Safety Board)

As it approached the wreck, the UK-165 started to shift its heading to port. The AIS⁹ data on which Figure 2 is based show that current and wind conditions meant that a compass course alteration of approximately 45 degrees resulted in only a relatively small change

in the course over the ground of between 15 and 20 degrees. The altered compass course did not take the UK-165 far enough away from the wreck of the Ruth.

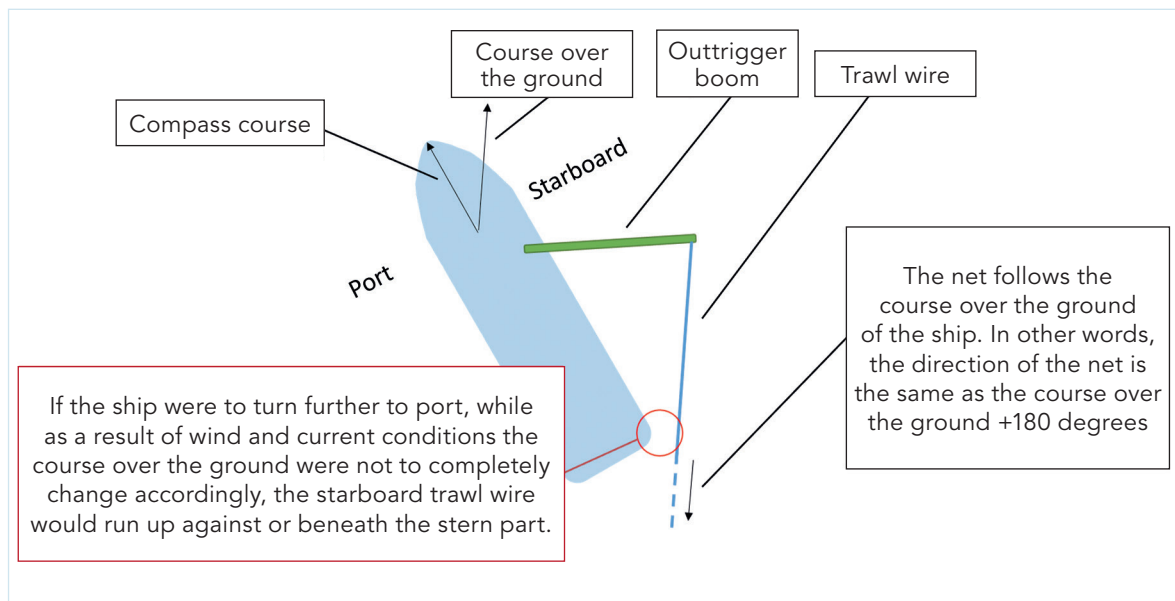
Figure 4: Starboard trawl wire close to the stern part. (Source: Dutch Safety Board)

The AIS data show a very abrupt change in both compass course and course over the ground, when the nets, that were suspended approximately 50 to 60 metres behind the ship, reached the position of the bow of the Ruth. The position of the UK-165 at this moment (05.25:29 hours) is marked in Figure 2 with a small orange circle. At that point, partially propelled by current and wind, the vessel was travelling at a speed of 3.8 knots over the ground.

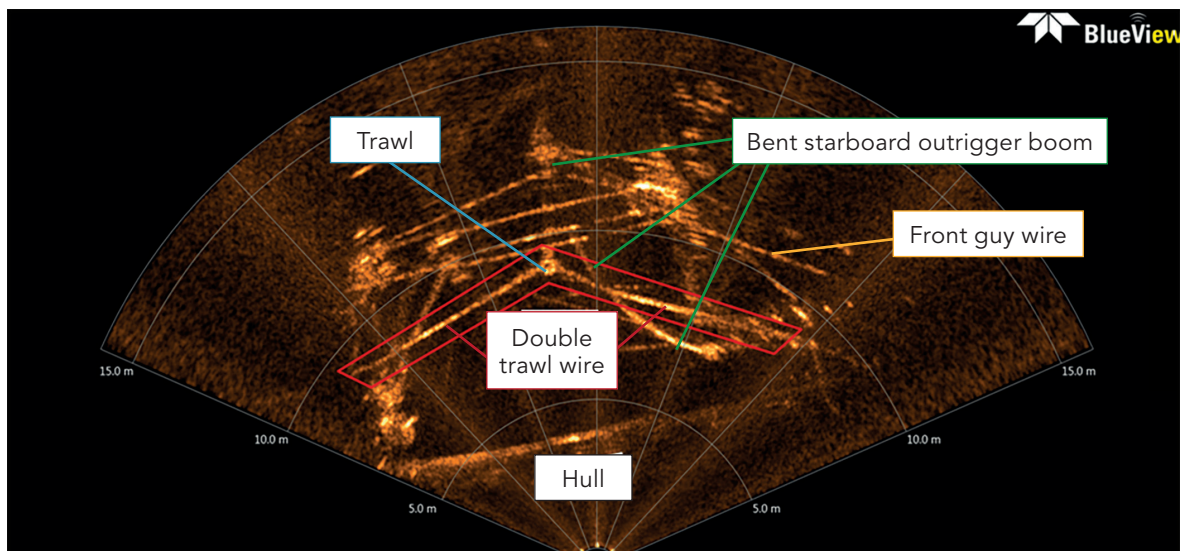
- The UK-165 was found 600 metres north-northeast of the wreck of the Ruth, on the seabed.
- The port fishing gear was intact. The port outrigger boom had been set at an angle of 45 degrees, and the port gear had been hauled in to the tip of the port outrigger boom. The cod end of the fishing net had been lifted to above the afterdeck. It can therefore be concluded that after becoming snagged, the crew had been working to haul in the port net to prevent the net or the trawl wire coming into contact with the propeller, while manoeuvring. The investigation revealed that this was standard procedure on board, whenever the gear became snagged with an obstacle on the seabed.

- The double sheared starboard trawl wire was intact. This wire travelled from the winch below the wheelhouse via the stern part and the guide pulley behind the mast to the quadrant block suspended from a small davit on the fore part. From there the trawl wire travelled via the trawl block past the rear mast and backwards away from the ship towards the wreck of the Ruth. This is shown on the underwater image in Figure 5. More than 60 metres behind the ship, the trawl wire travelled via the underwater block back to the ship, past the rear mast and through the trawl block back to the davit, to which the quadrant block was also attached. At that point, the trawl wire was connected to the davit via a shackle.

Figure 5: Underwater image wreck UK-165. (Source: Rijkswaterstaat)

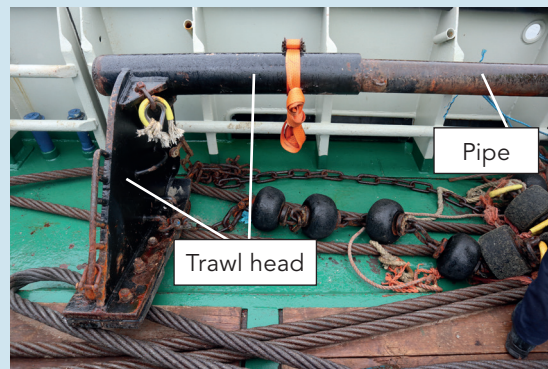
- Three chains were attached to the starboard underwater block. Two of these chains were connected on the other side to the trawl heads of the starboard beam trawl. The pipe (or beam) which should have been in place between the two trawl heads was missing. The majority of the fishing net and the bobbin wire were missing.
- Both heavy steel trawl heads on the starboard gear were discovered to be displaced. This is clear evidence that the trawl heads had been subjected to considerable forces.

Figure 7: Trawl head and pipe of the port beam trawl of the UK-165. (Source: Dutch Safety Board)

On board the UK-165, as shown in Figure 6, the catch nets were attached to the underwater block through which the trawl wire was passed, with three chains. Figure 7 shows one of the trawl heads of the portside beam trawl of the UK-165, once it has been raised above water, during the recovery.

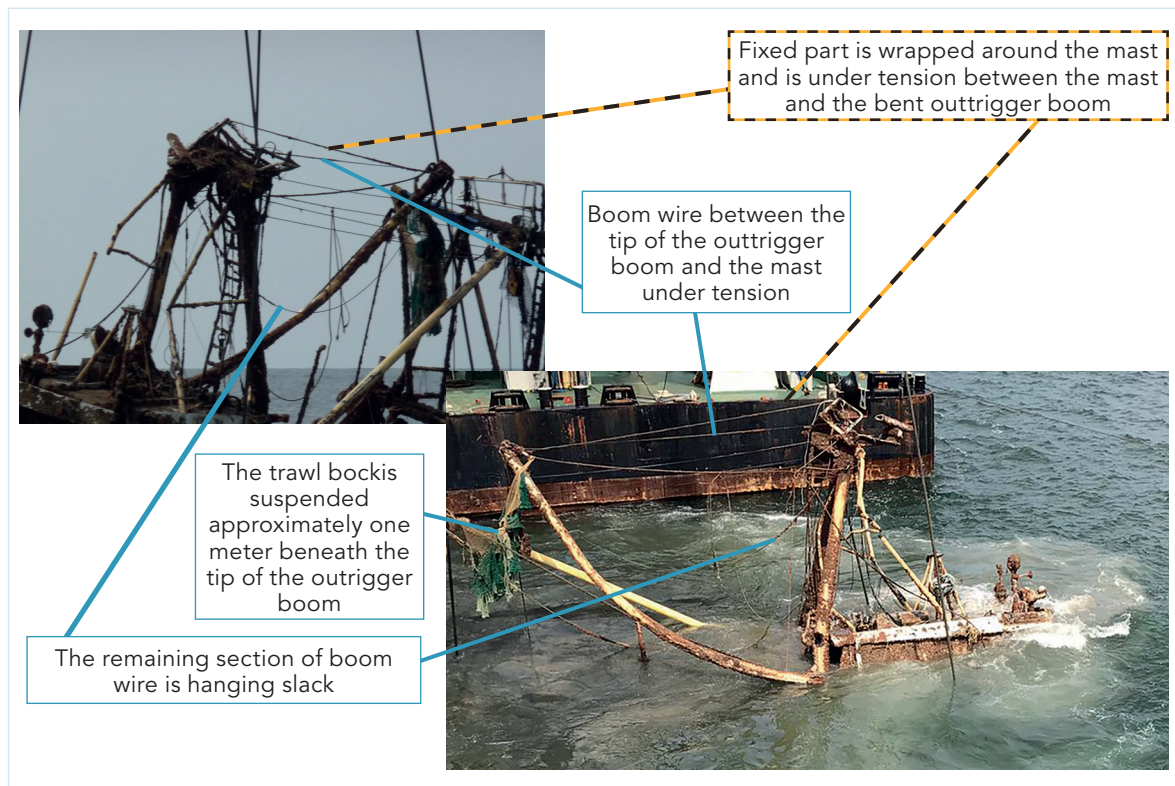
- The starboard outrigger boom was bent towards the mast.
- The fixed section between the mast and the tip of the outrigger boom was wrapped around the mast, where it became trapped behind the remains of a small platform. The part leading to the tip of the outrigger boom was taut, while the other part hung slack.
- The starboard trawl block was suspended approximately one metre below the tip of the starboard outrigger boom. The slip construction was open or had failed, which meant that the trawl block could hang in this position.
- The boom wire on the starboard trawl block passed through the tip of the starboard outrigger boom to the top block on the mast, and due to the weight of the trawl block was under tension. The boom wire was trapped near the mast, in the bracket attaching the fixed part to the boom wire. This bracket was itself trapped between

the remains of the small platform on the mast. Part of the boom wire hung slack. This was the part which ran from the winch beneath the wheelhouse, via the lower block to the mast and via the block on the lower lifting beam from the slip patent to the upper block in the mast (Figure 8).

Figure 8: Photographs of recovery with explanatory notes. (Source photograph top left: Dutch Safety Board. Source photograph bottom right: Multiship Towage & Salvage).

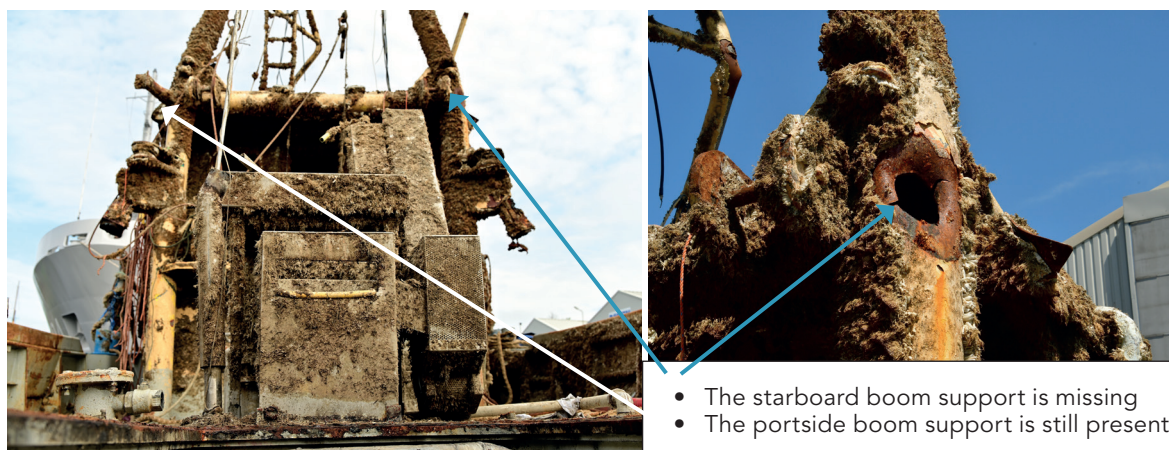
- The rear guy wire of the starboard outrigger boom was broken, with badly frayed break.
- The starboard trawl wire on the winch below the wheelhouse was severely tangled. This effect occurs when the winch is paying out, while the wire on the winch is not running out quickly enough, if at all. In other words, if there is no or too little tension on the wire.
- The support on the starboard mast, against which the outrigger boom rests when raised to the vertical position, had broken off. Figure 9 clearly shows that at this point the mast is dented, and there are clear tears in the metal. This is an indication that the boom smashed into the support with considerable force.

Figure 9: Missing boom support. (Source: Dutch Safety Board)

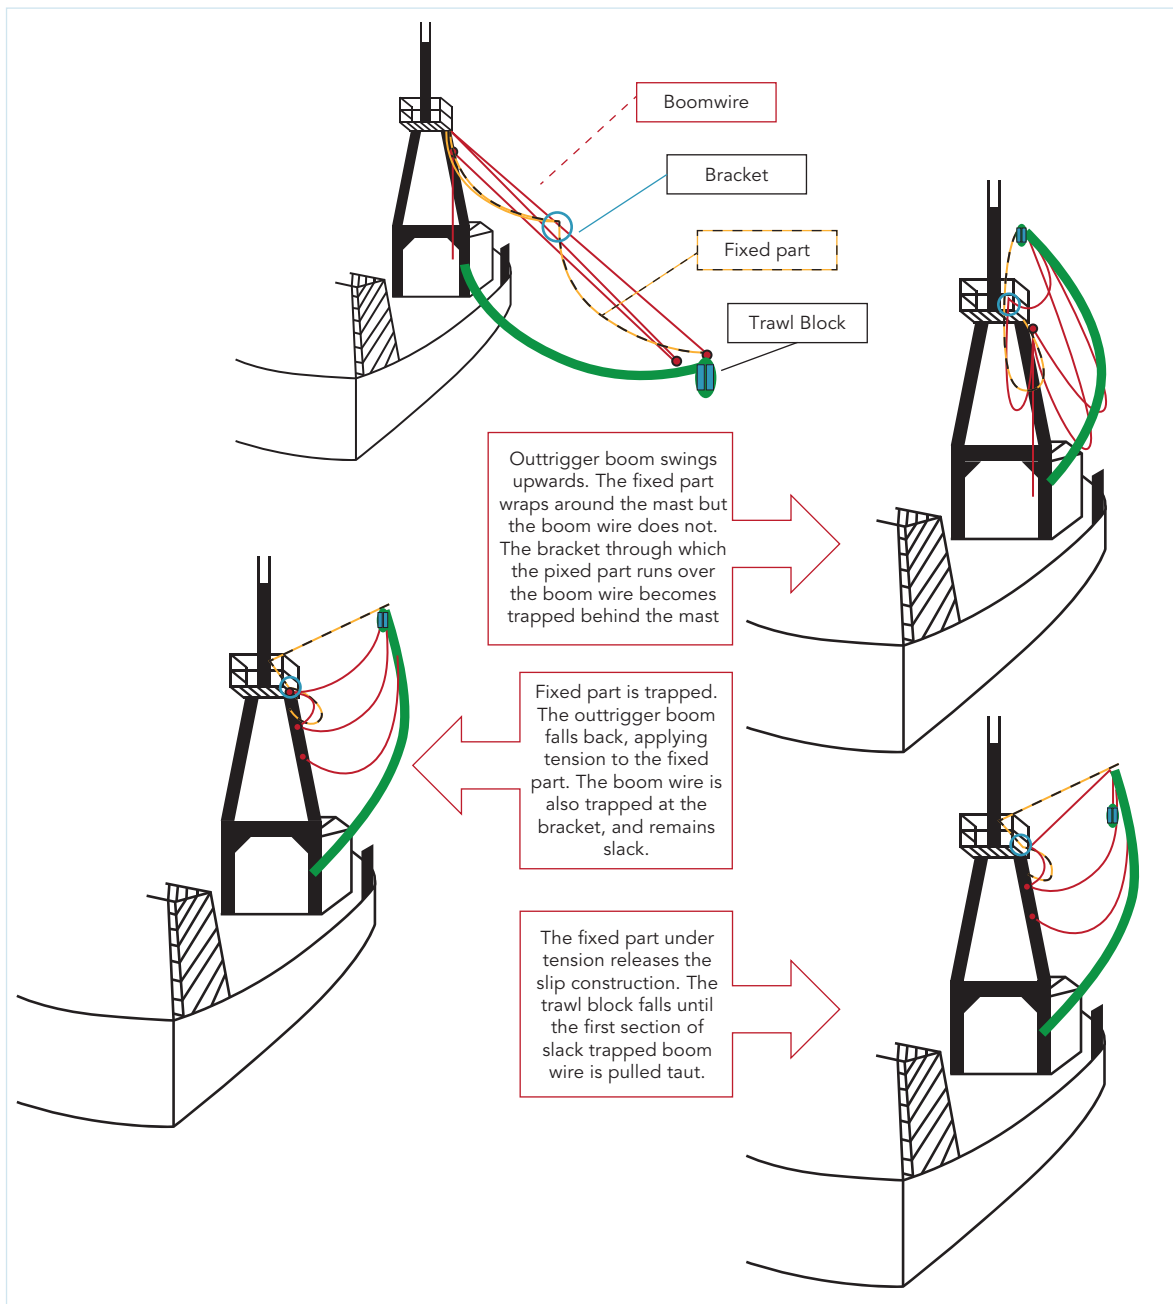
Figure 10: Swinging up of the boom and release of the slip construction. (Source: Dutch Safety Board)

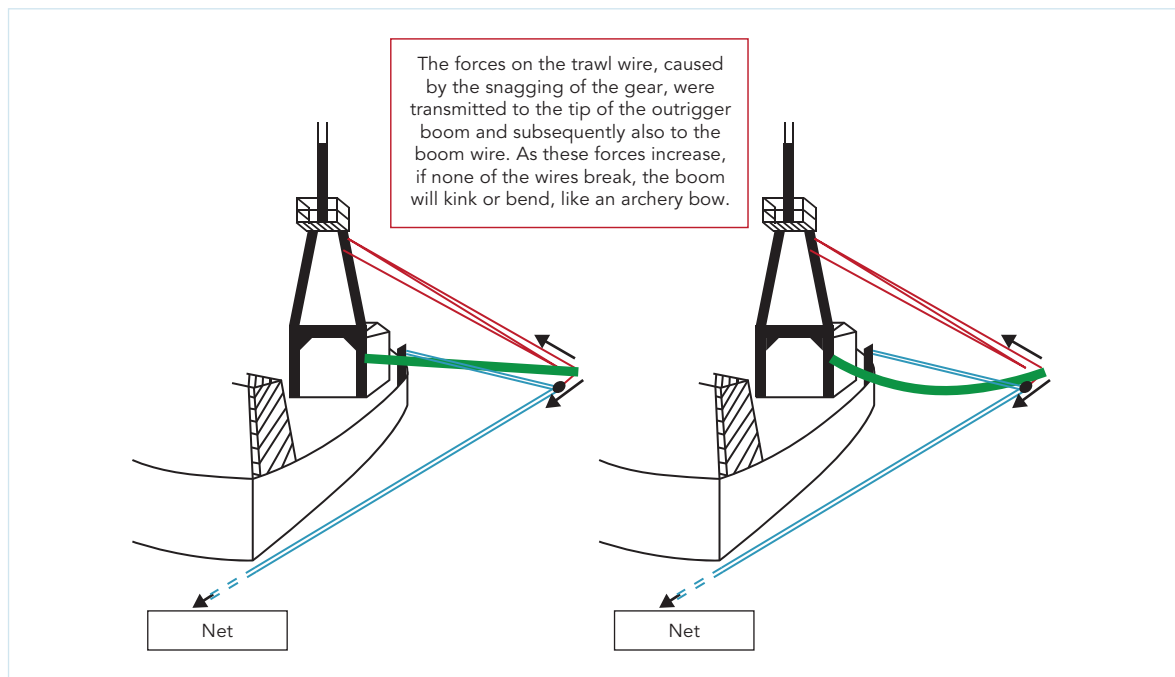
Because huge forces must have been involved in the bending of the starboard outrigger boom, without being able to draw a conclusion with absolute certainty, it seems apparent that the bending took place when the gear became snagged. As described earlier in this report, and as further illustrated in Figure 11, the trawl wire travelled at an angle past the rear of the stern part. The outrigger boom was bent in the same way that a bow is bent during archery. In this situation, it is entirely possible that the boom was bent with the tip of the boom bending towards the mast, rather than towards the water.

Figure 11: Bending of the outrigger boom. (Source: Dutch Safety Board)

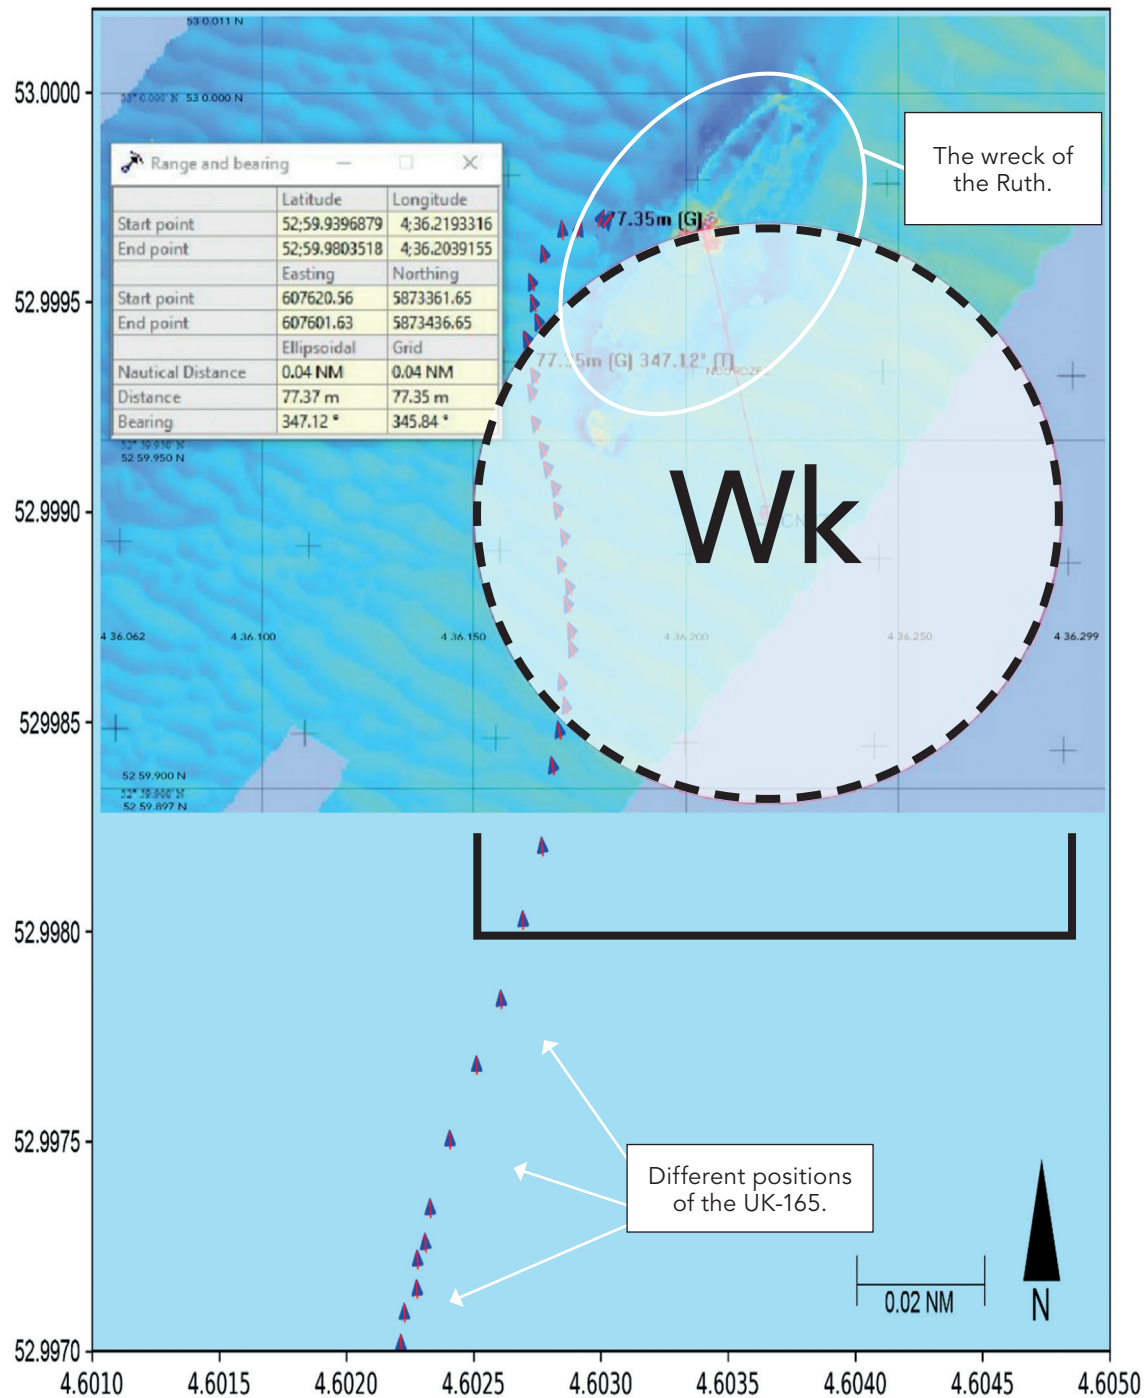
Figure 12: Track of the UK-165 up to the moment of becoming snagged. The wreck symbol on the paper sea chart is projected. (Source: RWS and Dutch Safety Board)

A wreck is marked on a paper chart with a symbol. The symbol covers part of the chart. According to the scale of the chart, it is possible to determine how large the area of the covered section of the chart is, in reality.

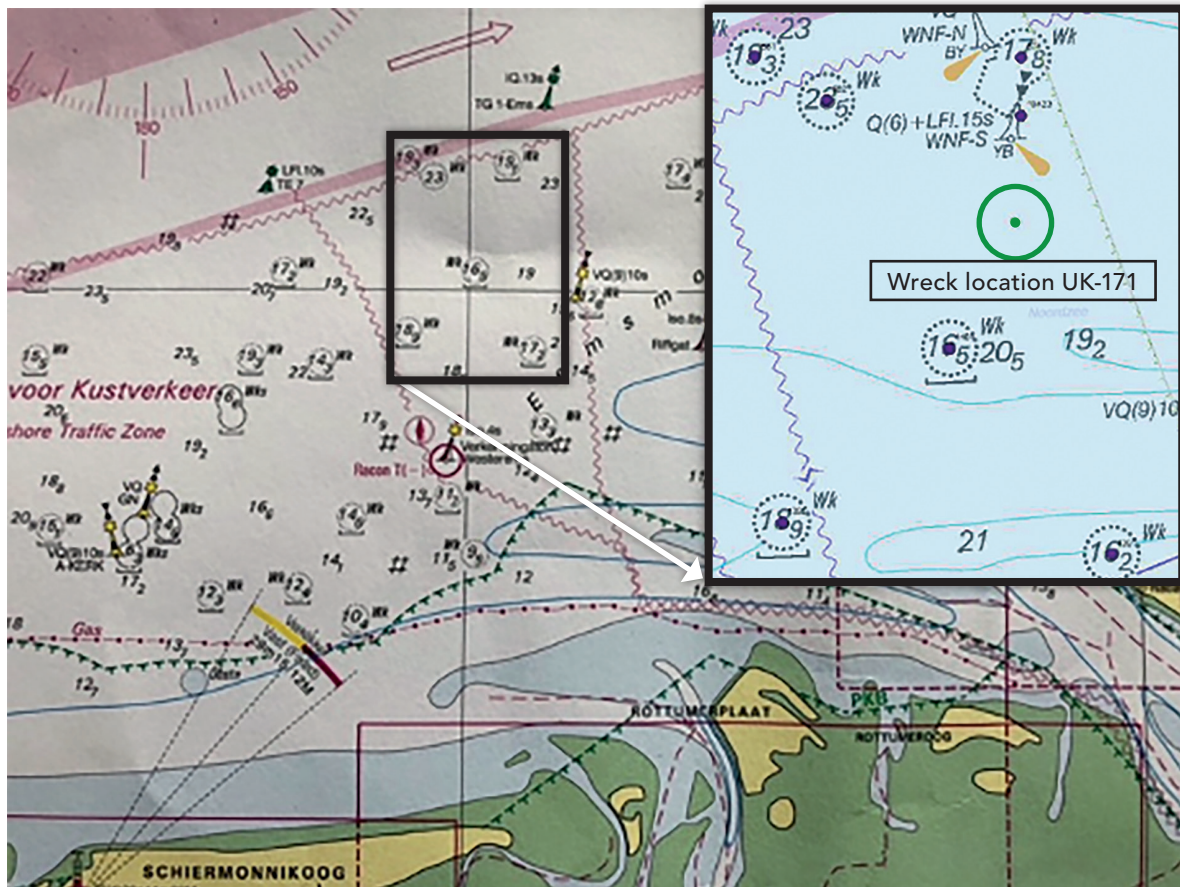
Figure 14: Section of sea chart showing the position of the wreck of the UK-171. (Source: Rijkswaterstaat)

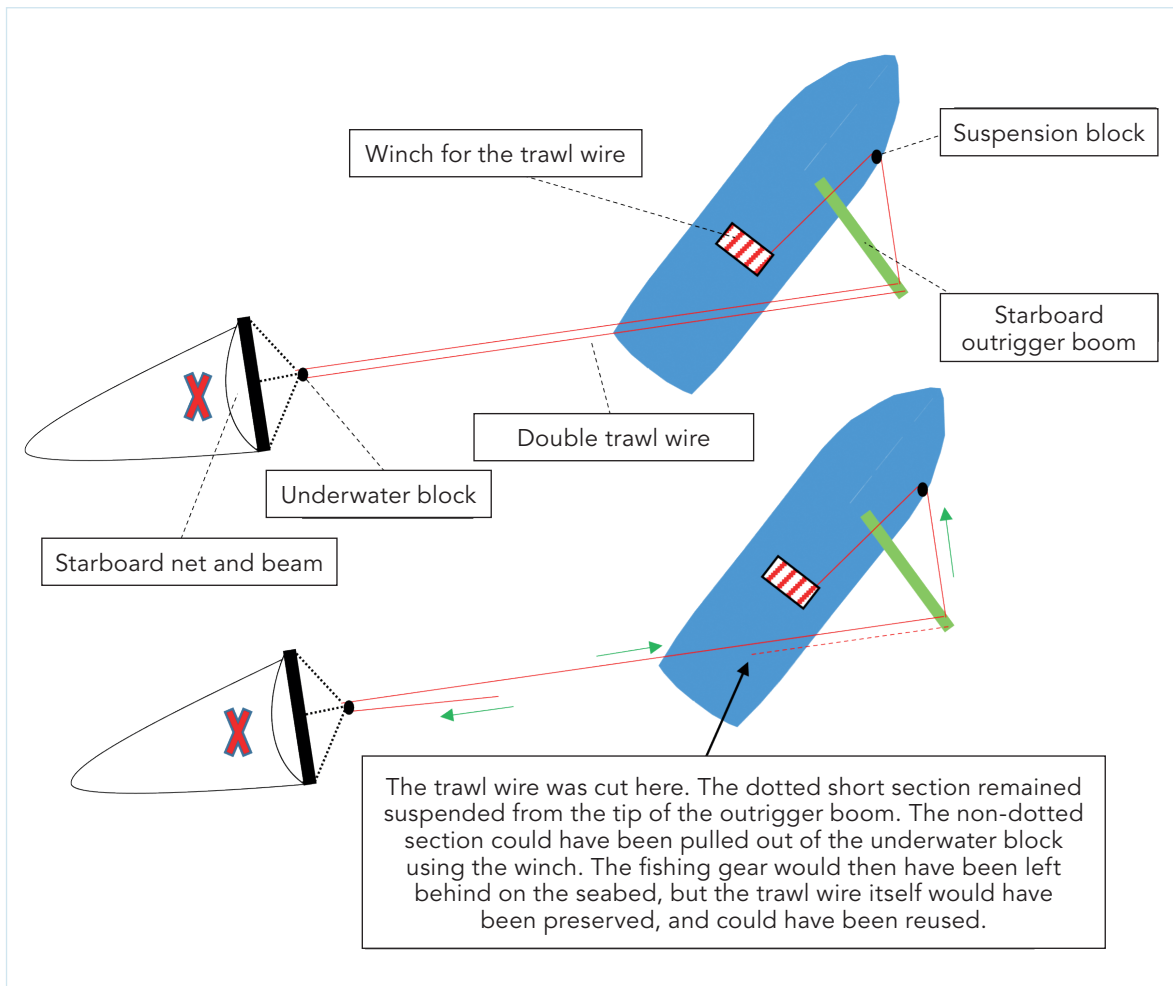
Figure 15: The cutting of the starboard trawl wire on the UK-171. (Source: Dutch Safety Board)

On the UK-171, the trawl wires were double run, as shown for the starboard side in diagrammatic form, in Figure 15. From the winch below the wheelhouse, the wire travelled via the suspension block to the tip of the outrigger boom, and from there to the underwater block, that was attached to the beam trawl and fishing net with a series of chains. The trawl wire then ran back to the tip of the outrigger boom, through the underwater block. At that point, the trawl wire was attached to the tip of the boom with a shackle.

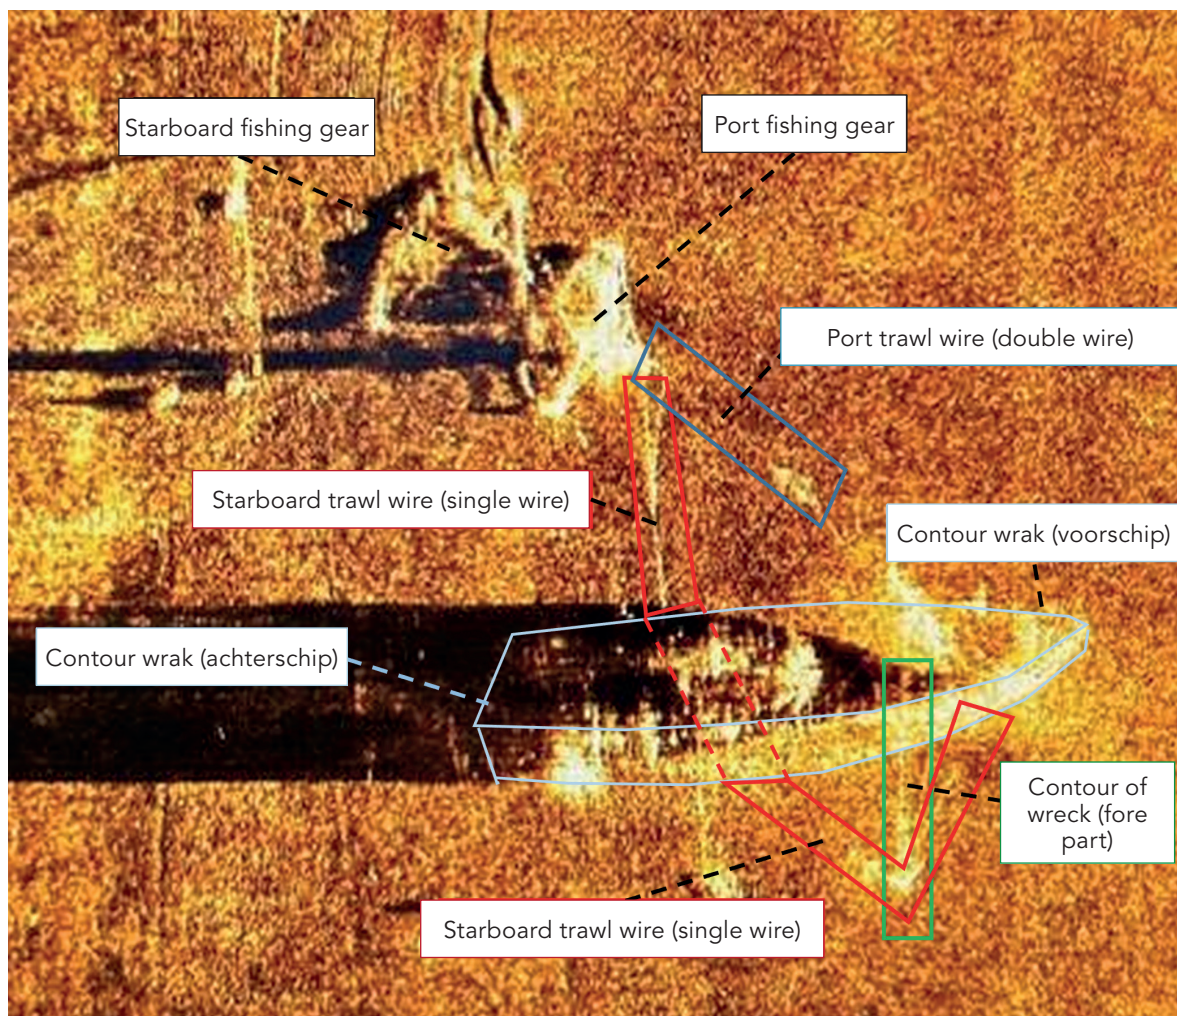
In Figure 16, the contour of the hull of the wreck is shown in light blue. Both sets of fishing gear were found close together on the port side of the wreck. In the red-marked area, we also see the starboard trawl wire. This runs from the starboard bow of the vessel to the tip of the starboard outrigger boom and then appears to run under the wreck towards the two sets of gear. The starboard outrigger boom is marked within the green area. The dark-blue area surrounds the port trawl wire.

Figure 16: Sonar image of the wreck of the UK-171 on the seabed. (Source: Rijkswaterstaat)

The sonar image in Figure 16 appears to show the port and starboard fishing gear entangled together. If the starboard trawl wire had become trapped in this entanglement, that would explain why the starboard trawl wire could not be pulled through the underwater block.

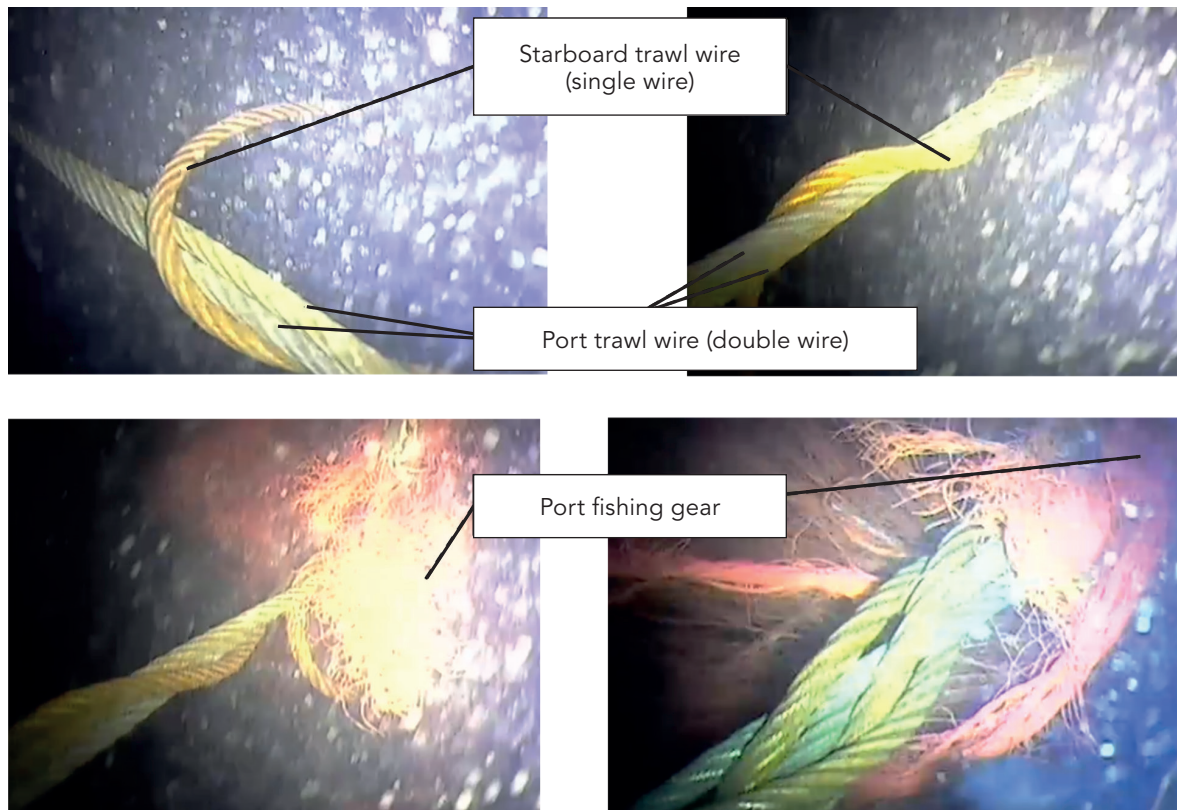
This information also clarifies why during the hauling in of the port fishing gear, the starboard fishing gear was also raised. At a certain moment, the weight of both sets of fishing gear was suspended from the portside outrigger boom.

Figure 17: Starboard and port trawl wires UK-171 entangled. (Source: Multraship Towage & Salvage)

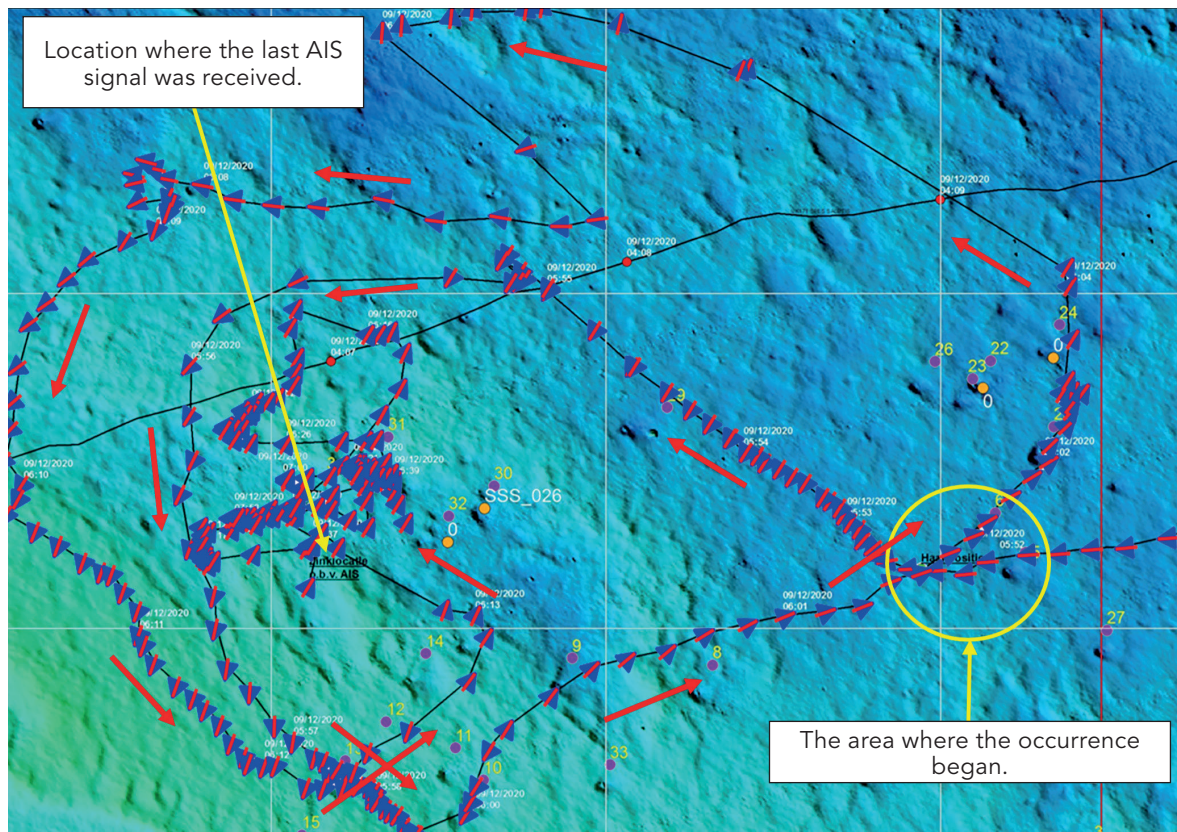
The AIS data shows that while fishing, the vessel maintained a fixed heading and fixed speed for a lengthy period of time. In the area marked in Figure 18 with a yellow circle, that period of fixed heading and speed ends abruptly. Thereafter there was no comparable period. This leads to the conclusion that the occurrence started in the area marked by the yellow circle. It was in this area that the deputy skipper felt the starboard fishing net jolt.

There are two rocks of sufficient format to be recorded in the underwater survey in the area marked by the yellow circle, but it is not possible to say with certainty that these rocks were actually involved in the occurrence. Moreover, no damage was observed to the nets, after they were recovered. There were no large rocks or other heavy objects in the nets. It was not possible to determine what caused the jolting of the starboard fishing gear.

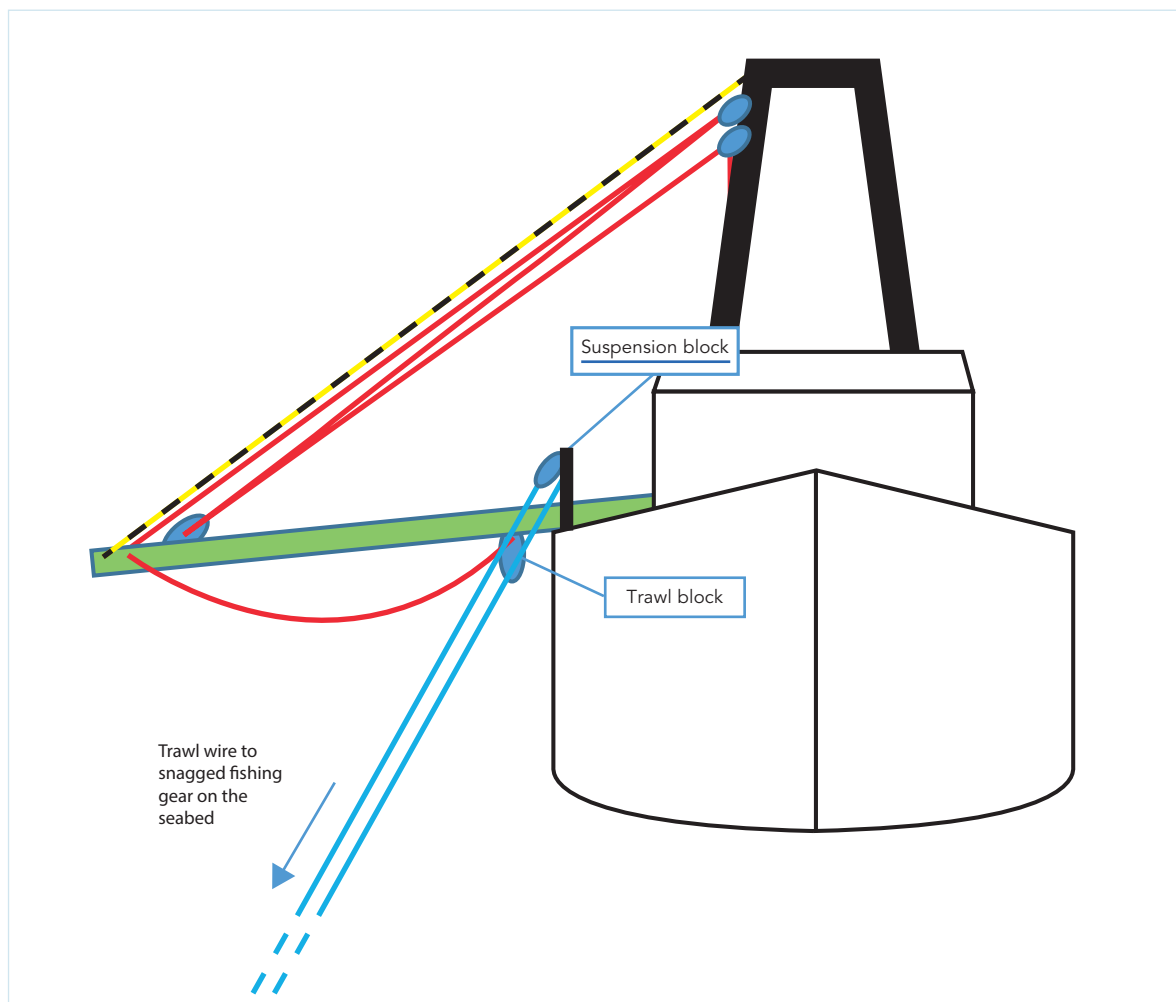
This slip construction had an important function in situations in which the fishing gear became snagged behind an obstacle on the seabed. The trawl wire attached to the fishing gear passed through the trawl block. Pulling on the fishing gear to release it, while the block was clamped against the boom would have resulted in the applied force being transferred to the boat, via the boom. At that point, the end of the boom was relatively far from the transverse midpoint of the boat, which would result in a relatively large heeling moment, with the risk of capsizing. By slipping the trawl block, the block could be pulled towards the gangway, a position far closer to the transverse midpoint. As a result, the heeling moment would be far lower, and consequently so would the risk of capsizing. This is shown in Figure 25.

Figure 25: The slipped trawl block is paid out to below the suspension block. In other words, there is no more force applied to the slack hanging boom wire, and as a consequence to the (tip of the) boom. (Source: Dutch Safety Board)
