DUTCH
SAFETY BOARD

Insufficient thrust setting for take-off

The Hague, March 2018

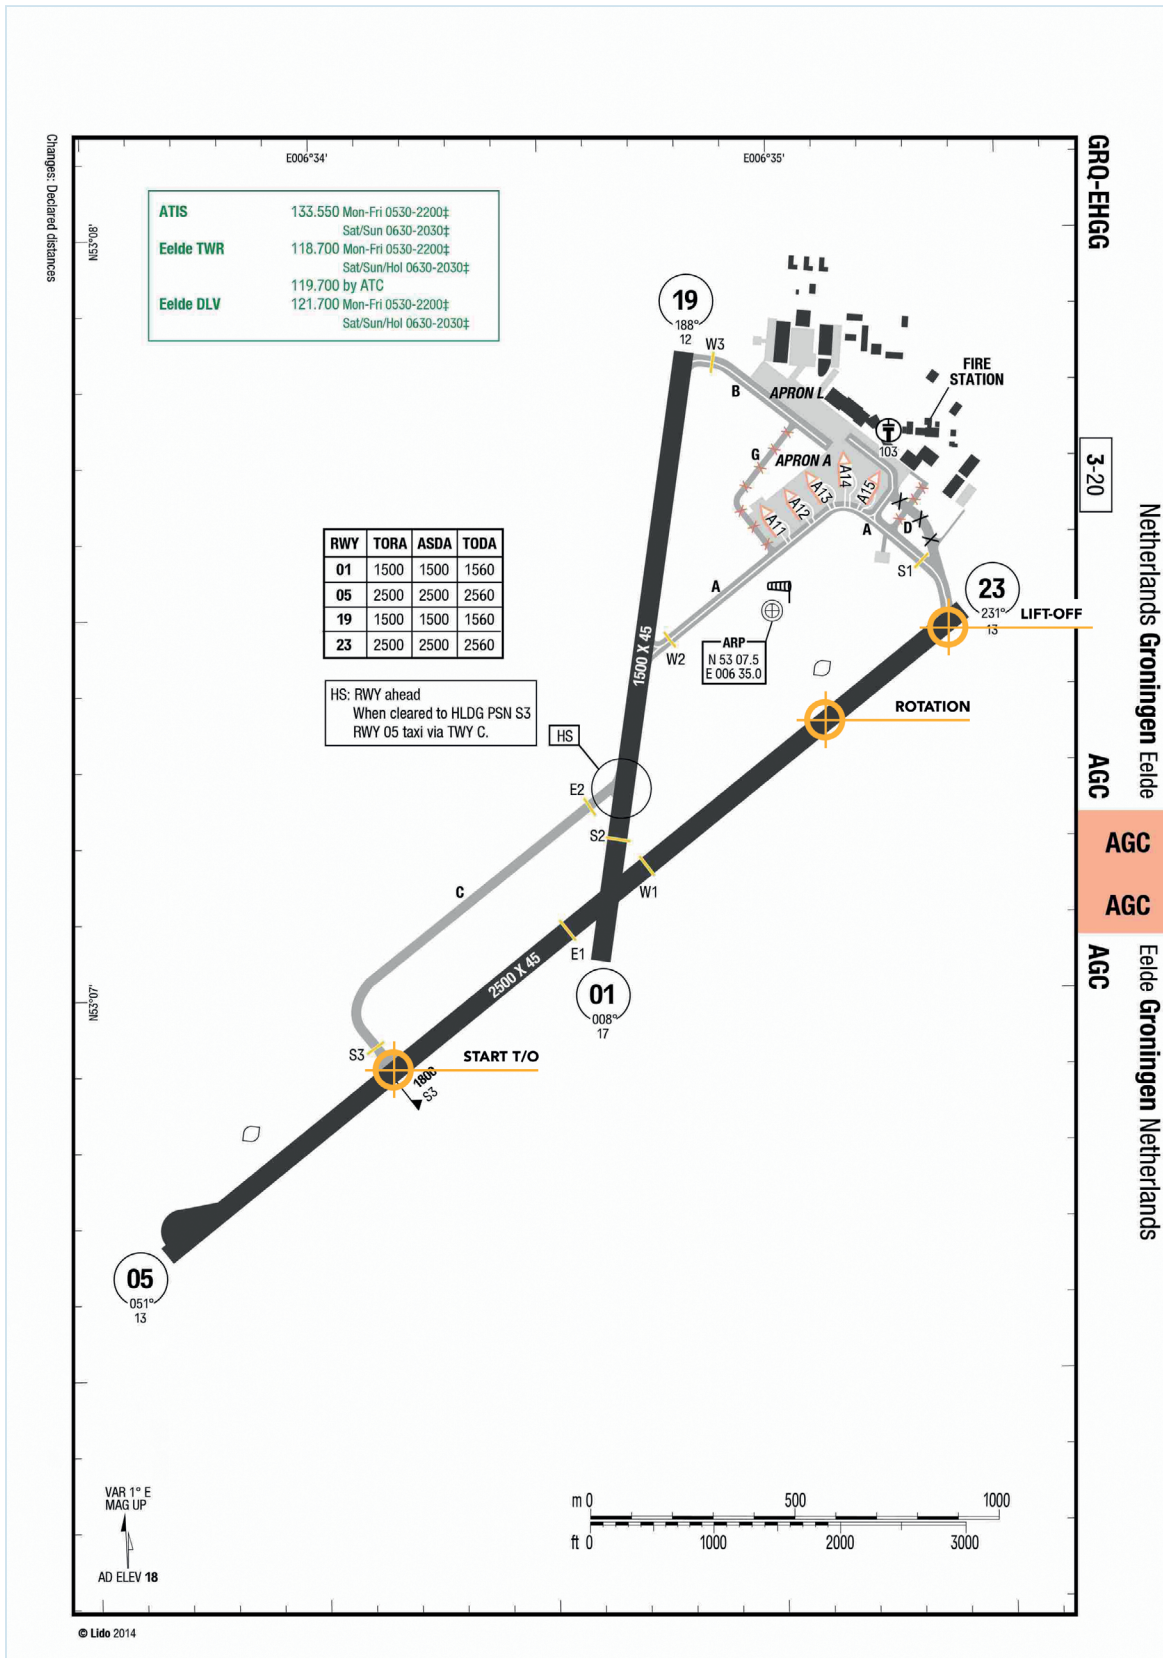
Groningen Airport Eelde (elevation 18 ft) has two runways (see *Figure 2*). Runway 01-19 is 1,500 m long and runway 05-23 is 2,500 m long. The length of runway 05 from intersection S3 is 1,800 m. To use the full length of runway 05, a backtrack from intersection S3 to the beginning of runway 05 is required.

Figure 2: Groningen Airport Ground Chart, the Start T/O, Rotation and Lift-Off positions are marked.

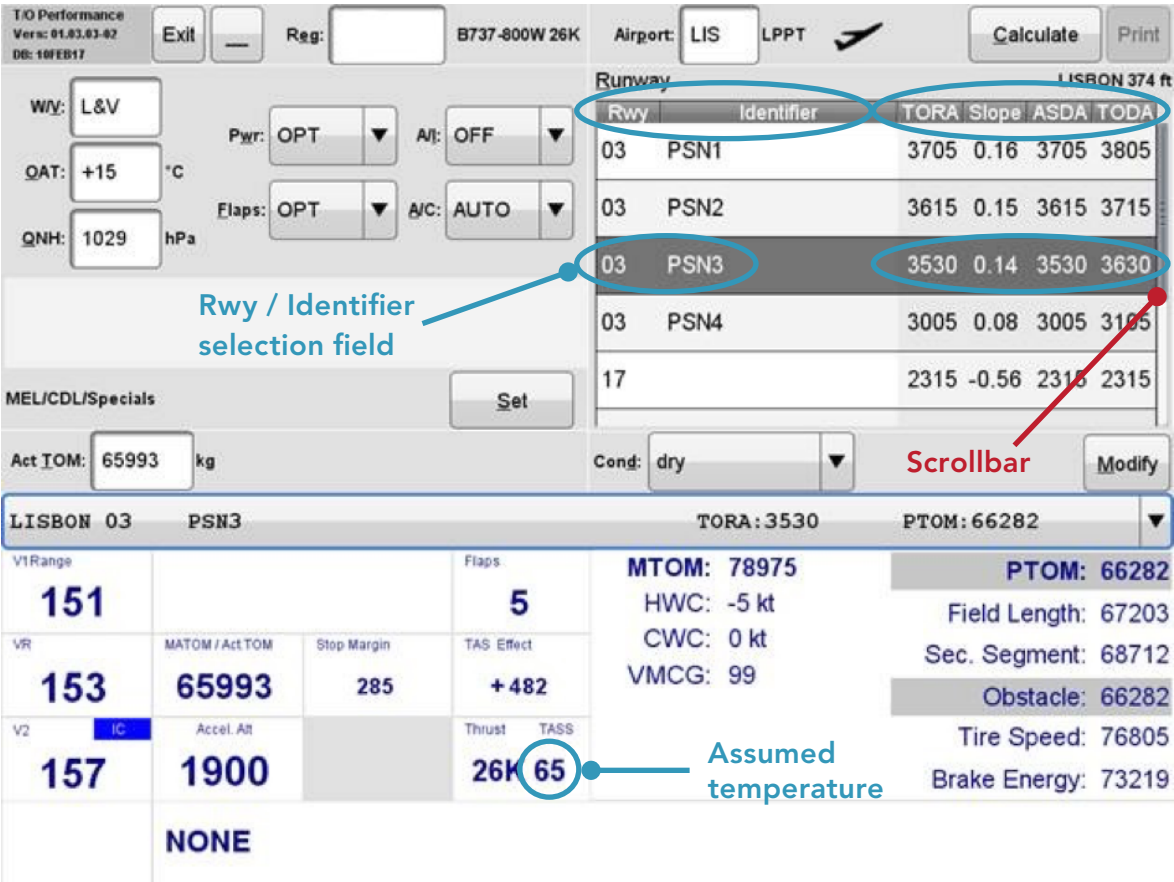
In the EFB take-off performance module, both pilots inadvertently selected position 3 on the first page of the runway/identifier selection field. This was take-off position 3 of runway 03 instead of take-off position 3 of runway 21 (see figure 6).

Figure 6: Runway (Rwy) and Identifier selection window before scrolling down. The results on the lower part of the screen only become visible after a selection has been made and the calculate button (top right) has been pressed. As the EFB is controlled by means of a touch screen, scrolling down the rwy/identifier list can also be achieved by moving a finger over the rwy/identifier column.

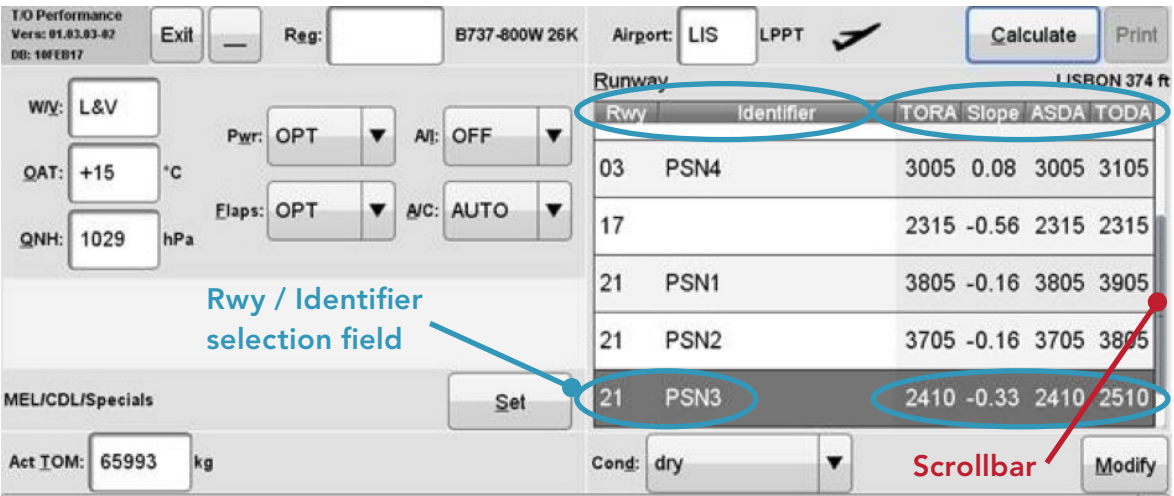
Figure 7: Runway (Rwy) and Identifier selection window after scrolling down.

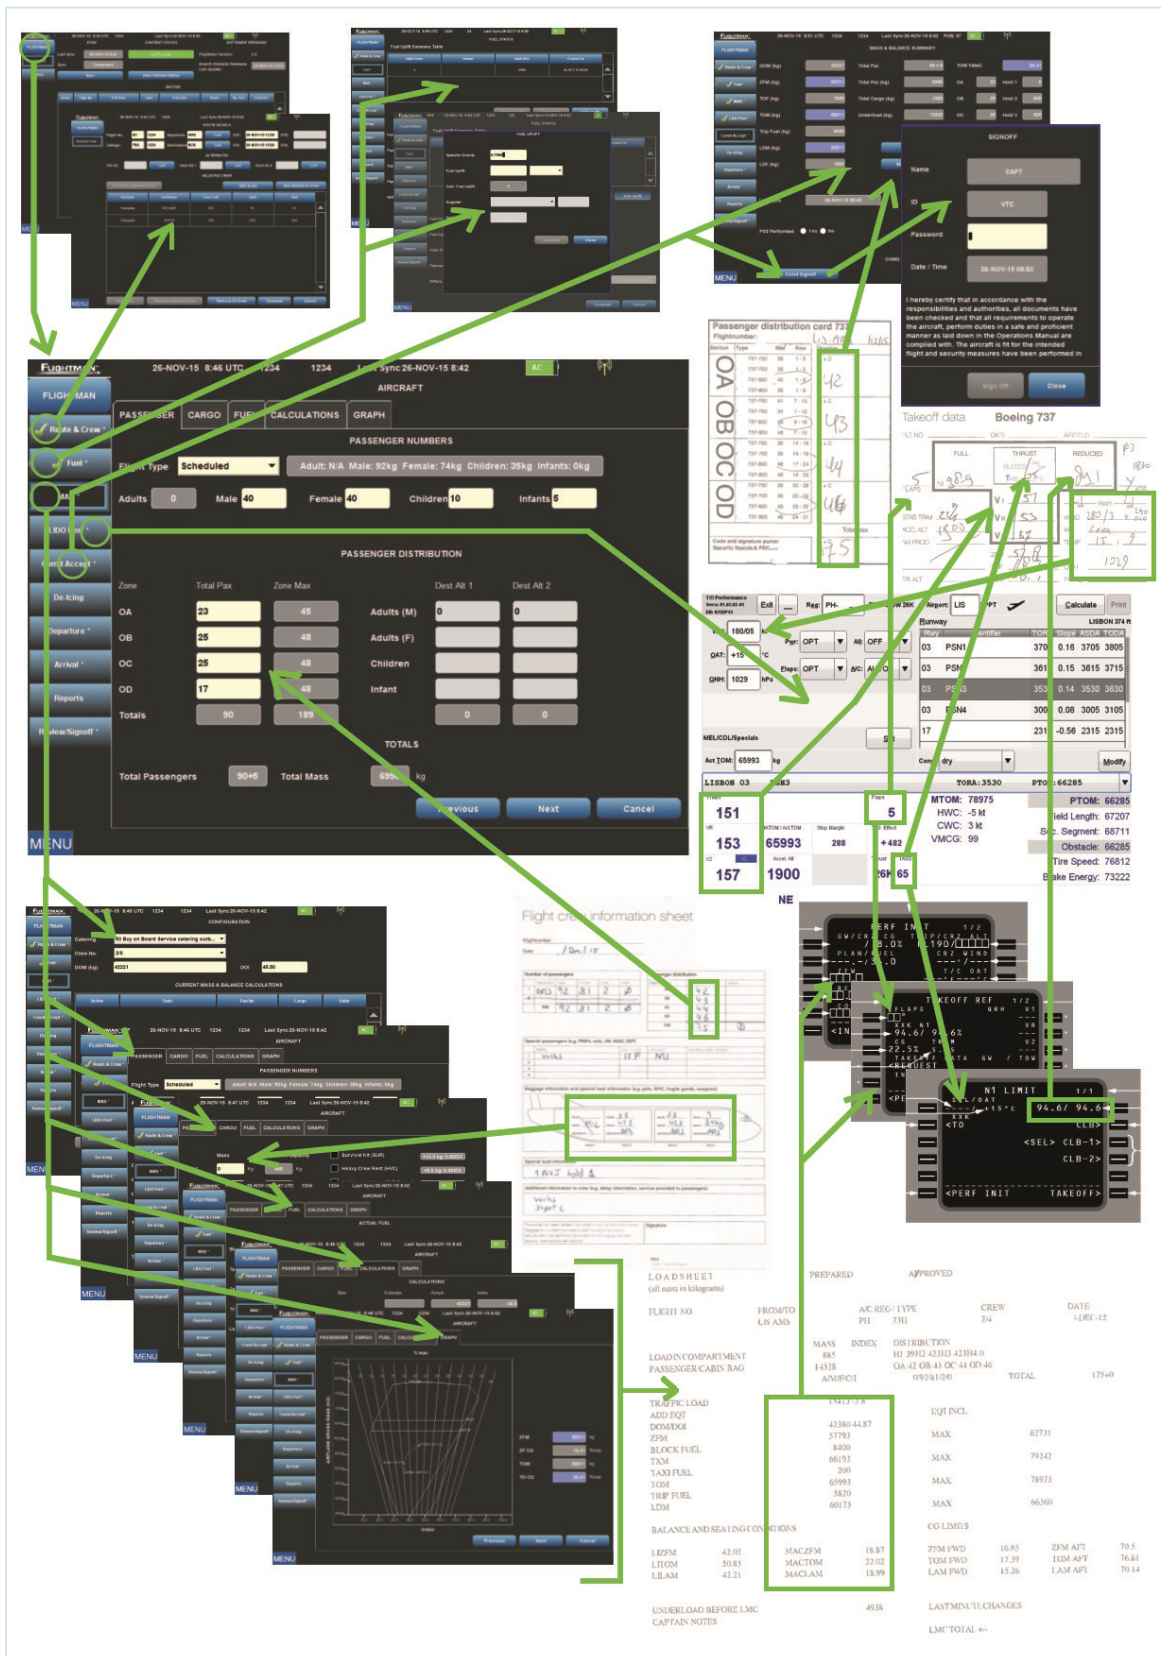
Although the EFB reduces the number of calculations compared to the manual load and trim procedure (as in the Groningen incident), it still requires a large amount of manual data entries and data transfers. The operator is planning to incorporate a further integration of these functions in the next phase of the EFB, which will decrease the number of data entries.

Figure 8: Illustration of the standard EFB flight preparation, weight and balance and take-off performance calculation workflow. Arrows indicate data transfer/entry between different EFB screens, flight documents, FMC and bugcard.

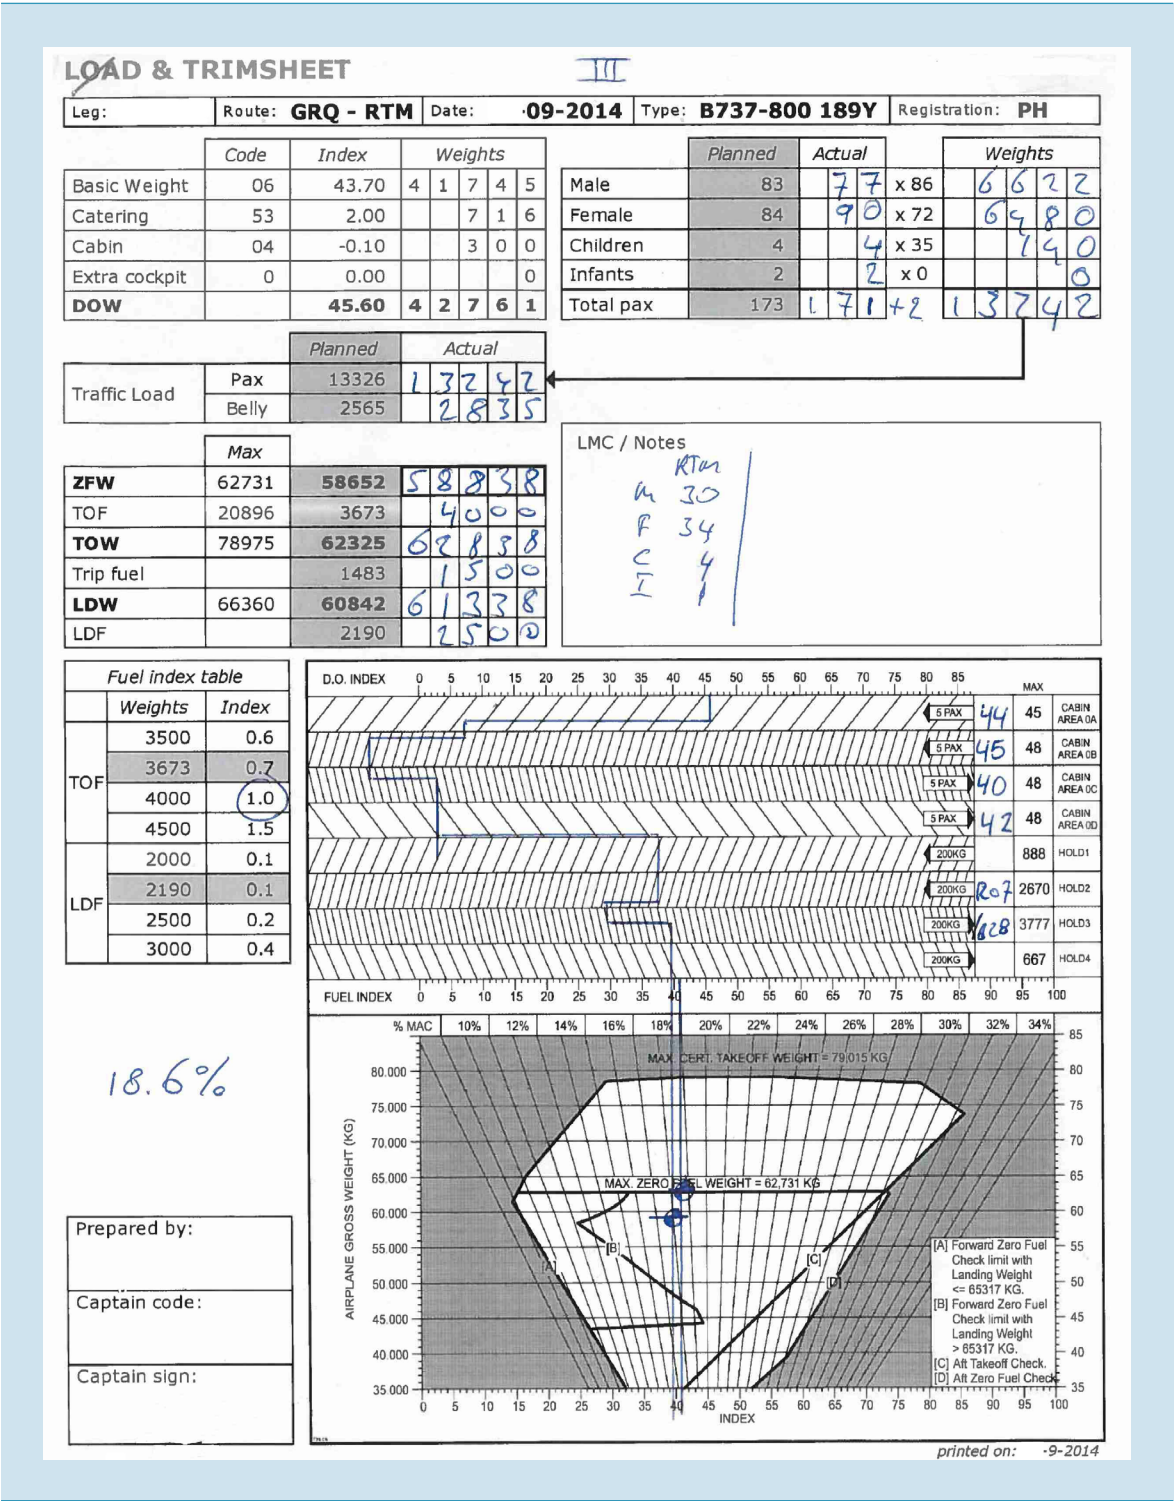
Figure 1: Appendix A - LTS Groningen.

The weight used for the performance calculation was the weight as written on the bugcard, which was 52,9 t. Performance penalties for the use of bleed air and a lower than standard QNH were correctly applied to this weight. Hence, the weight used in the performance tables was 55,5 t. The flight crew used the zero wind column in the performance tables to find the maximum assumed temperature at which the engines would provide sufficient thrust for a safe takeoff. This showed a temperature of 60 degrees Celsius, which was the maximum temperature noted in the performance tables. When entering the performance tables with the correct takeoff weight, adjusted for performance penalties to 65,5 t, the tables show an assumed temperature of 30 degrees Celsius. The thrust setting corresponding to an assumed temperature of 30 degrees Celsius is significantly higher than the thrust setting corresponding to an assumed temperature of 60 degrees Celsius and would have been sufficient for a safe takeoff in windless conditions.

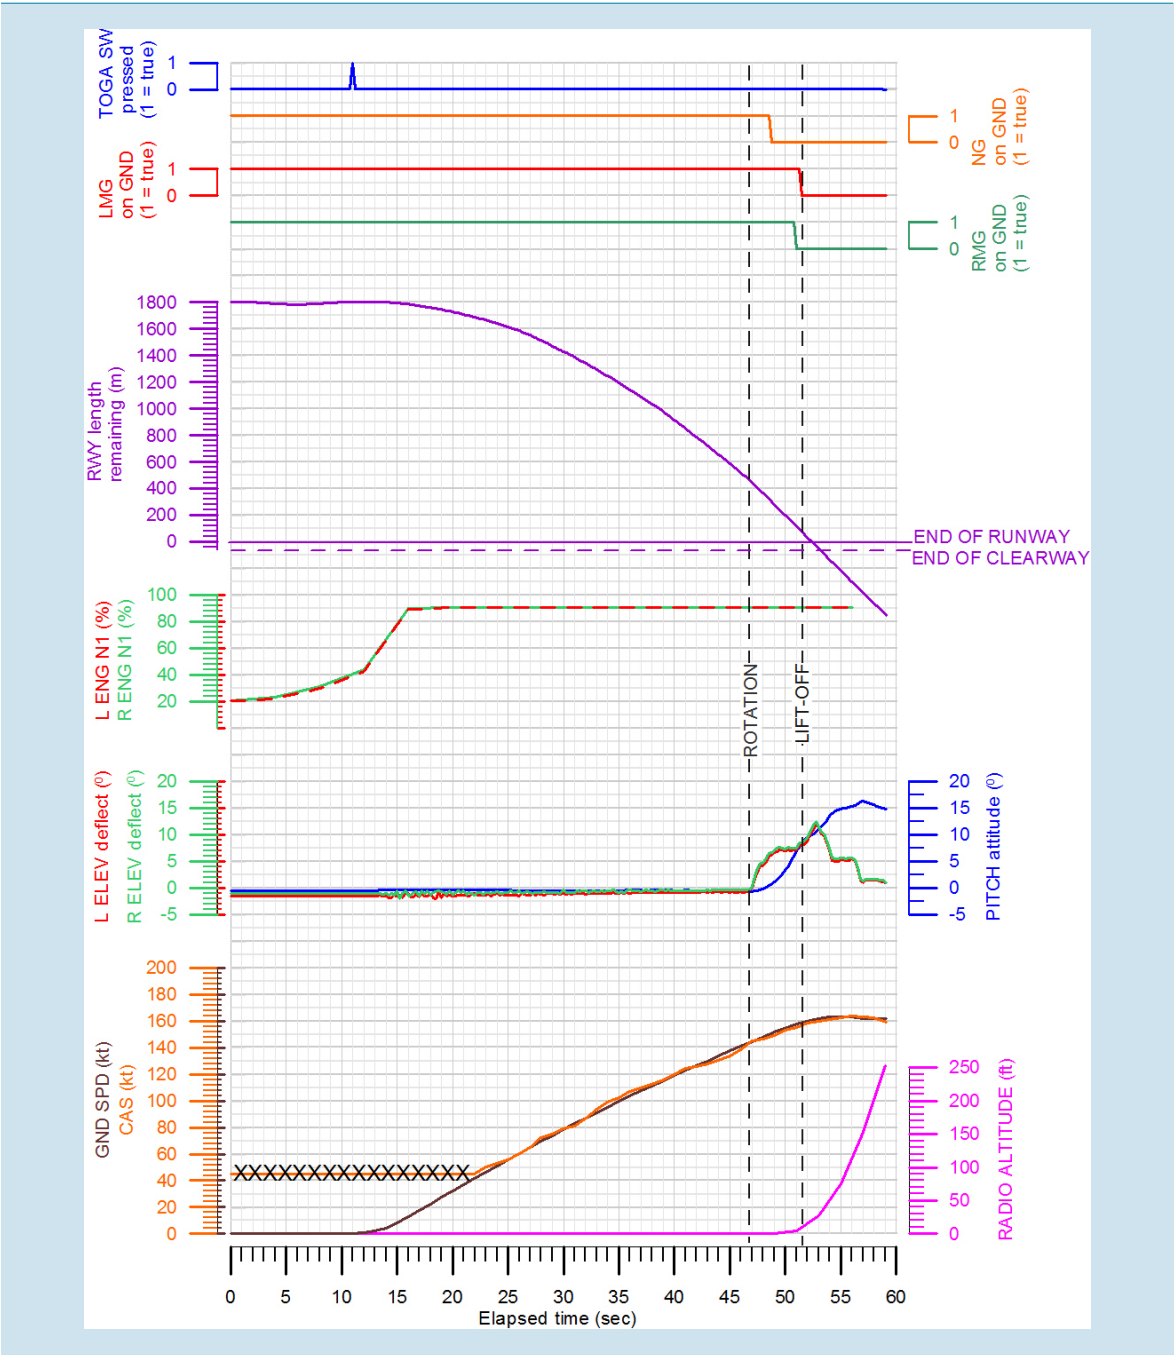
Figure 1: Appendix C.

Groningen incident

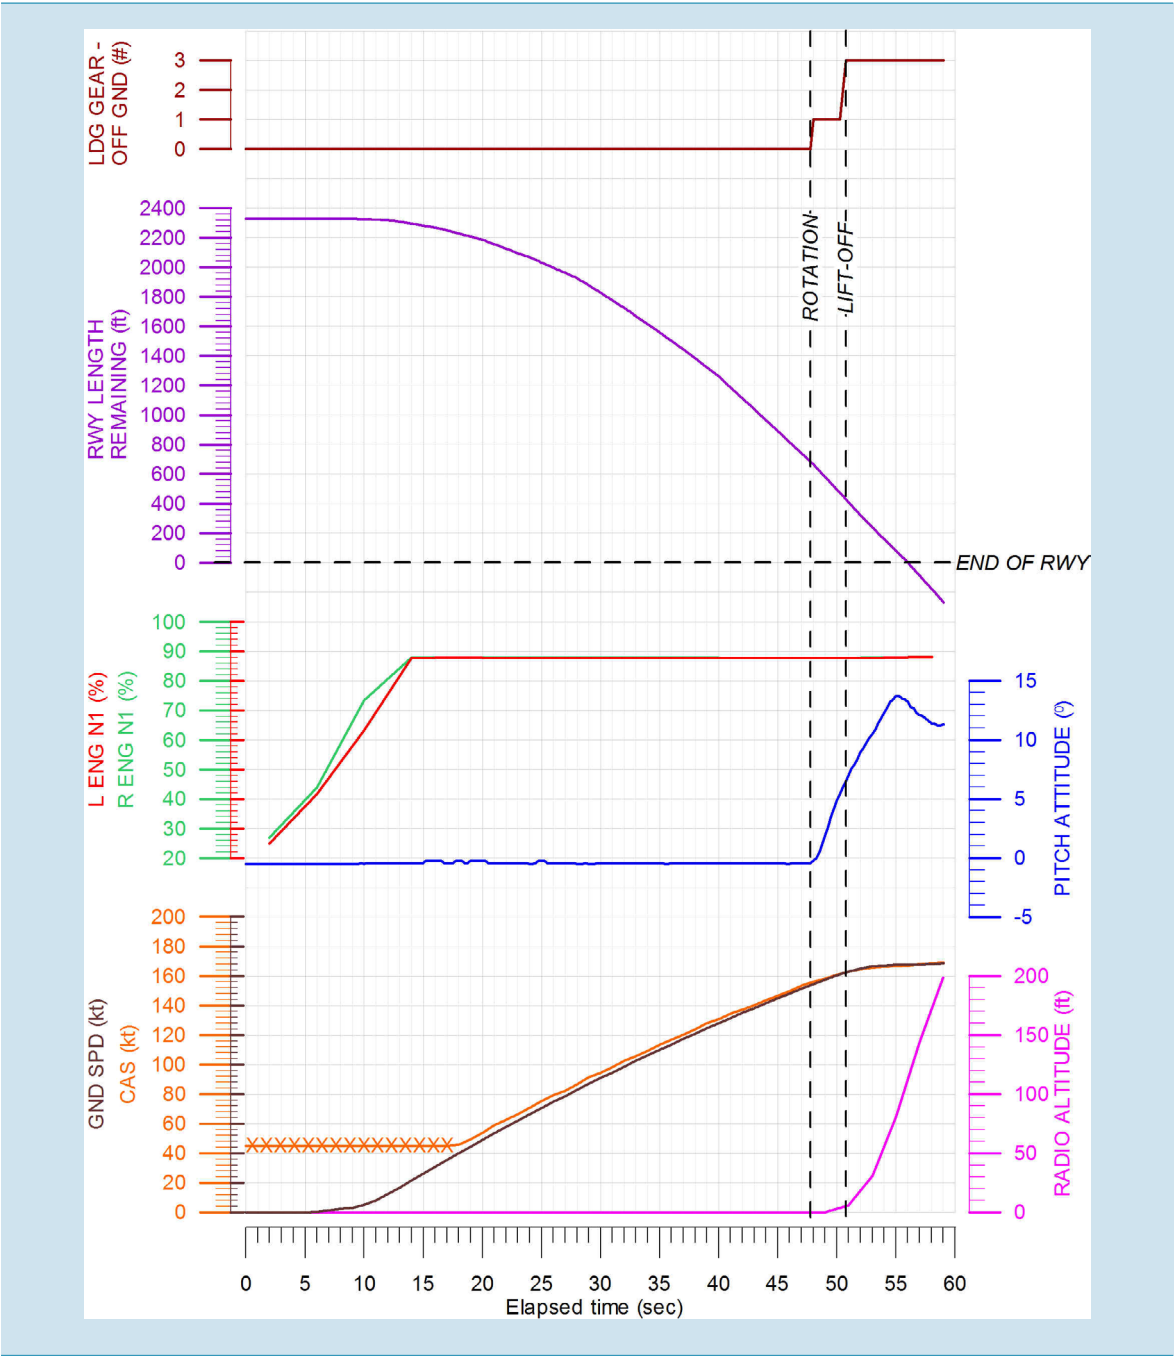
Figure 2: Appendix C.

Lisbon incident
