DUTCH
SAFETY BOARD

Emergency landing after partial loss of engine power

The Hague, January 2019

| Aircraft model: | Diamond DA-40 D |

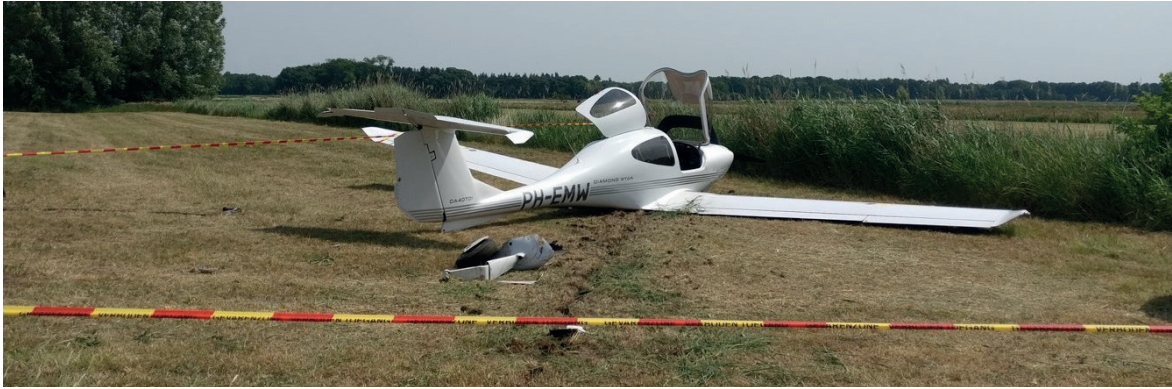
The aircraft descended through 600-700 feet and the pilot chose a field for an emergency landing. The chosen area was free of trees and buildings but with crosswise ditches. After a 180 degrees turn the aircraft touched down gently but with a high groundspeed. Although both occupants applied maximum braking power they could not prevent that the aircraft went through a ditch. All three landing gears broke off and the aircraft came to rest. Both occupants left the aircraft uninjured. Besides the landing gears the (wooden) propeller blades were also broken.

Figure 2: PH-EMW after the emergency landing. (Source: R. van Dooren)

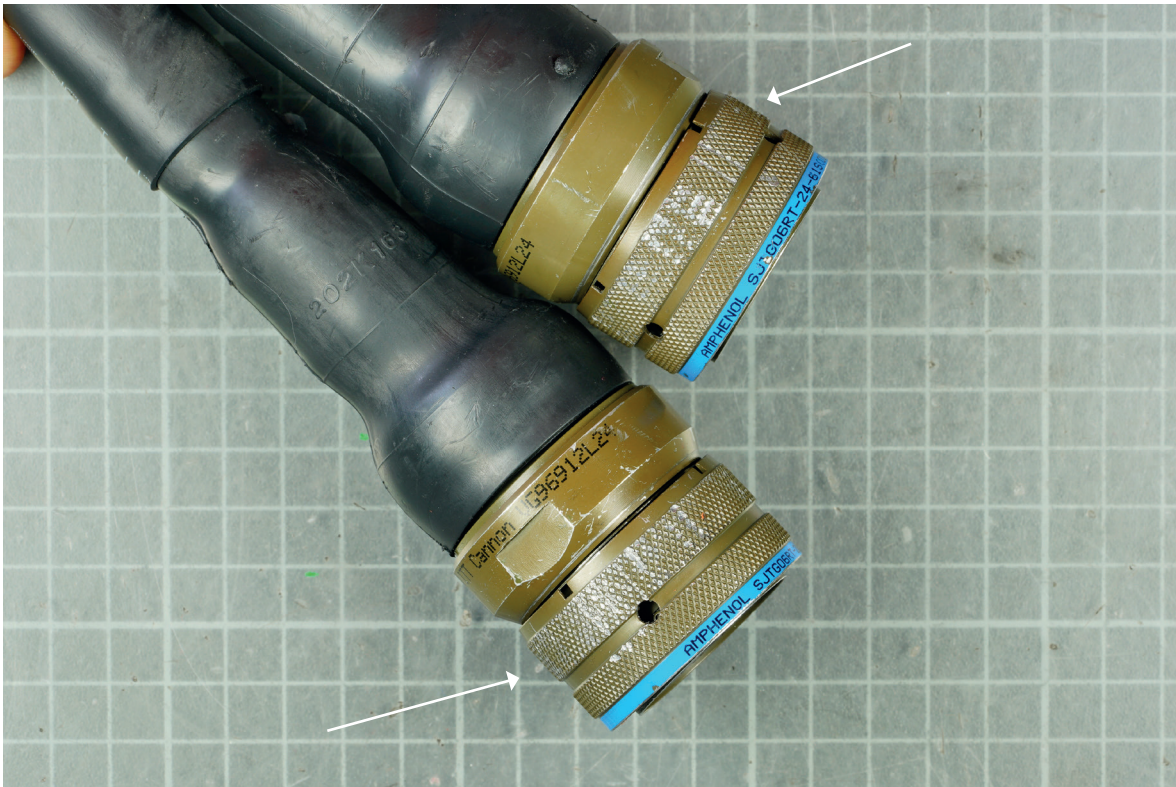
The union nuts of both electrical connectors that connect the loom (engine wiring harness) to the FADEC indicated tool marks.

Figure 3: Tool marks on the union nuts. (Source: Technify Motors)

A more detailed investigation with the aid of a microscope indicated that the tool marks most likely were caused by a wrench turning the union nuts clockwise (fastening). The connectors are designed to use hand force only to fasten and lock them, no excessive force is required. That only hand force is required has been confirmed by engineers with long time experience with this type of aircraft.

According to the aircraft mechanic, however, it is common practice to use a wrench to lock the union nuts.

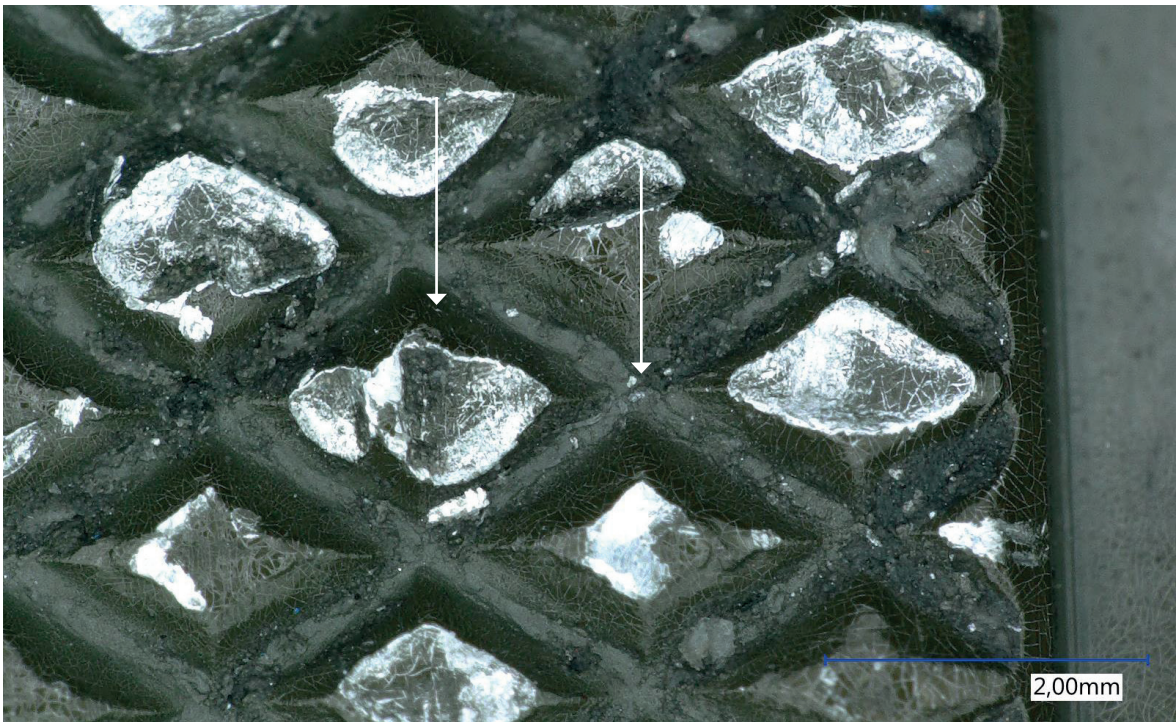
Figure 4: Tool marks with direction of rotation on the union nuts. (Source: Technify Motors)

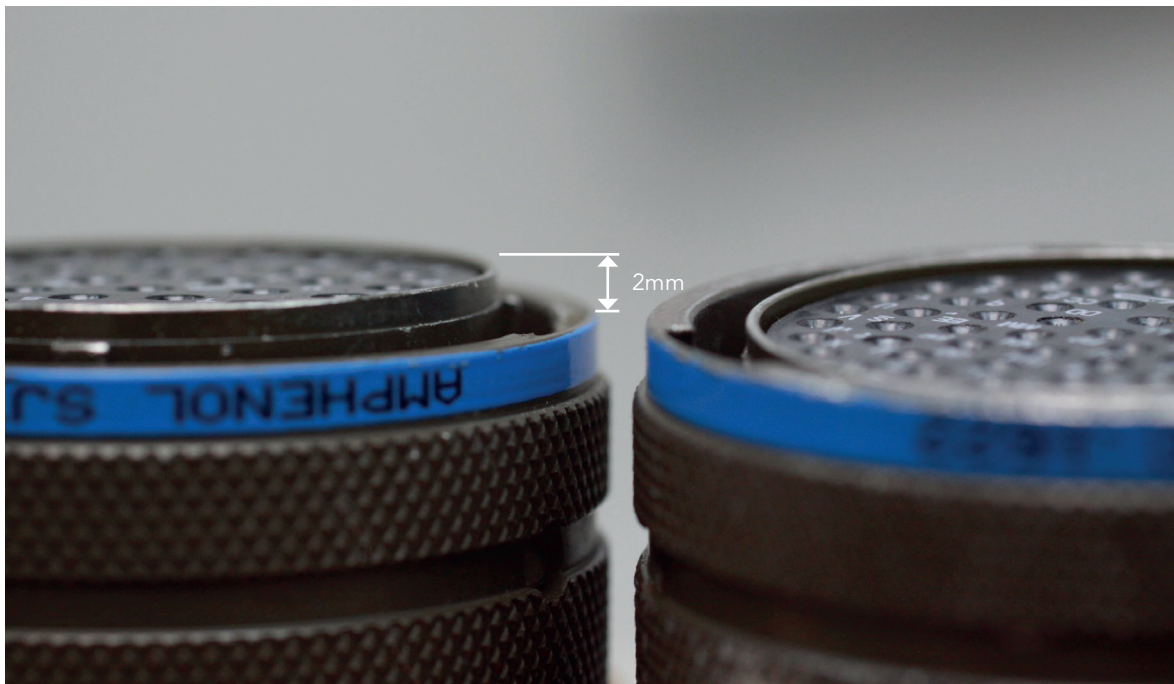
Usually when the union nuts are well connected and locked to the FADEC the connection is stiff and there is no wiggle room. In this case, however, the connectors were not tightly connected and could be moved a bit. Further investigation revealed that the inner part of the connectors was damaged by the applied force. As a comparison two connectors were photographed side by side; an undamaged connector (left in Figure 5) and one of the connectors that was fitted during the accident flight (right in Figure 5). The undamaged connector protruded 2 millimetres more than the damaged connector.

Figure 5: Undamaged loom connector (left), damaged loom connector (right). (Source: Technify Motors)

The reversed installation of the connectors generated high forces on the connection pins forcing the locking pins outwards. Besides that, the inside of the connectors was damaged as well (see Figure 5). When subsequently the correct connector is fitted, space exists between some connection pins and the corresponding connection holes. This is a sum of the damaged loom connector and FADEC socket. Although it seems that the connectors are placed correctly, the internal space may cause intermittent contacts.

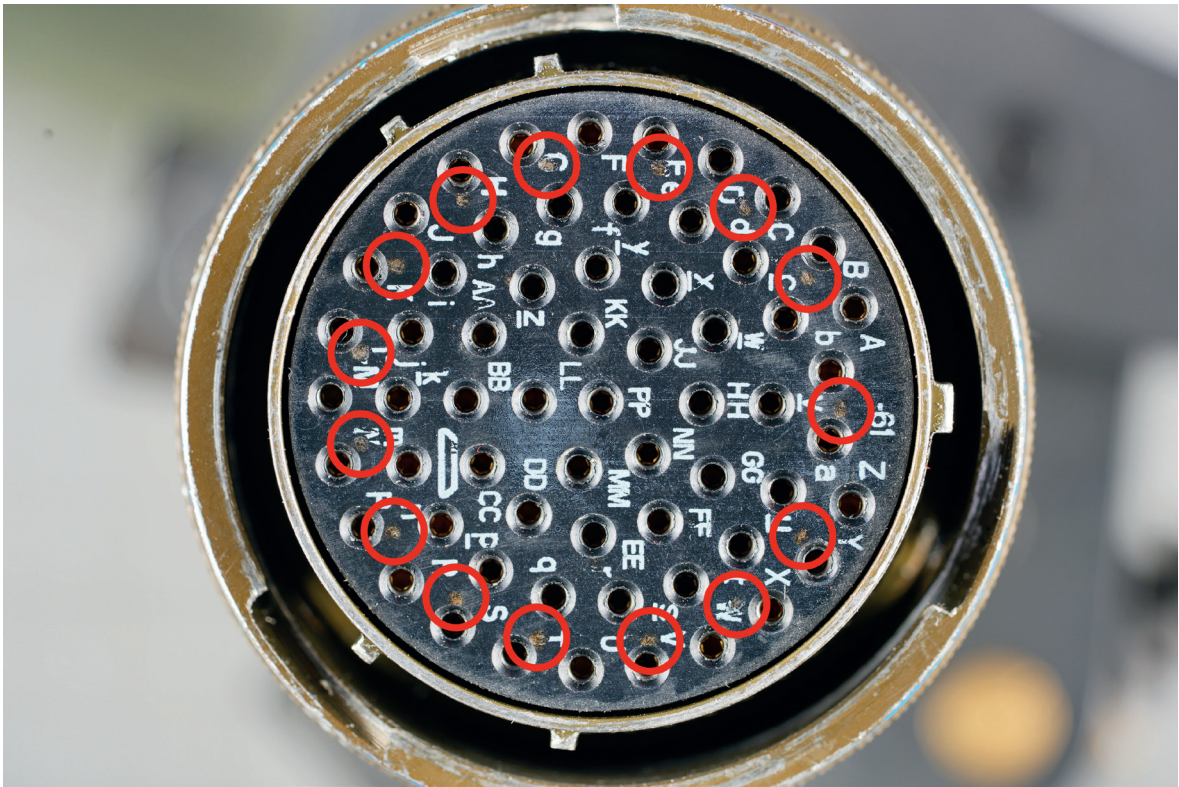
A detailed inspection of both inner connector surfaces involved in the accident showed visible pin marks indicating a cross connection of loom connector A to FADEC socket B and vice versa (in a correct installation, connector A is fitted to socket A and connector B to socket B). The diameters of both connectors and the locking mechanism are identical but pin diameter and pin layout are different and the connectors are not interchangeable.

Figure 6: FADEC B socket pin marks on loom connector A. (Source: Technify Motors)

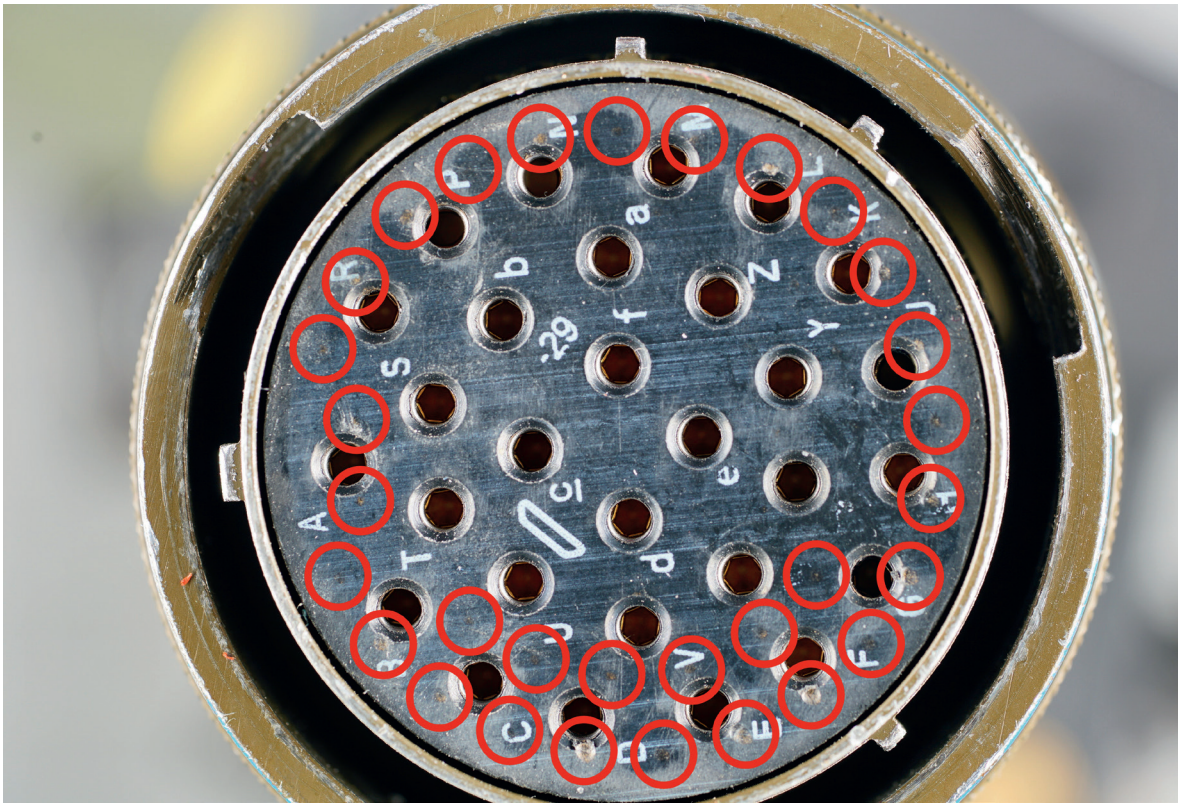
Figure 7: FADEC A socket pin marks on loom connector B. (Source: Technify Motors)

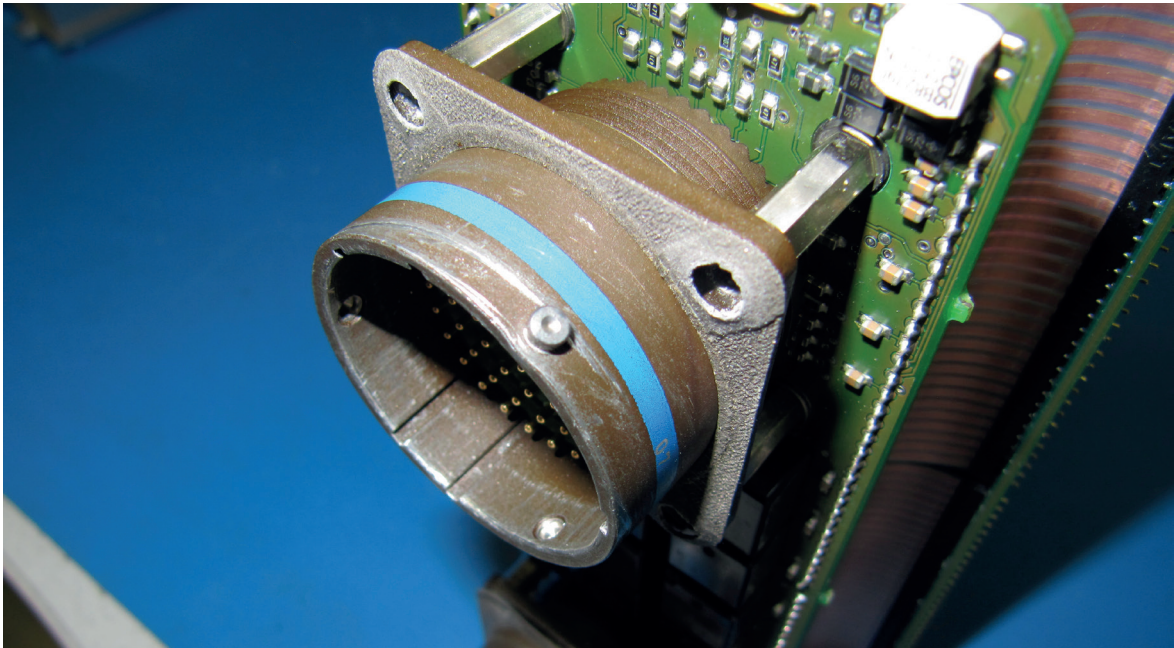
The original FADEC was inspected and it was discovered that great force had been applied to the locking pins of the connectors. The rim was bulged in the direction of the force.

Figure 8: Damaged FADEC socket. (Source: Technify Motors)

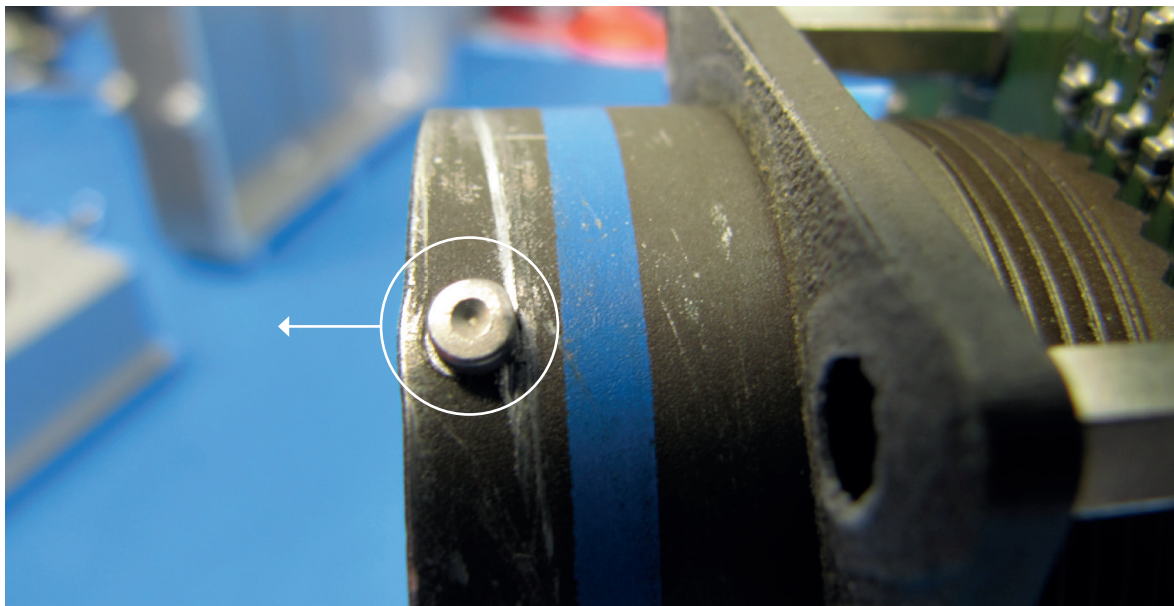
Figure 9: Damaged FADEC socket. (Source: Technify Motors)

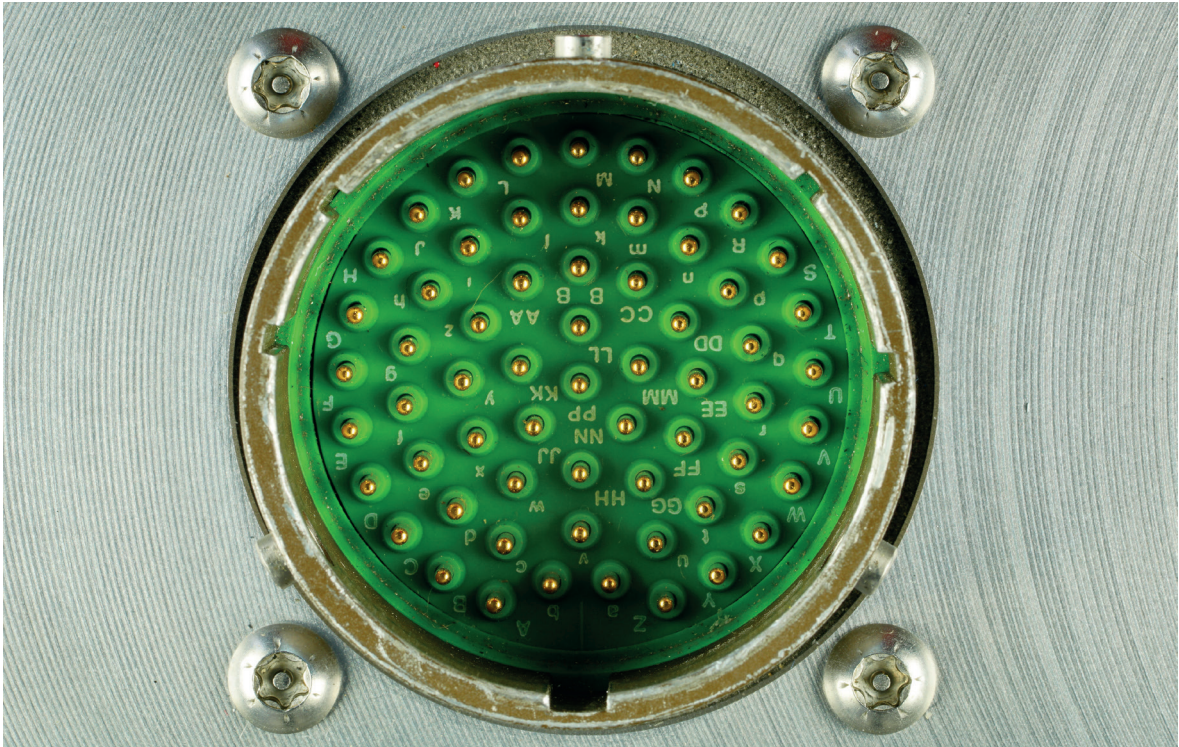
Analysis of the connection pins inside the sockets showed that they were dented at its tips, indicating that force had been applied. In good condition the tips are rounded and are not subject to any forces. Only the sides of the connection pins make contact with its counterparts.

Figure 10: FADEC A socket pins. (Source: Technify Motors)

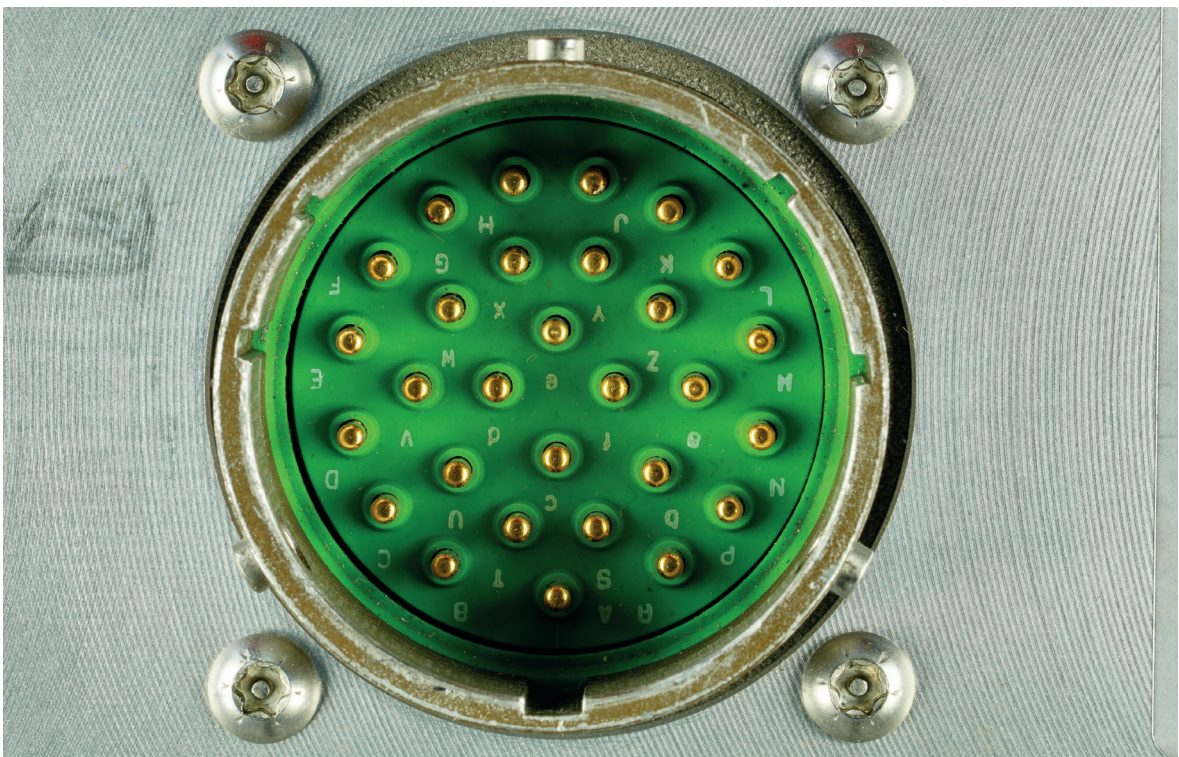
Figure 11: FADEC B socket pins. (Source: Technify Motors)

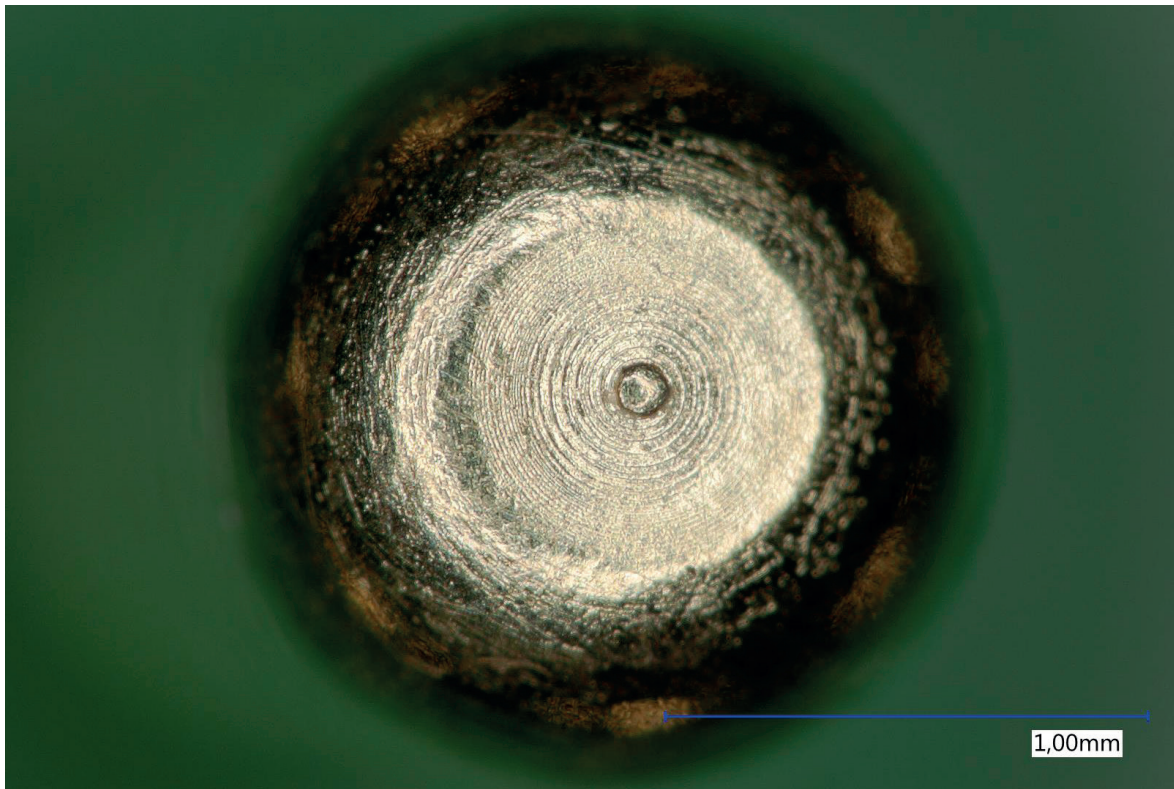
Figure 12: Close-up of the tip of one of the FADEC B socket pins of figure 11. (Source: Technify Motors)

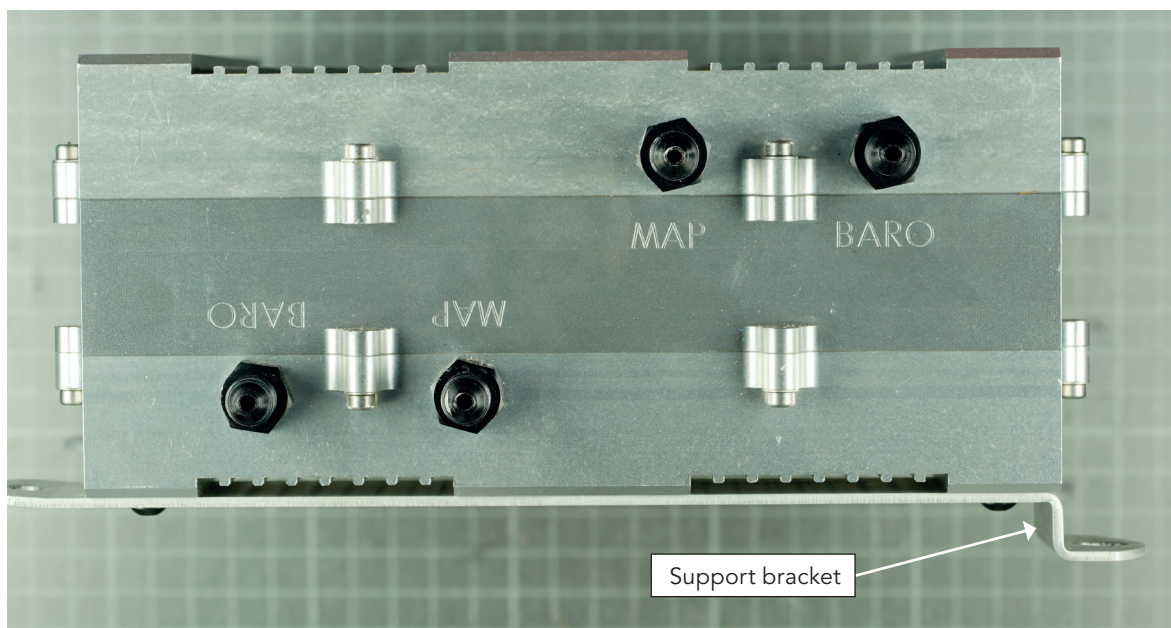
Before the installation of FADEC with serial number 4453 to the airframe, the aircraft mechanic had to fit the two support brackets to the FADEC. The FADEC housing is symmetrical to be able to use the same housing on different airplane types.

Figure 13: Support bracket fitted to the FADEC. (Source: Technify Motors)

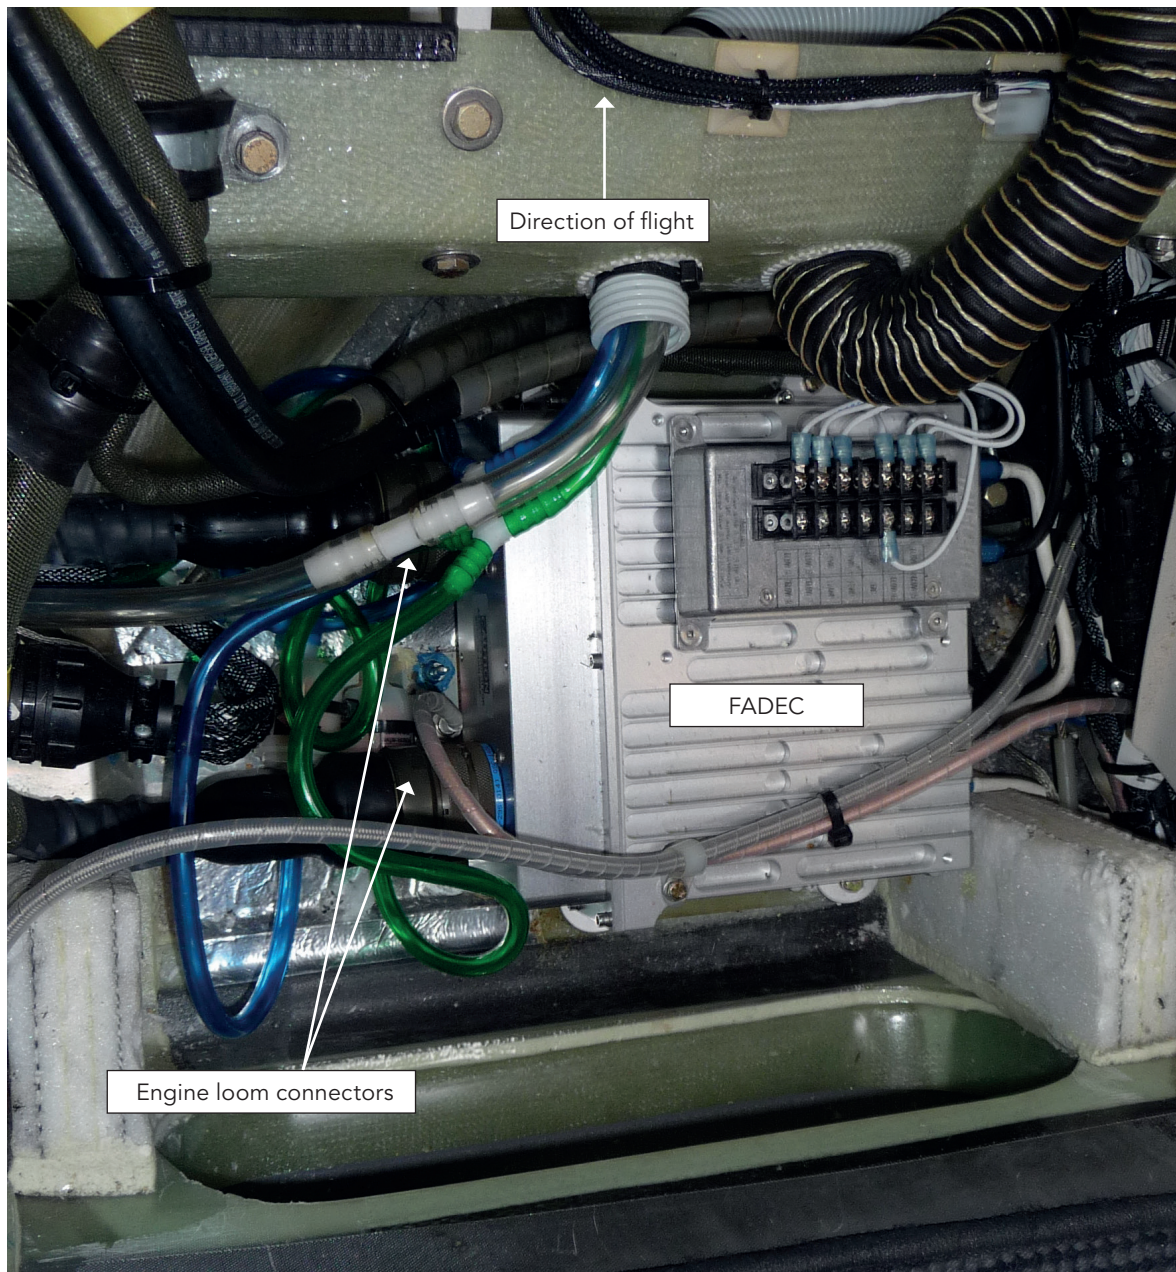
The FADEC is located underneath the left-hand seat. To get access to the FADEC, its mounting bolts and the different connectors, the seat needs to be removed. The sockets of the FADEC are facing towards the left-hand side of the fuselage (see Figure 15). Because the mechanic did not realise that the sockets had also changed position he tried to connect the wrong connectors. With help of a wrench he managed to fit the engine loom connectors to the FADEC. However, because none of the pins of both sockets made contact with its counterparts, the subsequent systems check failed and it was mistakenly concluded that this was caused by a faulty FADEC. The FADEC with serial number 4453 was removed from the airframe and returned to the engine manufacturer again for investigation.

Figure 15: Location of FADEC and connectors beneath the left-hand seat (note that the seat has been removed to get access).
