# Fatal accident during unloading in Moerdijk

Lessons learned from the accident on board  
the A2B Future

*The Hague, January 2019*

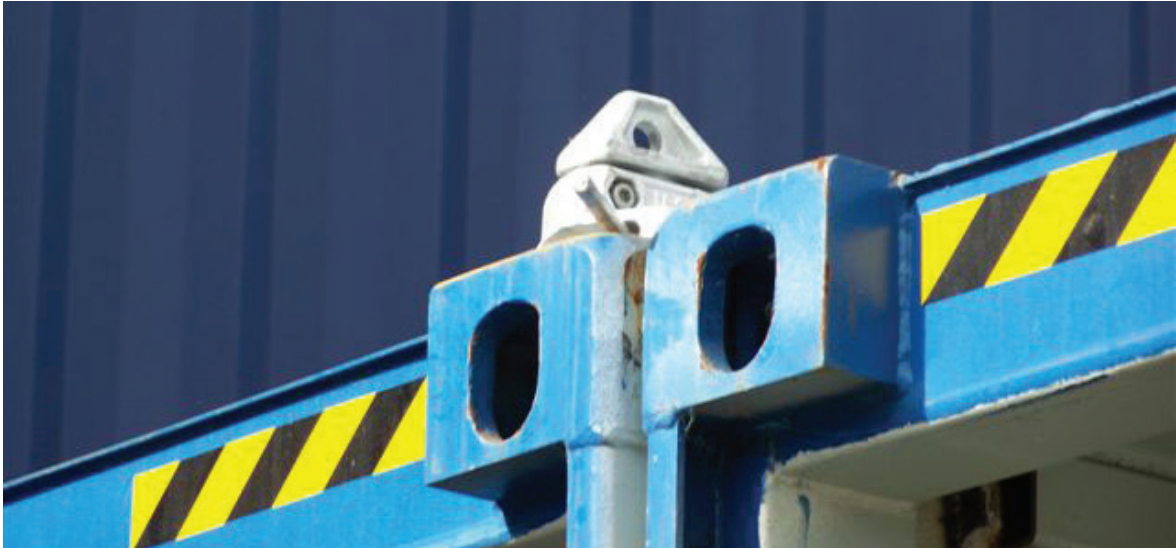
Figure 5: Twistlock in a corner casting. (Source: Dutch Safety Board)

During the unloading of a container on board seagoing vessels, it is not uncommon for a semi-automatic twistlock to become accidentally relocked. Situations of this kind are therefore not exceptional. It may be expected that a clear, simple and practical procedure be produced for a situation of this kind, in which multiple people are involved, to enable them to carry out this work safely. This procedure must also be clearly explained to the employees involved. There was no such procedure in this case.

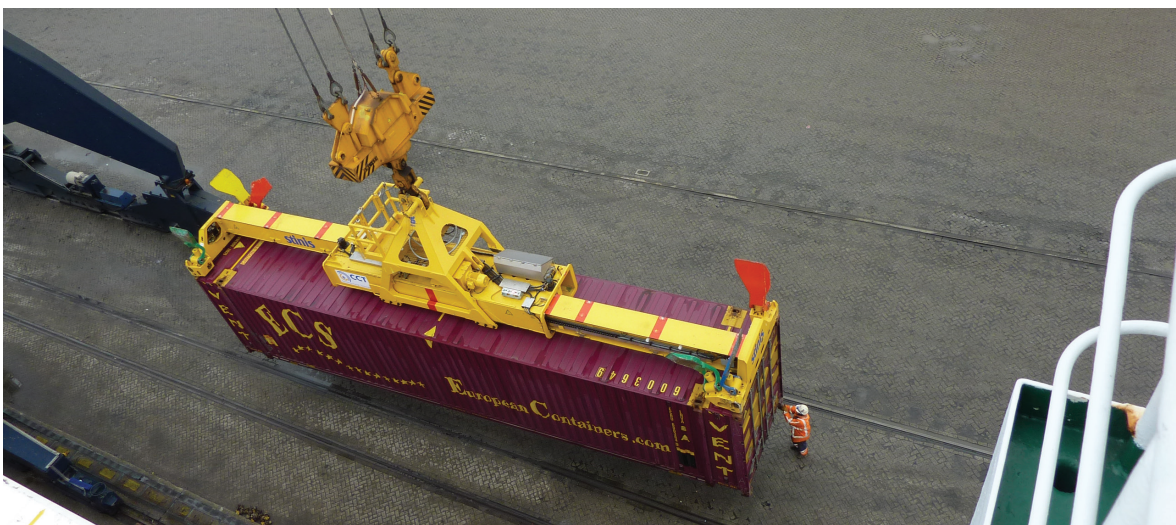
The deckhand who later became the victim stood on the dockside to release and remove the semi-automatic twistlocks below the suspended containers. After the container is lifted from the vessel by the dock crane, the twistlocks remain behind in the corner castings. These have to be removed by hand. The container is then passed down the logistic process chain.

Figure 6: Twistlocks are removed on the dockside from below the suspended containers. (Source: Dutch Safety Board)

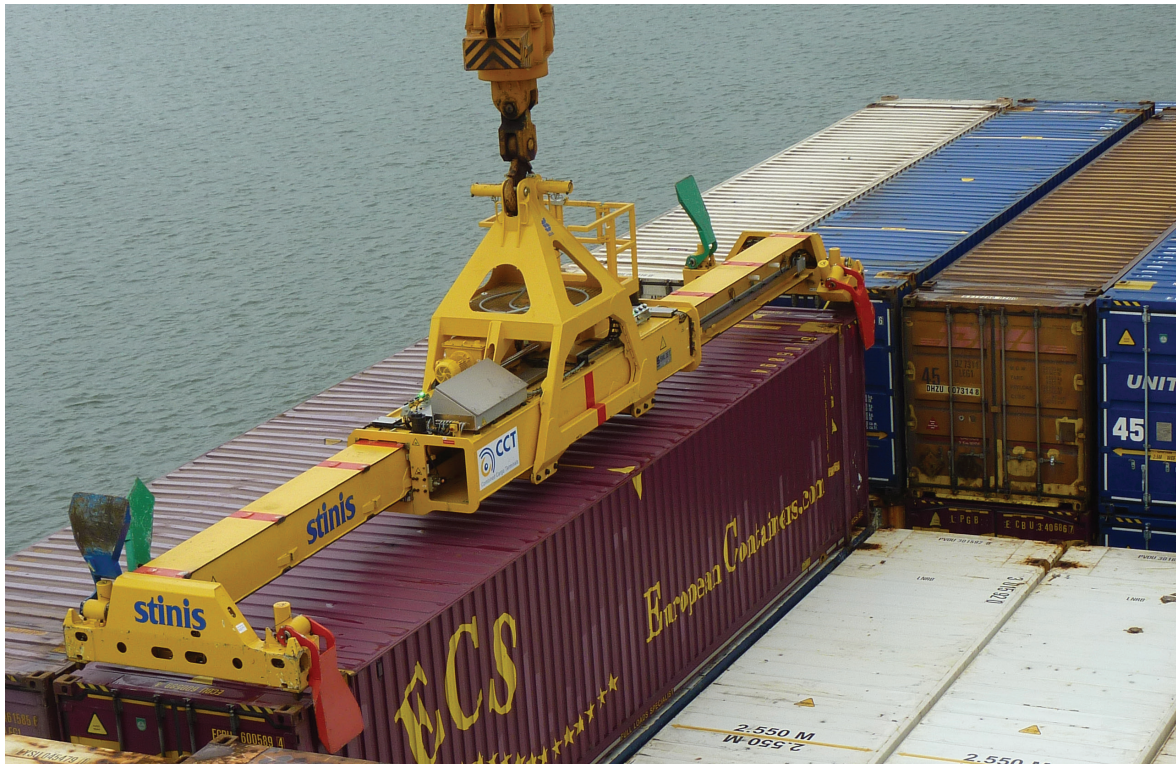
During the unloading process, one container could not be lifted from its position because it was still attached to the container below it. At this point, the victim went back on board the vessel. Via the gangway he walked to the location where the containers were stuck together. Once there, via a permanent stairway, he climbed up the deck hatch and between two rows of containers until he reached the container in question, to open the still closed twistlock.

Figure 7: A spreader is placed on top of the container. (Source: Dutch Safety Board)

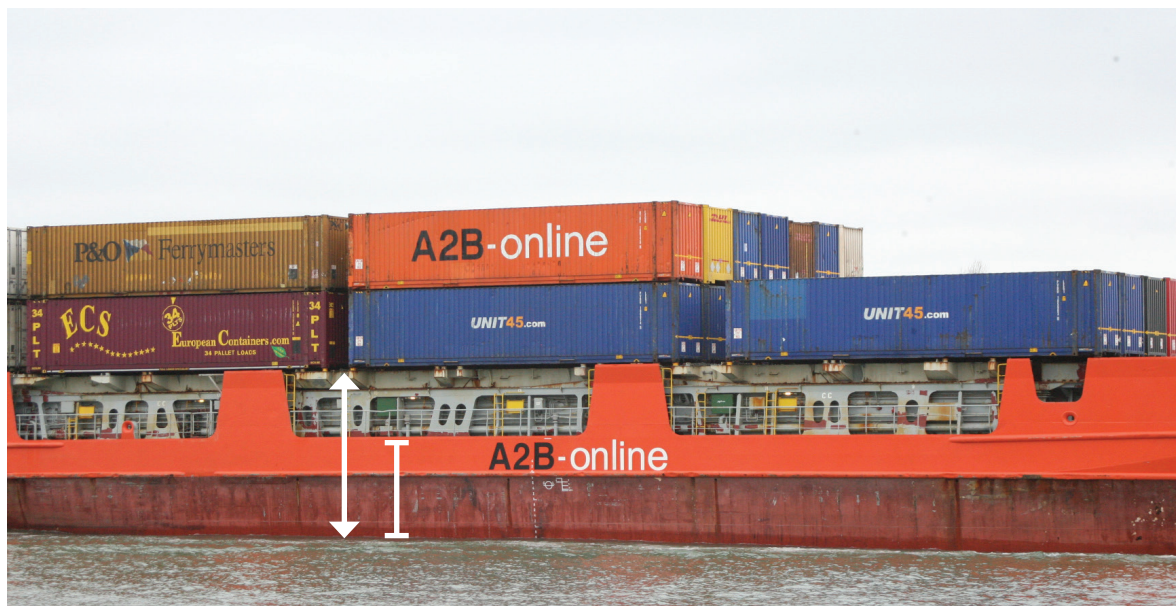
The investigation revealed that the victim was walking back to the permanent stairway to leave the deck. Although no one saw the victim fall, it is likely that he fell from the deck hatch which is not fitted with any provisions to prevent falling, such as a railing.

Figure 8: Illustration of fall height by way of indication. (Source: Dutch Safety Board)

Due to the absence of permanent measures (such as railings) or personal protective equipment (such as a harness) to prevent the falling from height, the victim fell into the water.

At the accident location, the installation of adequate protection to prevent falling overboard, such as a railing, is not immediately possible. In situations where permanent protection is not possible, other methods of reducing the risks of falling (overboard) must be sought.

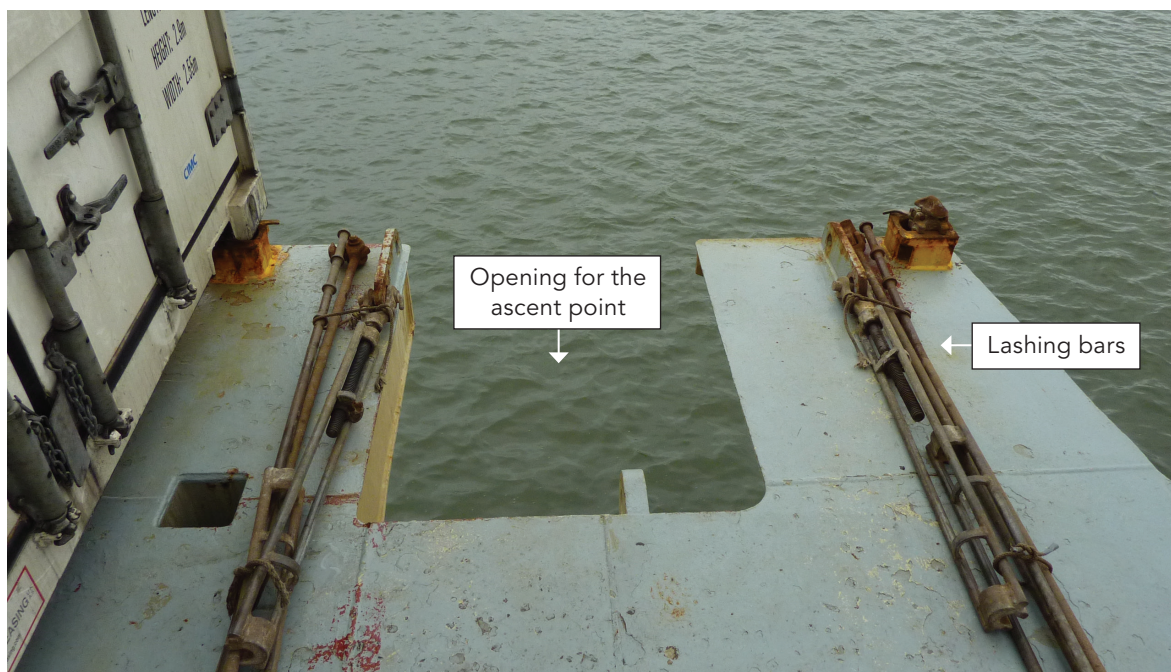
Figure 9: Opening for the ascent point. (Source: Dutch Safety Board)

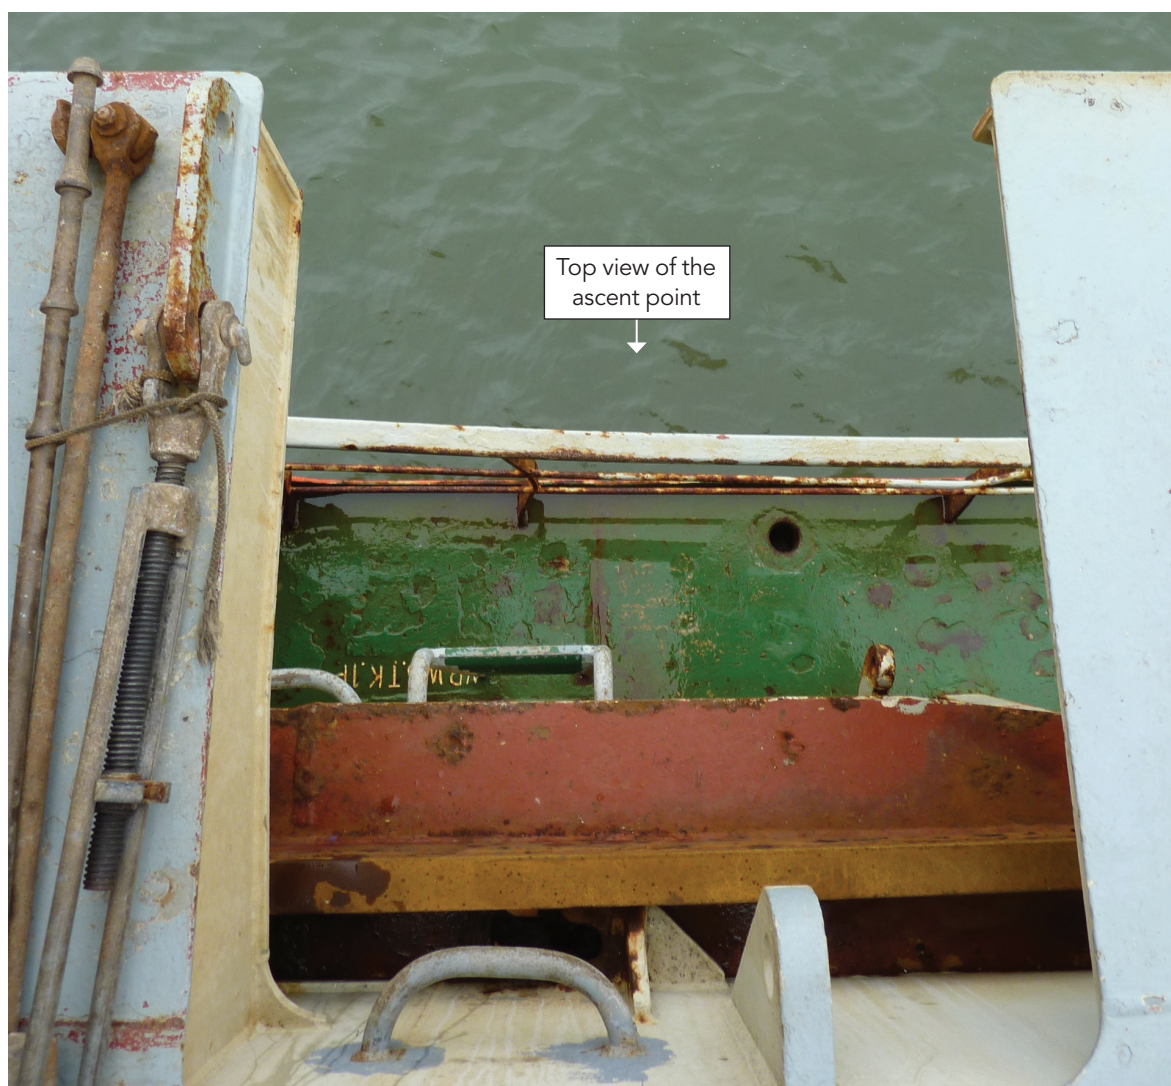
Figure 10: Opening for the ascent point. (Source: Dutch Safety Board)
