# Mortar Accident Mali

*The Hague, December 2017*

On 6 July 2016, members of a mortar squad from the Airmobile Brigade were conducting an exercise firing 60 mm mortar rounds. During the exercise one of the rounds exploded in the mortar. As a result, the two members of the mortar squad operating the mortar lost their lives and a third one was seriously wounded. The exercise took place near the UN camp in Kidal, Mali, where the Netherlands is participating in the UN Multidimensional Integrated Stabilization Mission in Mali (MINUSMA).

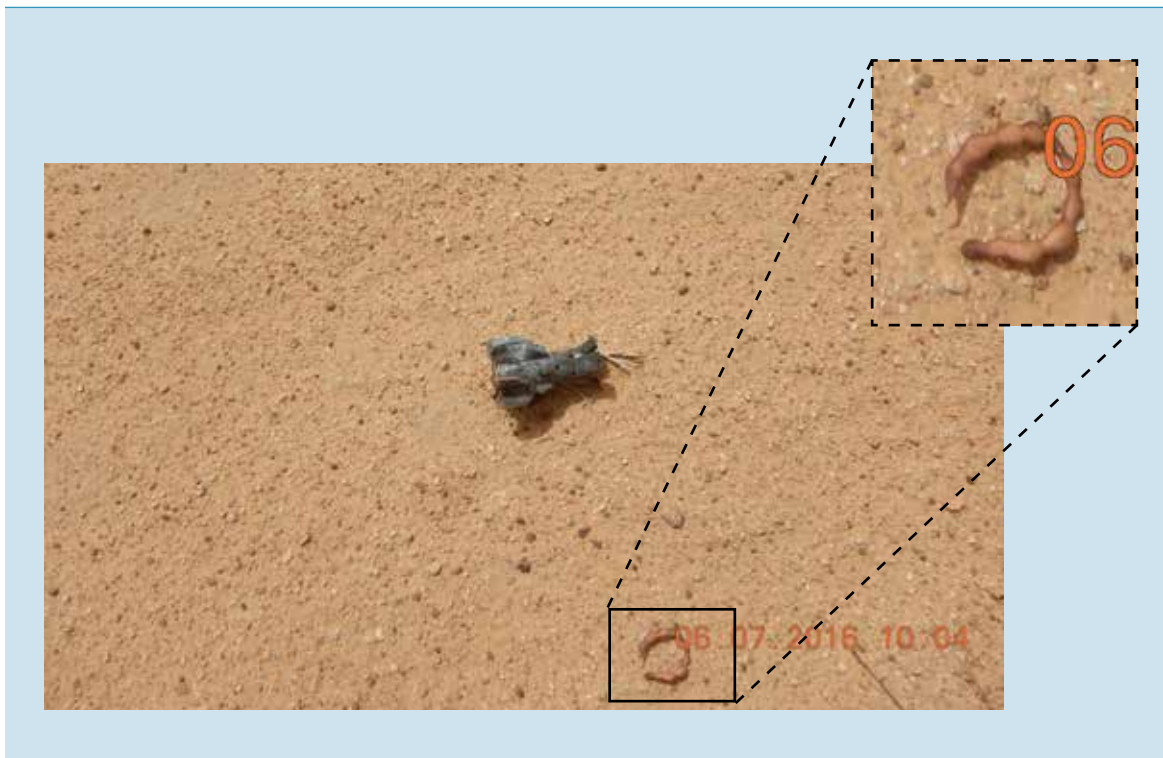
One of the photographs taken after the accident shows the tail assembly of the mortar round, which was found at about 10 meters from the site of the explosion. In the immediate vicinity of the tail assembly is a horseshoe-shaped object of which the shape and size correspond with that of an augmenting charge, the additional propellant cartridge that was originally attached to the tail assembly (Figure 5).

Figure 5: Object near the remnants of the tail assembly, photographed after the accident.  
(Picture: Ministry of Defence)

Under normal firing conditions no recognisable remnants of an augmenting charge can be found because the charge is completely consumed. If the horseshoe-shaped object is indeed the remnant of the augmenting charge this would demonstrate that the combustion process of the propellant charge was interrupted by the detonation of the main charge.

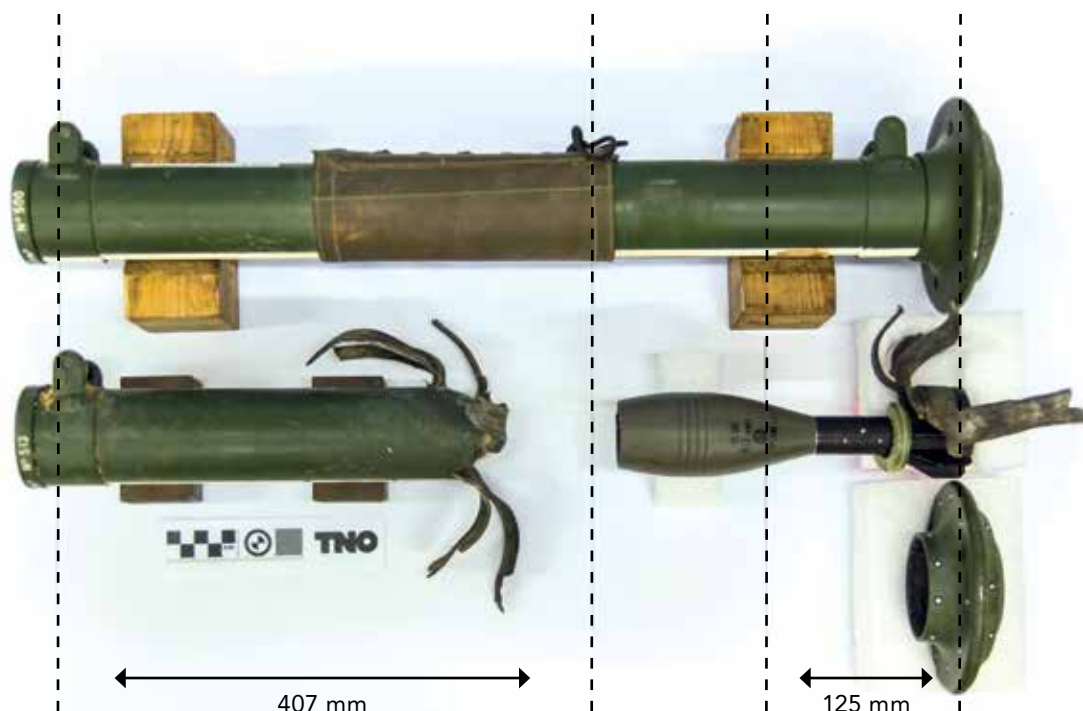
The damage pattern to the mortar (see Figure 6) and to the tail assembly of the round, and an imprint of the fragments of the steel shell body on the inside of the launch tube, point to a detonation of the main charge.<sup>10</sup> Moreover, no traces of unburned or partially burned explosive compounds (TNT) were found around the site of the accident, as would be expected in case of a deflagration or a fire.

Figure 6: Position of the mortar round aligned with the remnants of the muzzle end and baseplate end of the mortar. An intact mortar is positioned above the reconstruction for comparison. The presented dimensions relate to the muzzle and baseplate ends of the mortar. (Picture: TNO)

Reference tests, performed by the Knowledge Centre for Weapon systems and Ammunition (KCW&M), show that only a detonating round can cause this kind of damage (see Appendix E). Figure 7 shows, on the left, the remnants of a mortar destroyed by the detonation of a 60 mm mortar round. On the right, Figure 7 shows a mortar in which a mortar round has deflagrated. Due to the internal pressure the mortar expands and the sight unit is blown off, but the mortar does not fragment.<sup>11</sup>

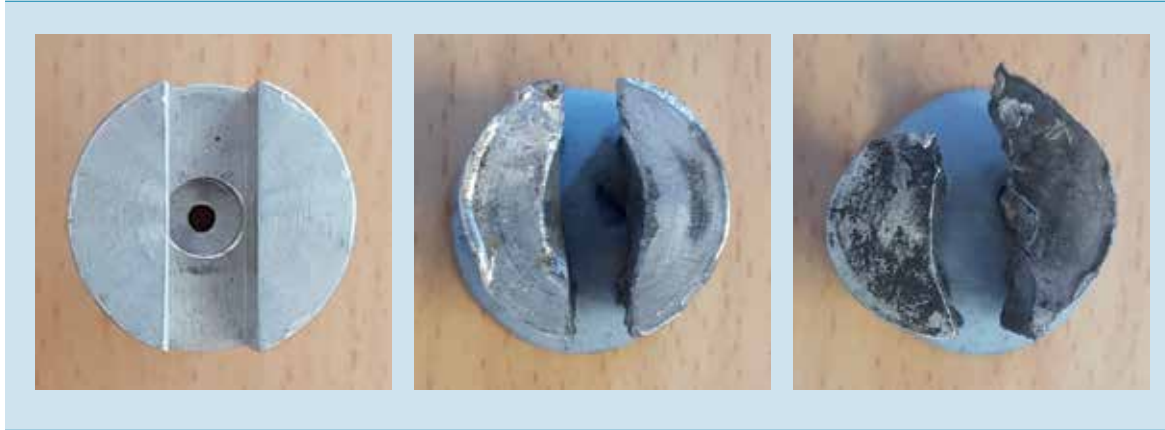
The lower end of the slider housing is circular with a rectangular recess in the centre in which the slider moves, see Figure 12 (left). When the detonator fires due to the impact of the firing pin the housing deforms. In armed position this deformation is imposed on the centre of the housing. The deformation is virtually symmetrical in radial direction, see Figure 12 (centre). The remnants of the slider housing from the accident round also display deformation, see Figure 12 (right). This deformation deviates from the radially symmetric and centred deformation that is found in the test in armed position. This is an indication that the accident round detonated in safe position.

Figure 12: Different appearances of the lower end of a slider housing: an unused housing (left), a housing from the test in armed position (centre) and the housing from the accident (right). (Pictures: TNO)

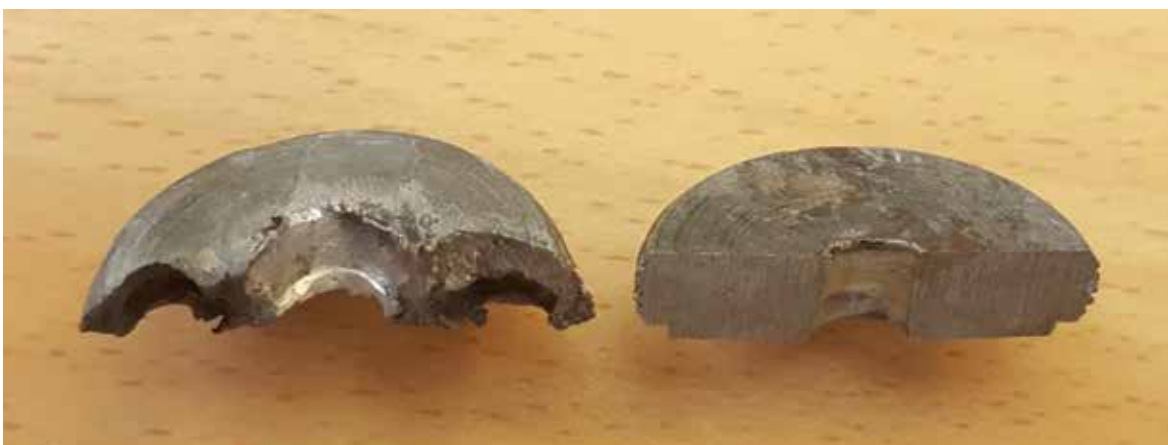
Additional evidence is provided by the variation of the deformation of the central hole over the thickness of the barrier. In armed position the detonator is in line with the lead charge. When both charges detonate, the explosive force on the barrier is largest in the area where both charges are in close proximity. Therefore, the radial deformation is larger at the top side of the barrier than at the bottom side, where the deformation is determined only by the lead charge, see Figure 14 (left). This variation of radial deformation over the thickness of the barrier is not observed in the central hole of the barrier from the accident round; this is clearly cylindrical, which indicates a reaction of the lead charge only. This observation also demonstrates that the accident round was in safe position at the time it was fired.

Figure 14: The barrier from the test in armed position (left), and that from the accident (right). The barrier from the test in armed position is broken as a result of the detonation, the barrier from the accident was recovered in one piece, but was cut in half for further examination. (Picture: TNO)

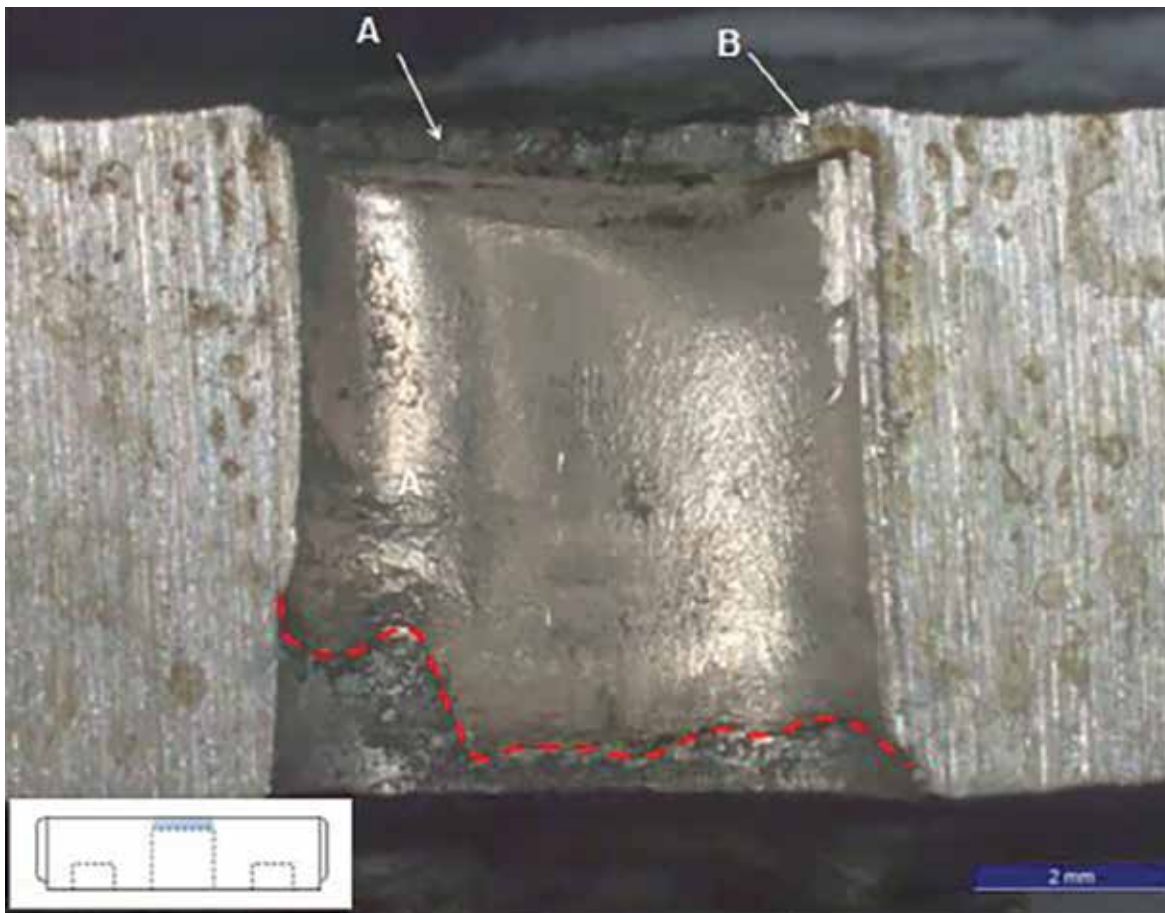
Figure 18: Central hole of the barrier with edge blown away at A, downward bending at B, and a red dashed line (shiny surface with the remnants of the lead charge cup - see Figure 19). (Picture: TNO)

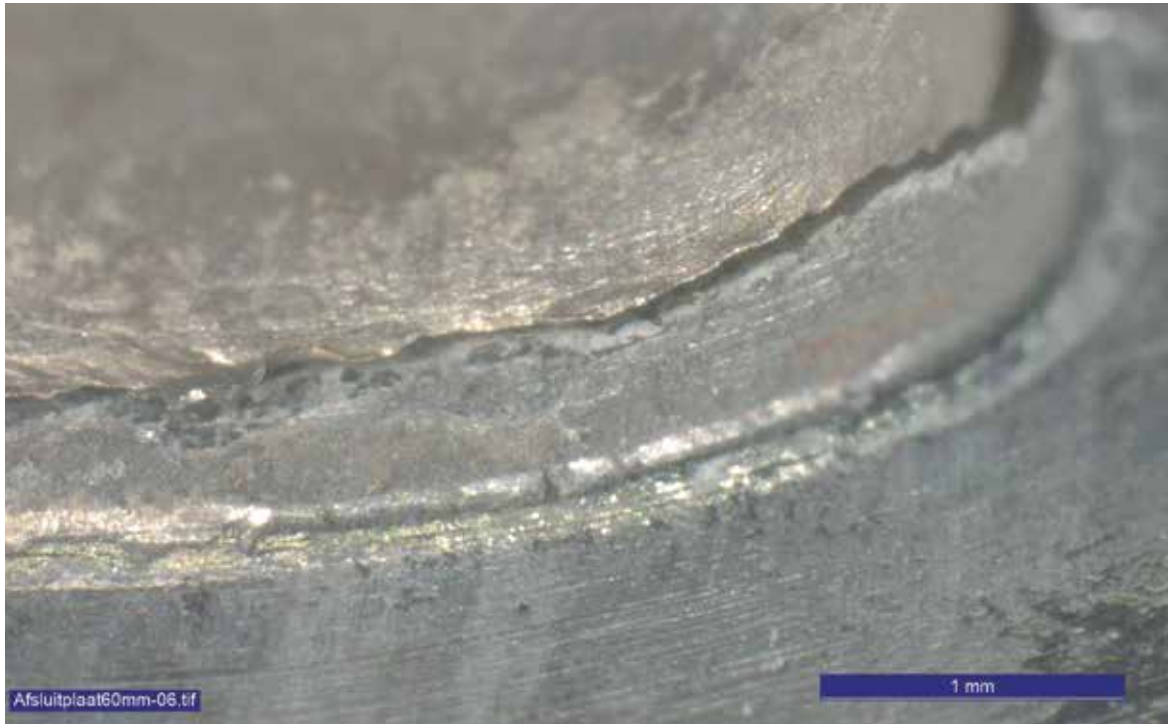
Figure 19: Lower edge of the lead charge cup (red line in Figure 18) on the inside of the central hole of one of the parts of the barrier. (Picture: TNO)

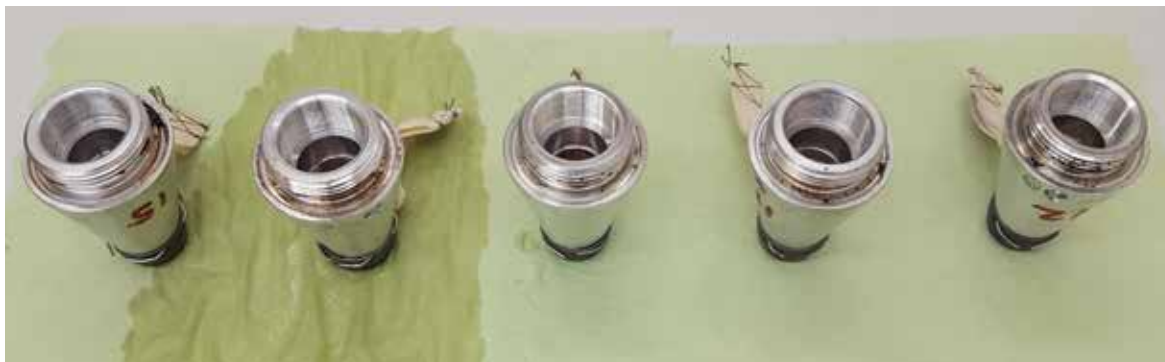
Figure 22: The adhesive layer of one of the five M6-N fuzes is leaking after a drop test from about one metre height with random impact orientation. (Picture: TNO)

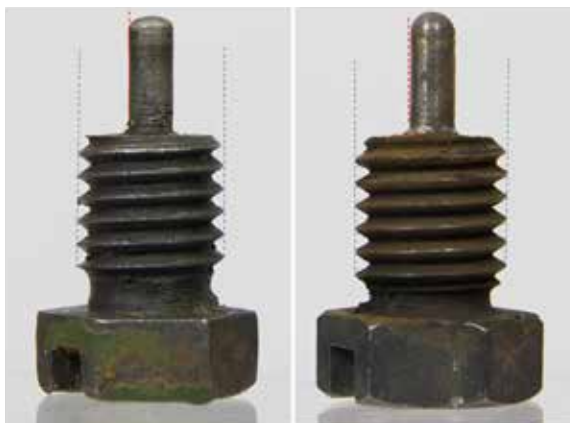
Figure 4 Comparison of the two firing pins (left: reference, right: accident).

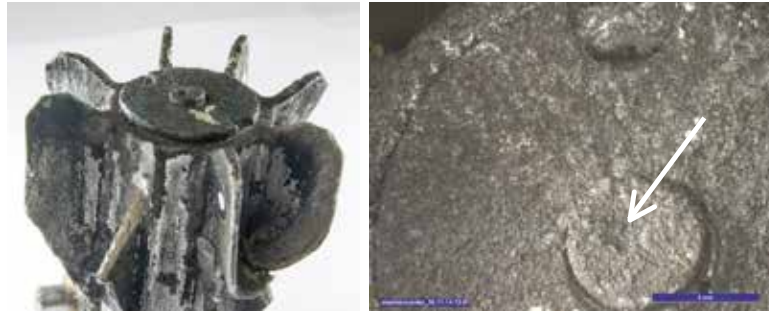
Figure 7 Indentation in the percussion primer of the propelling charge in the tail assembly of the mortar round (left), with a microscopic magnification of the percussion primer (right).

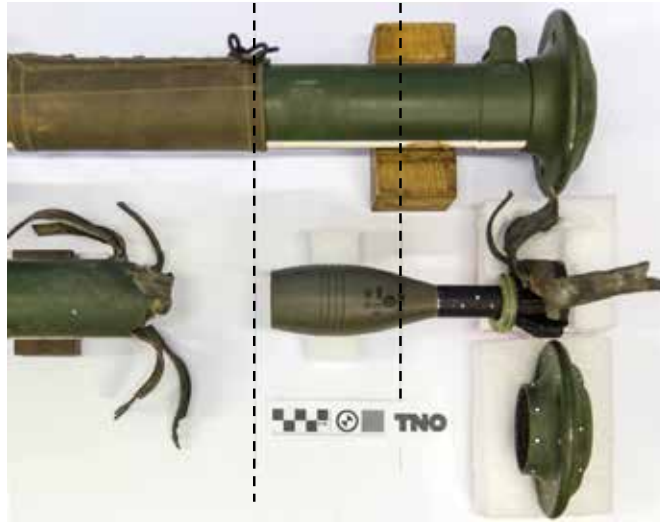
Figure 16 Damage to the launch tube.

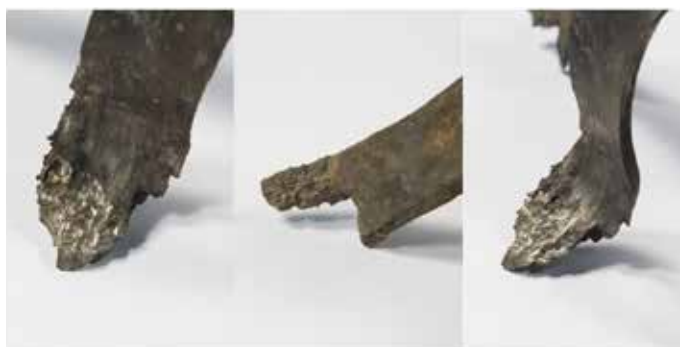
Figure 18 Damage to the elongated strips from the lower end of the launch tube.

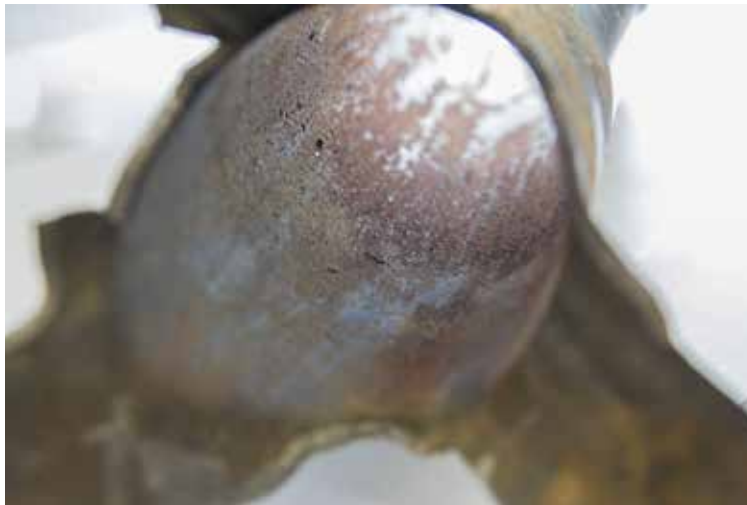
Figure 24 Several minor irregularities on the inside of the remnants of the launch tube No. 513 after the accident.

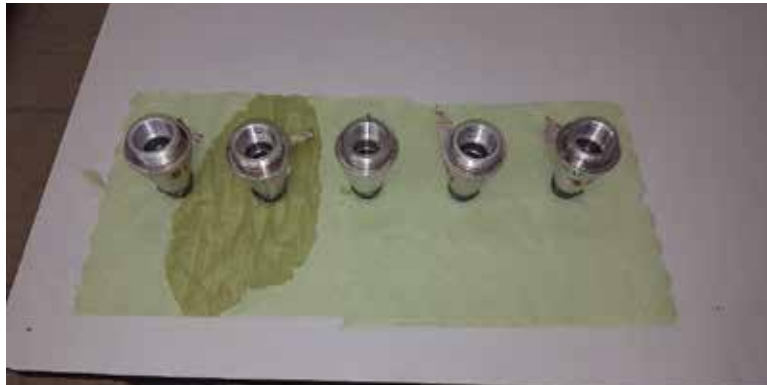
Figure 8 The adhesive layer of one out of five M6-N fuzes is leaking after five drop tests from about one meter height and random impact orientation with the ground.

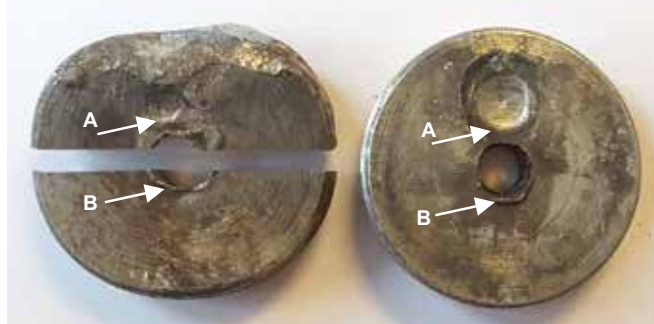
Figure 16 Comparison of the barrier from the impact fuze involved in the accident (left) with the barrier from the impact fuze used in experiment 3 (right).

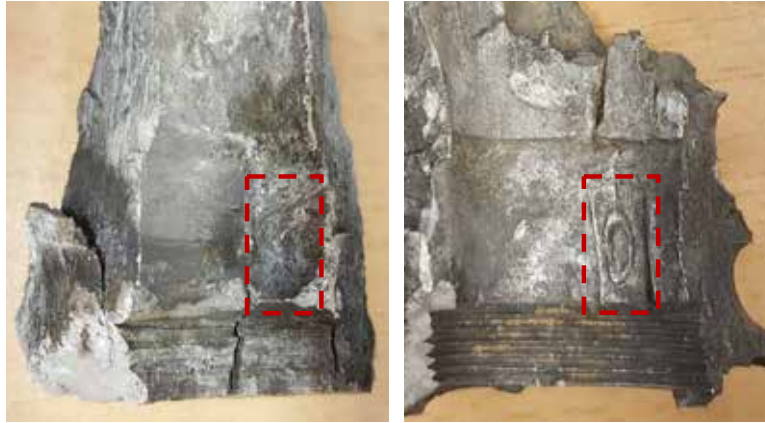
Figure 6 Imprint of the slider and slider spring on the inner wall of the fuze body from the test in armed position (left) and on the inner wall of the fuze body from the accident mortar round (right).

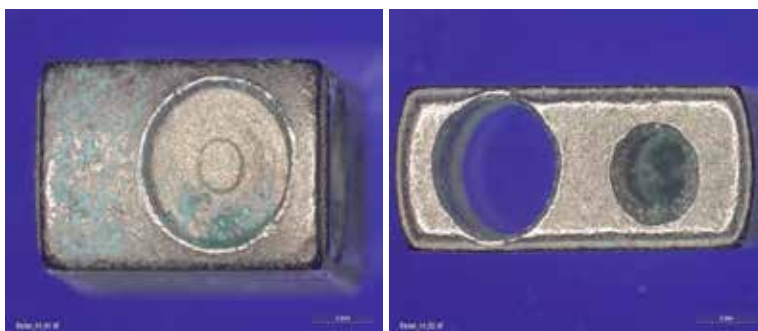
Figure 12 Optical micrographs of slider number 14. Corrosion is visible on the side wall and in the recess for the slider spring (left) and on the top, on the edge of the hole for the detonator and on the edge of the recess for the firing pin (right).

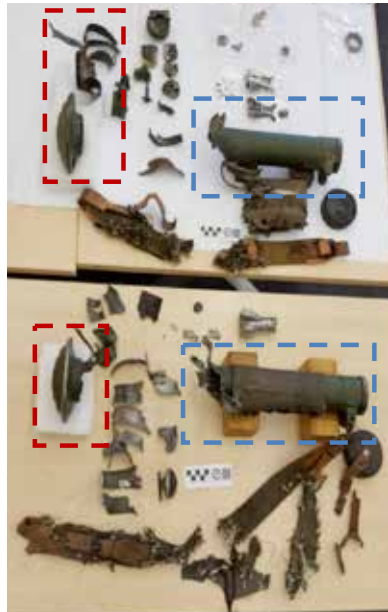
Figure 15 Damage to the mortar from the accident (top) and to the mortar after the test with the fuze in armed position by KCW&M (bottom).

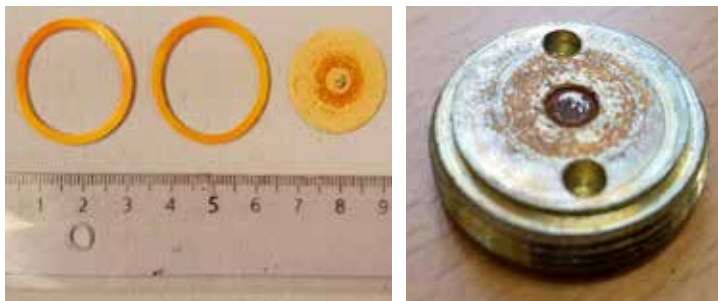
Figure 26 Discolouration of the O-rings and cardboard disk (left) and deposit on the bottom surface of the barrier (right) in the M6-N fuze used in the 70°C explosive train interruption test.
