DUTCH  
SAFETY BOARD

# Quarterly Aviation Report

January - March 2023

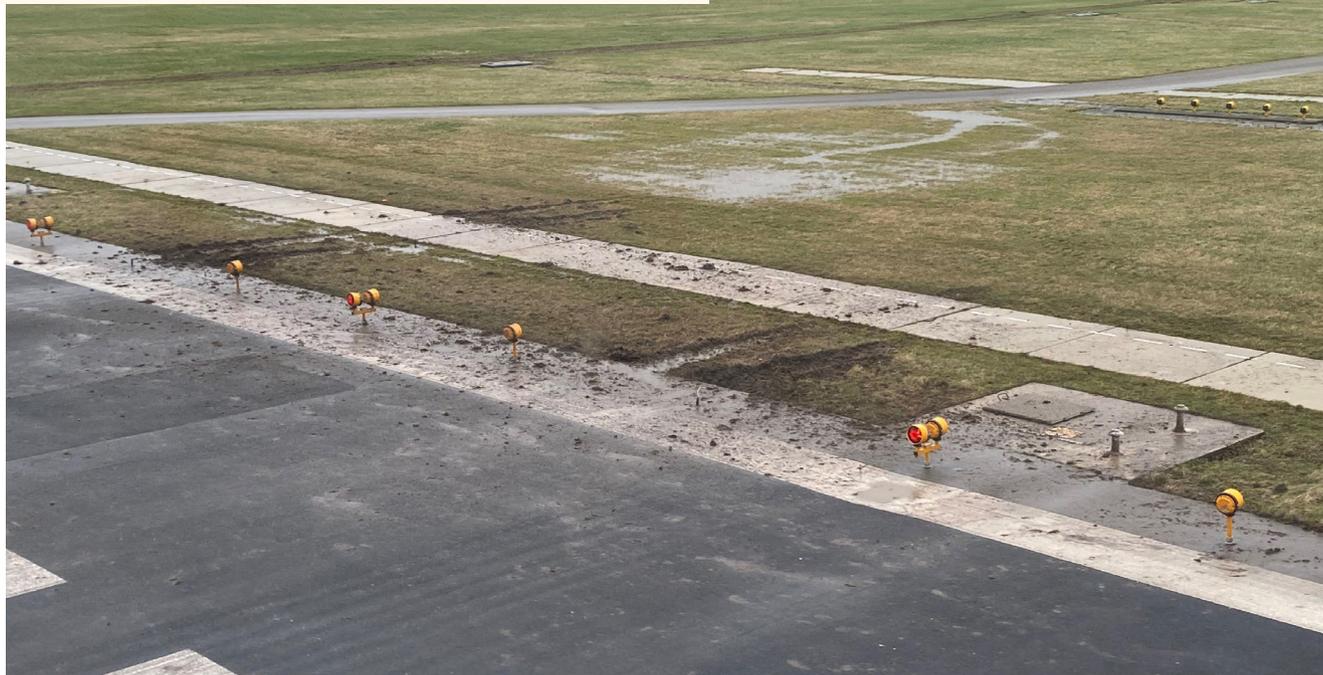
An Airbus A330-300 landed on Runway 22 at Amsterdam Airport Schiphol. The main landing gear of the aircraft touched down on the ground before the threshold of the runway and impacted some runway threshold lights. The aircraft sustained minor damage. The occupants were unharmed.

- ▶ Tracks in the grass in front of the runway threshold. (Source: Dutch Aviation Police)

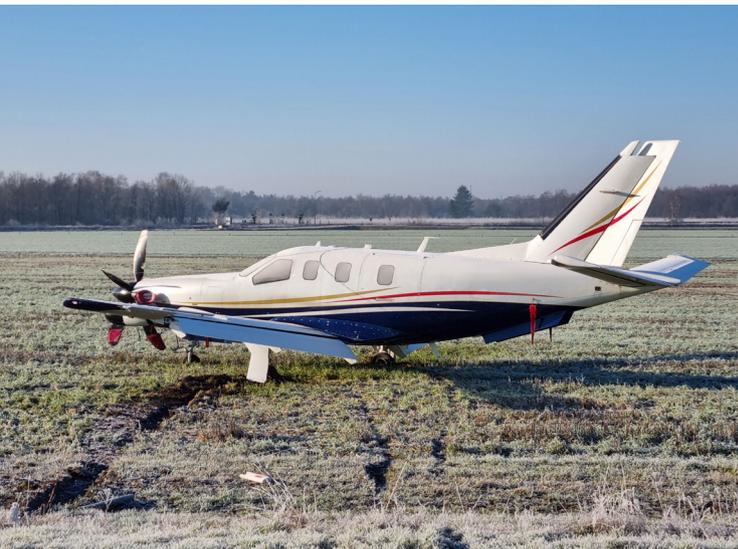
▲ The TBM 700 after the runway excursion. (Source: Dutch Aviation Police)

Due to a technical problem the engine produced more power during landing than usual. As a consequence, the air speed during landing was higher than normal, whereupon the aircraft did not stop on the paved runway. It overran the runway and came to a stop in the grass. The aircraft suffered damage. The pilot was unharmed.

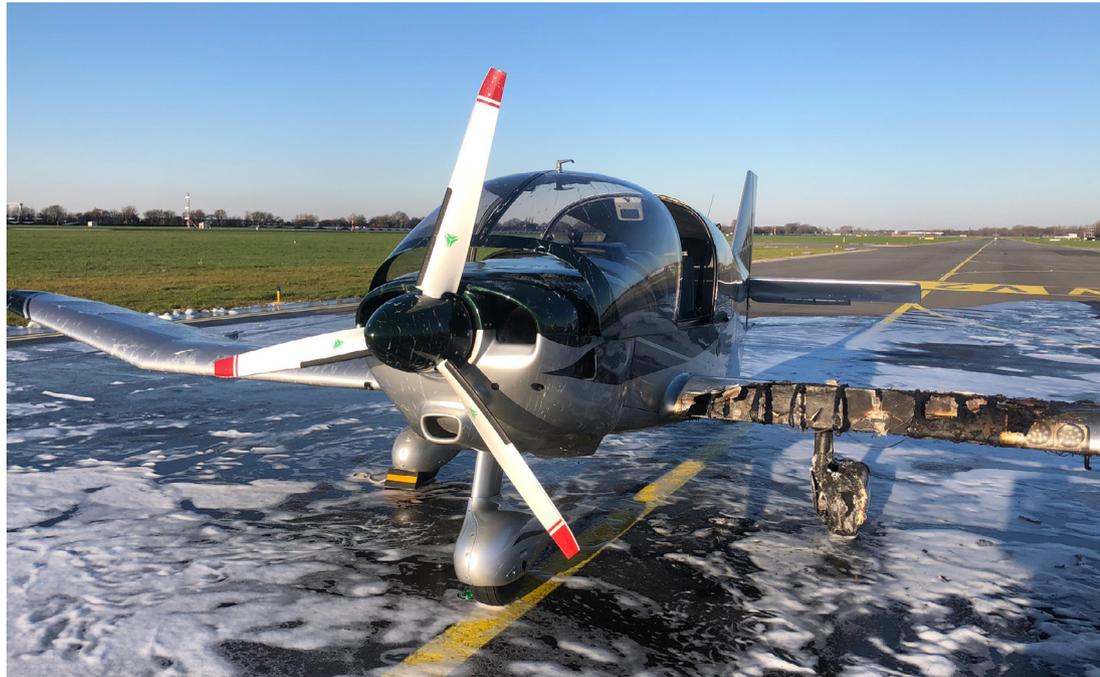
After landing during taxi, smoke and flames were visible near the left-hand main landing gear of the aircraft. The pilot brought the aircraft to a stop. Subsequently, the fire spread to the left-hand wing. A big part of the wing burnt down. The fire was extinguished by the airport fire brigade. The pilot escaped unhurt.

▼ *The burnt left wing.*

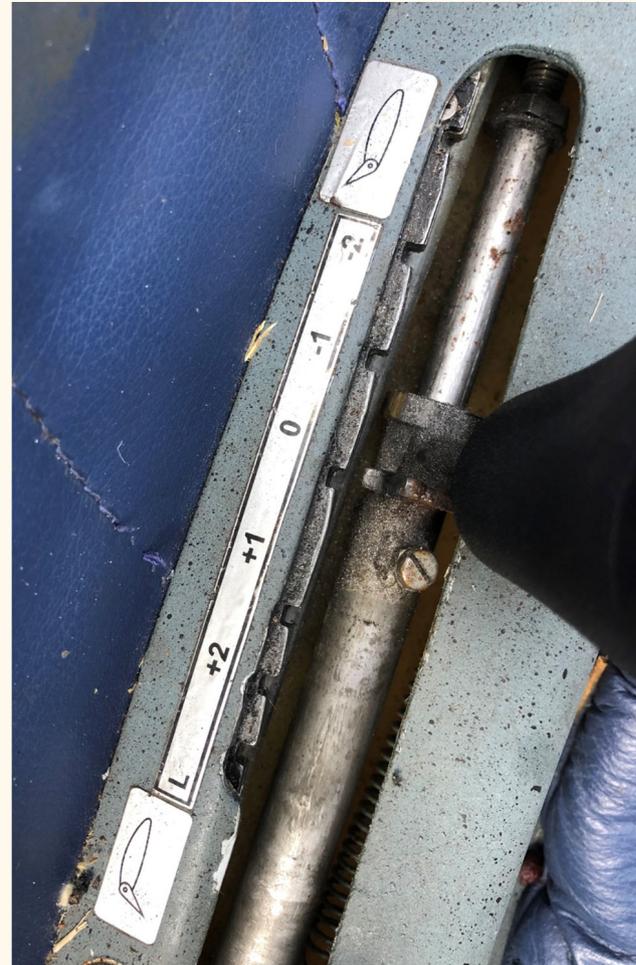
Inspection of the flap handle mechanism showed that the pawl on the flap handle showed wear and that a notch had formed. This allowed the pawl to release from the detent plate, when forces on the flaps increased after the pilot had opened the air brakes.

▲ Seven detents for the flap control lever.

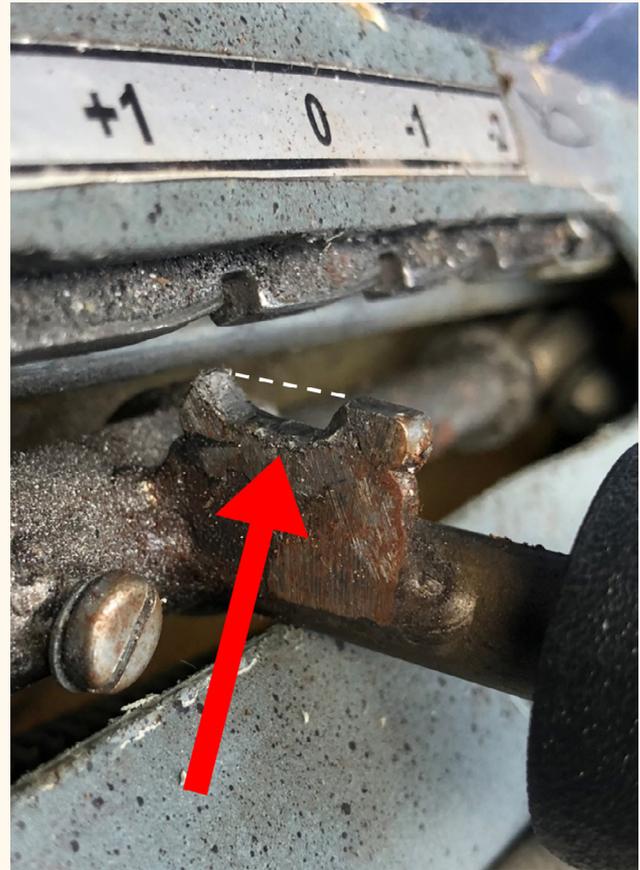
The fact that wear can occur on the pawl was known to Schempp-Hirth, the manufacturer of the glider. In December 2011, Schempp-Hirth therefore issued a technical note which also applied to the Nimbus-3T.<sup>24</sup> It stated that during maintenance, the maintenance information<sup>25</sup> for the flap

control SHK-M-01-11 must be noted. This information must also be appended to the service instructions. The maintenance information stated, among other things, that in addition to the detent plate, the pawl on the flap handle must also be checked for wear, that it must have a rectangular cross-section and the edges must not be excessively rounded. It contained a picture of a badly worn pawl in which also a notch had formed, along with the text that this example has come a long way above the wear limit that would have required a repair.

▲ The pawl, with a notch in it, which is part of the flap control lever.

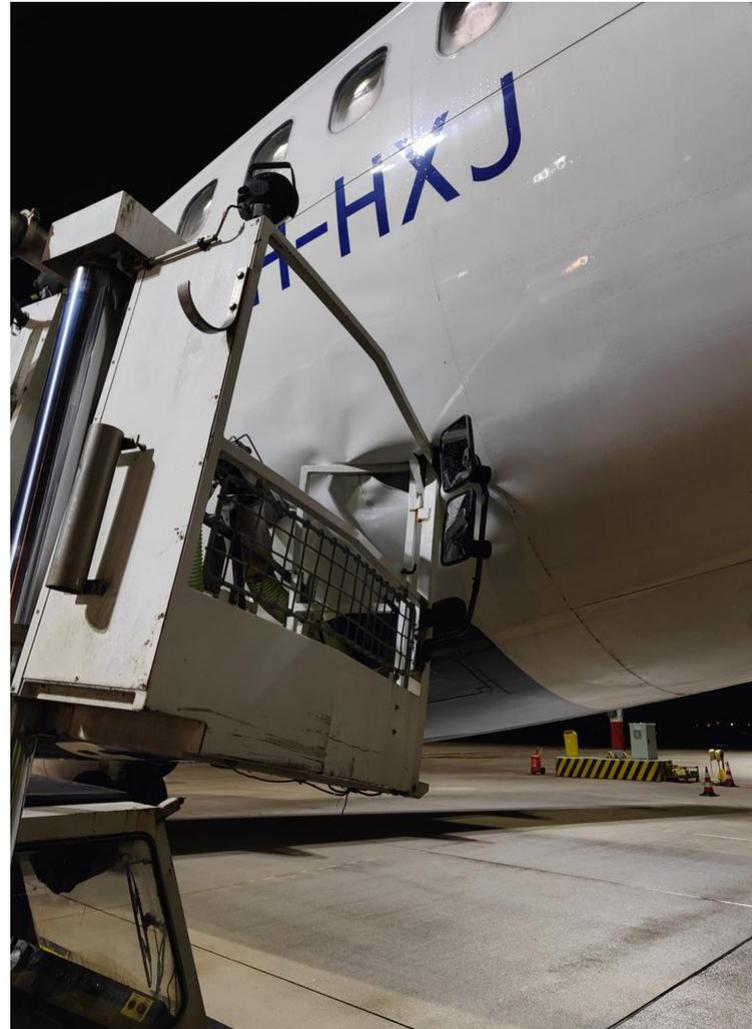
The platform can only be operated from outside the vehicle. Besides the driver, who was sat in the cab, no one was in the vicinity of the vehicle. Following a technical investigation of the vehicle and the platform by the ground handling company, together with the manufacturer, no cause was discovered for the spontaneous rising of the platform.

▲ The platform and the damaged aircraft fuselage.  
(Source: Rotterdam The Hague Airport)

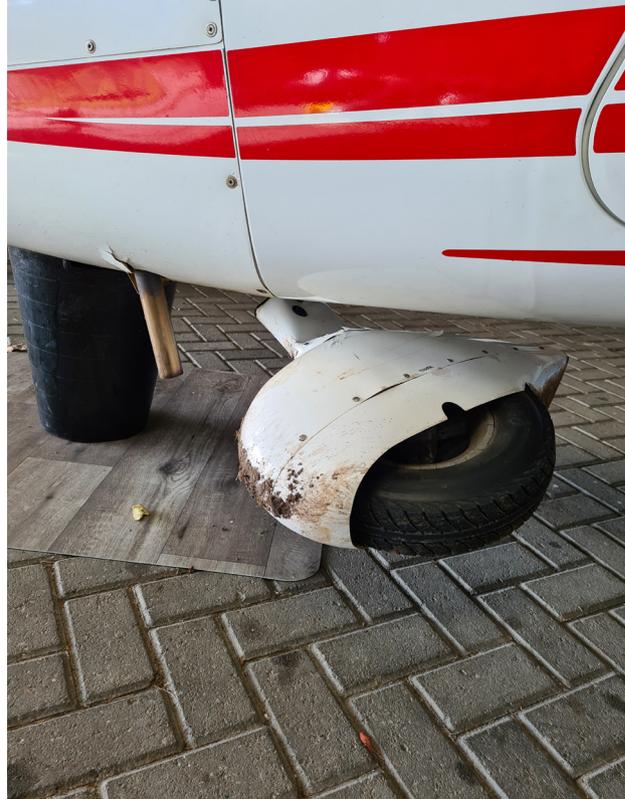
As a result of the accident, the aircraft suffered damage to the nosewheel leg, the propeller, the right wing tip and the wheel housings of the main landing gear.

▲ Bent nosewheel leg. (Source: pilot)

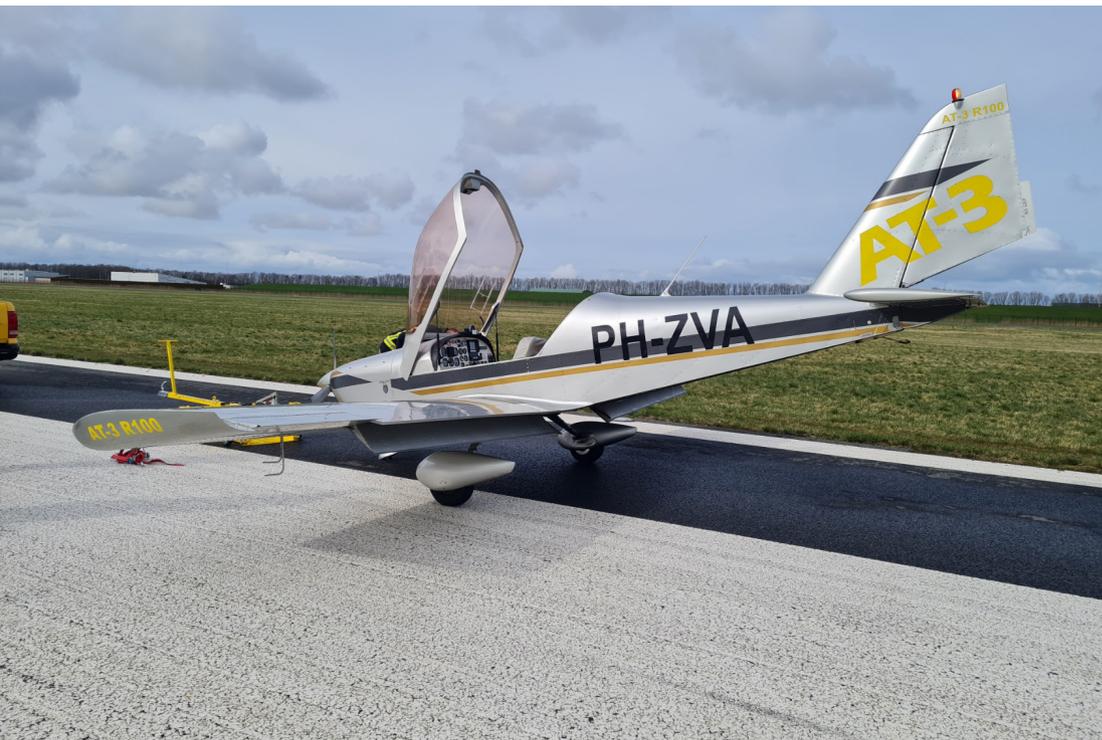
The tips of the propeller blades had also broken off. The pilot was unharmed.

▼ *The AT-3 following the landing. (Source: pilot)*
