DUTCH  
SAFETY BOARD

# Quarterly Aviation Report

October - December 2019

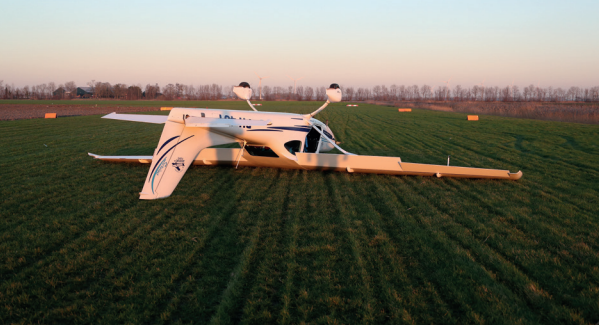
In the course of landing, the aircraft flipped inverted and came to a standstill upside down. Both occupants remained unharmed. The aircraft was damaged.

The Sirius after the occurrence. (Source: Police, Aviation Supervision Team)

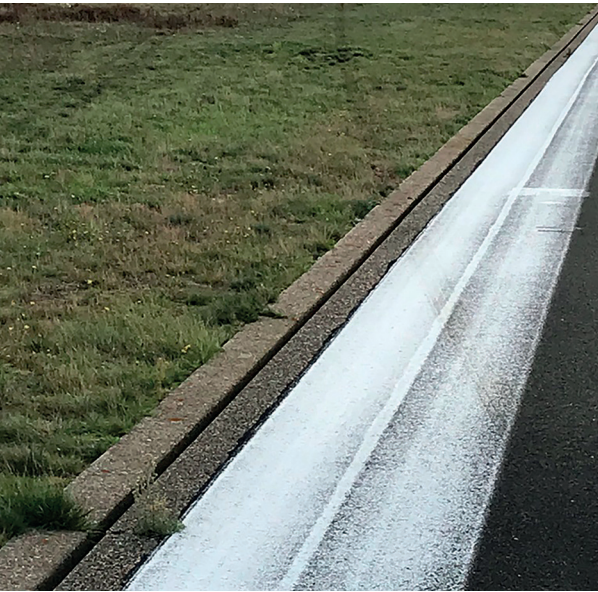
With three crewmembers and a passenger on board, the aircraft left the runway during takeoff. The aircraft sustained light damage. The occupants remained unharmed.

Tracks of runway excursion. (Source: BFU)

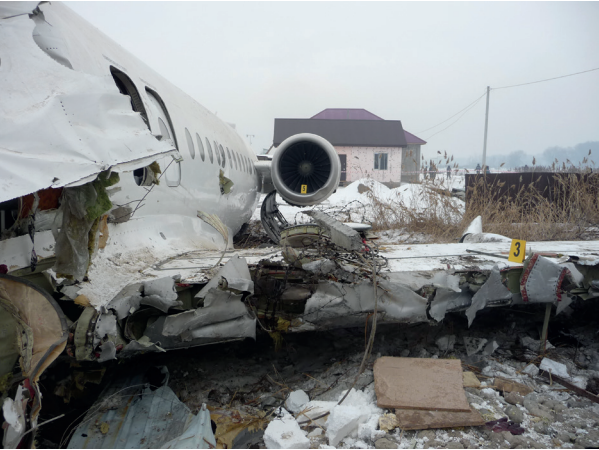
The Fokker 100 crashed shortly after takeoff on a national flight from Almaty Airport. The aircraft collided with a building. The aircraft carried 93 passengers and 5 crewmembers. Twelve of the occupants died and 35 of the occupants were seriously injured in this accident.

The crashed Fokker 100.

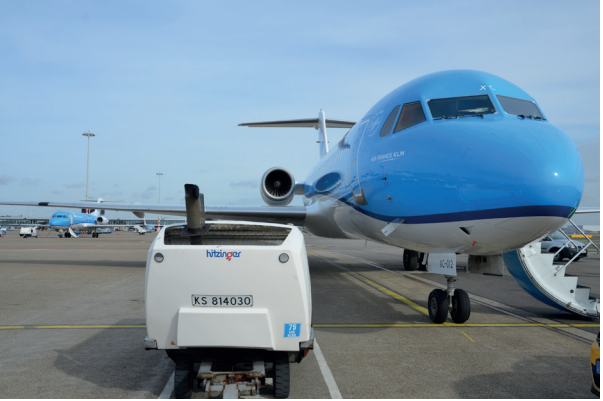
Once arrived at its assigned free aircraft stand (not at the terminal gate) both crew members stepped on the brake pedals to bring the aircraft to a full stop. The aircraft did not slow down noticeably. Despite an evasive manoeuvre to the left, the bottom of the aircraft’s right wing collided with the ground power unit (GPU). Handling personnel that were meant to connect the GPU and place the wheel chocks in front of and behind the wheels, were forced to run away in order to avoid being run over.

The aircraft continued to roll, ending up on a taxiway and moving towards one of the busy main taxiways around the Schiphol terminal complex. When the crew shut down the remaining engine, the brake pressure suddenly returned, bringing the aircraft to an abrupt halt. At the time, it had returned to the nearest main taxiway without having collided with other aircraft or obstacles. Clearly, the loss of brake pressure initially presented a serious risk to the safety of the handling personnel. After that, after the collision with the GPU there was still the risk of a subsequent collision with another object, particularly as PH-WXC drove onto a main taxiway where other aircraft might have been present. However, the alertness of the handling personnel, actions of the cockpit crew, and fortunate circumstance that there was no other traffic in the aircraft’s immediate vicinity, served to limit the consequences of this incident.

The Dutch Safety Board concludes that complex failures, generally in avionics systems (line replaceable units (LRUs)), are difficult to detect. The investigation of PH-WXC did not yield an immediate cause. Based on this investigation, the Dutch Safety Board is able to specify two factors that may present a safety risk in the maintenance environment, particularly when they are combined:

- Despite following the correct procedures for maintenance and the airworthiness requirements, LRUs may be recommissioned without the problem having been established and without being certain that it has been resolved.
- The pool system may affect the effectivity of monitoring the continuous airworthiness of LRUs (including tracking unplanned replacement of units and recurring incidents) because the operators are not aware of them.

The Fokker 70 and the GPU. (Source: Aviation police)

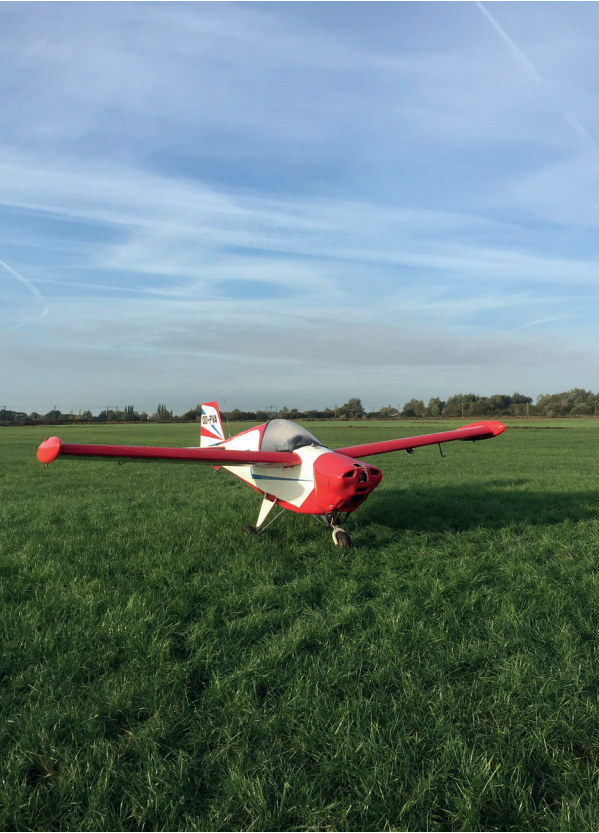
The aircraft took off from the Hilversum airfield on a local flight. During the first leg of the flight, the pilot detected vibrations in the aircraft. These vibrations disappeared after the engine speed was changed. Later in the flight, as he was pulling out of a looping, the pilot detected a different engine sound and an increased engine speed. He concluded that the propeller had disappeared and made an emergency landing in a meadow. The pilot was unharmed. The detached propeller fell into a meadow without causing any damage. The engine cover sustained light damage due to the propeller separation.

The investigation revealed that five of the bolts with which the propeller flange is mounted onto the (engine) crankshaft flange had fractured. One bolt had not fractured but had been yanked from the crankshaft flange in its entirety, severely damaging the thread. When the five threads remaining in the crankshaft flange were removed, it was noted that these could be unscrewed without any resistance. Three of the bolt heads were still wired together with the lock-wire.

Microscopic investigation of the fracture surfaces shows fatigue fractures that started in the thread core. This means that the bolts had slowly detached during the course of the flight, steadily increasing the clearance between the propeller flange and the crankshaft flange. This resulted in a combined bending moment and tensile force within the bolts, causing the bolts to eventually fracture due to excessive stress.

The engine manufacturer makes the following statement about the use of lock wire to secure propeller bolts: “no objection to lock-wire being used. However, lock-wire on its own has proven to be insufficient restraint for the screws. Loctite 620 must be used – all other restraints are optional”. However, no residue of Loctite 620 was found on any of the bolt thread sections. It was established that only lock-wire had been used instead of Loctite 620.

The engine had not been serviced in accordance with the manufacturer’s instructions. Failure to use the prescribed retaining compound caused the bolts with which the propeller was mounted onto the crankshaft to come undone. This led to fatigue fractures, which eventually resulted in the bolts breaking off. It is deemed unlikely that the absence of retaining compound would have been detected during the 25-hour inspection if it had been performed according to schedule, i.e. eight hours prior to the incident.

Topsy Nipper after the emergency landing.

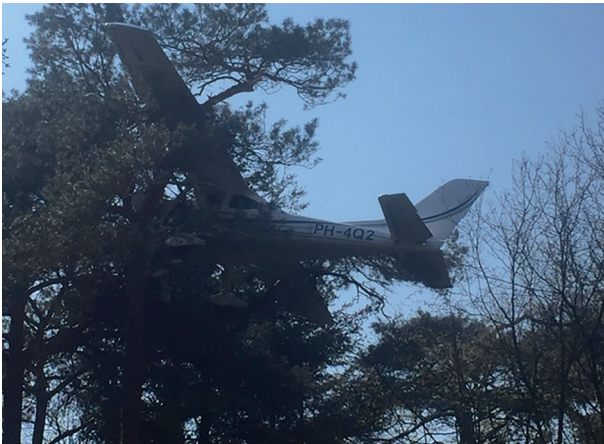
The TL-3000 Sirius was on a training flight with an instructor and a student on board. After three touch-and-go's on runway 07 of Hilversum airfield, the aircraft landed, intending to perform another touch-and-go. The aircraft had bounced on landing, after which the instructor took the controls and made a restart. The controls were then handed over to the student once again. At an altitude of approximately 300 feet, when the aircraft was in line with the runway and turned into the crosswind, the engine started to stutter. The instructor took back the controls once again and performed a failure check. He moved the throttle to idle and back to full power several times. The engine continued to stutter and delivered inadequate power to fly a short approach. The altitude was such that no other option remained but to land in the trees on a military terrain bordering the airfield. The aircraft came to a halt in a treetop. The two occupants were rescued from their situation by the fire department. They remained unharmed but the aircraft was heavily damaged.

A limited technical investigation was conducted of the engine, checking for the presence of fuel and oil, the control levers of the engine, the spark plugs, carburettor, cylinders, and valves, among other things. The investigation did not yield a technical explanation for the engine stutter.

The TL-3000 Sirius after its treetop landing.

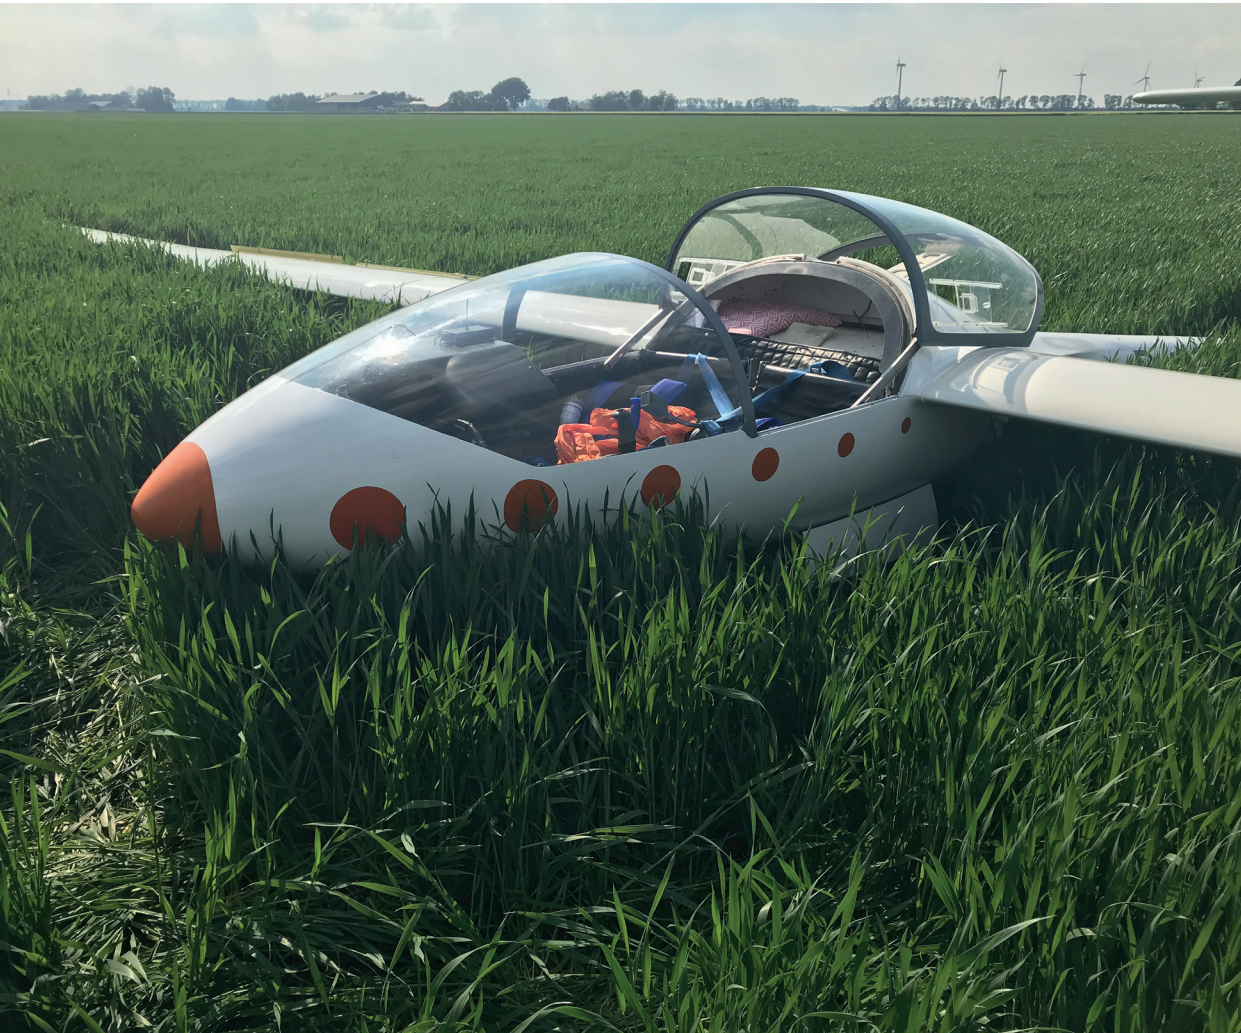
He stated that the wind pushed the glider to the right after he turned into the final approach leg. At that point he was unable to position the glider in front of the landing strip and decided to land in a nearby wheat field. During the ground roll, the glider made a ground loop. The occupants remained unharmed. The aircraft sustained damage to the wings and flaps.

Prior to the launch, the pilot had performed a cockpit check. He had also checked whether the canopy was closed and locked. He possibly overlooked the fact that the canopy was locked improperly on the right side. This incident emphasises the importance of a thorough cockpit check prior to every flight.

The Calif after the off-field landing. (Source: Aviation police)

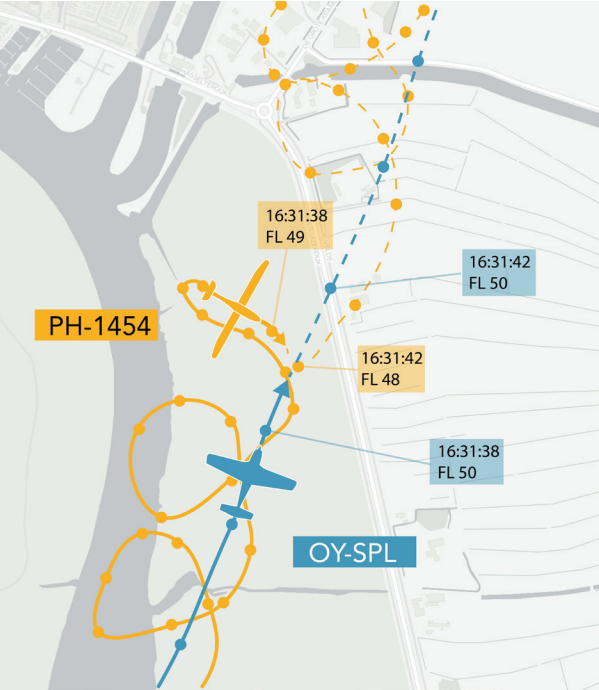
The radar images showed that PH-1454 was on a course of 065° at a radar altitude of 4900 feet at 16.31:35 hours. The following point recorded by the radar was at 16.31:47 hours, at which time the glider was still flying at the same altitude. The course line of PH-1454 was crossed by the course line of OY-SPL. This aircraft flew on a course of 010° at a radar altitude of 5000 feet. At 16.31:39 hours, PH-1454 was positioned to the left of OY-SPL. At 16.31:43 hours, OY-SPL was positioned to the north of the course line of PH-1454.

The incident occurred because both pilots did not visually acquire each other and therefore could not take timely evasive action.

Airprox near Zwartsluis. (Source: Radar data: LVNL, Map: OpenStreetMap)

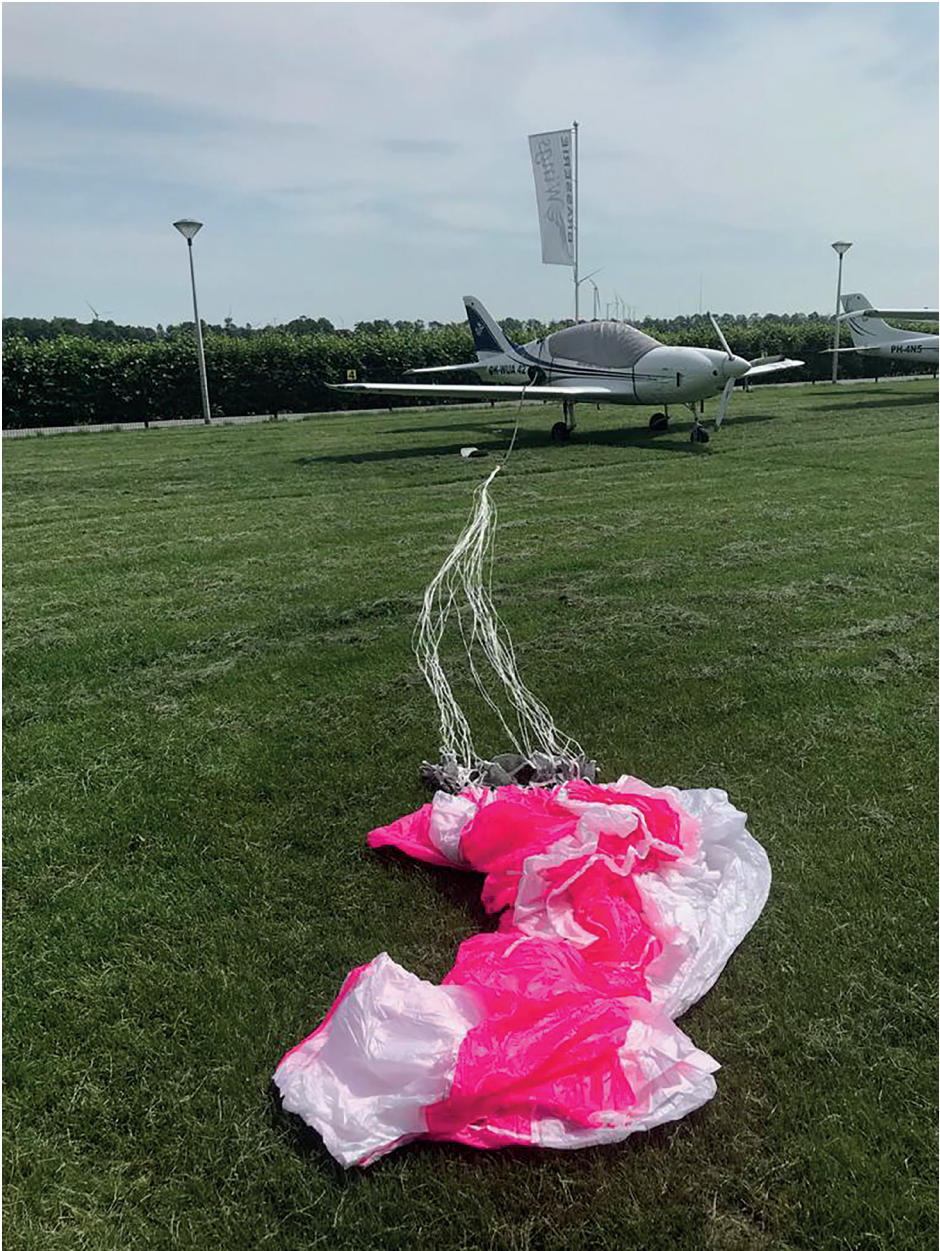
At the start of the flight, standing still on the platform, the passenger alerted the pilot that the (hindmost) locking pin of the parachute rescue system had not been removed. The pilot then gave the passenger permission to (carefully) remove the locking pin. The passenger accidentally activated the system, after which the parachute was ejected and opened. Nobody was injured but the aircraft sustained serious damage.

The passenger stated that moving the activation lever was necessary to be able to remove the locking pin. At the moment he was able to remove the pin, the lever also moved, activating the parachute. The passenger also stated that the force he exerted was small and that he had not pulled out the lever more than approximately 5 cm. The Emergency Checklist of the TL-ULTRALIGHT Stream specifies the following: *Parachute Activation Handle... PULL FIRMLY! With a force from 11.5 KG about 40 cm!*

The parachute of the rescue system. (Source: Pilot)

The aircraft’s owner has stated that the procedure for removing the pins will be reviewed and changed.
