**Collision and capsizing of tug Fairplay 22 on the
Nieuwe Waterweg near Hook of Holland**

**Collision and capsizing of tug Fairplay 22 on the
Nieuwe Waterweg near Hook of Holland**
11 November 2010

The Hague, March 2012 (project number M2010ZSV1111-01)

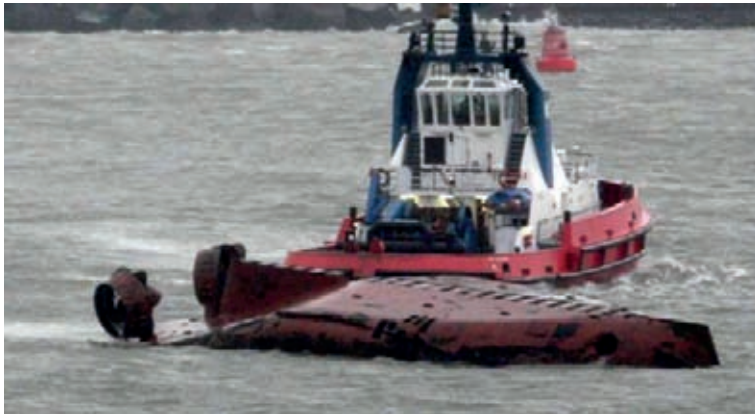
Over the course of the second attempt, Fairplay 22 collided with Stena Britannica. Fairplay 22 came broadside in front of Stena Britannica's bow with its starboard side, and heeled over to port. The captain of Fairplay III realised what was happening and communicated to the Stena Britannica captain by VHF: "Stena Britannica full speed astern". Stena Britannica complied immediately, and the ship reduced speed. The chief officer of Stena Britannica also saw that the tug started to heel. Shortly thereafter, the heeling of the tug was also reported to the bridge by the crew member on the fore deck of Stena Britannica. In the meantime, Fairplay 22's heeling angle had increased even further. A few moments later, Fairplay 22 capsized over its port side. Figure 6 shows Fairplay 22 after the vessel had capsized.

Figure 6: The capsized Fairplay 22 and tug RT Magic, which provided assistance after the accident [source: www.tugspotters.com].

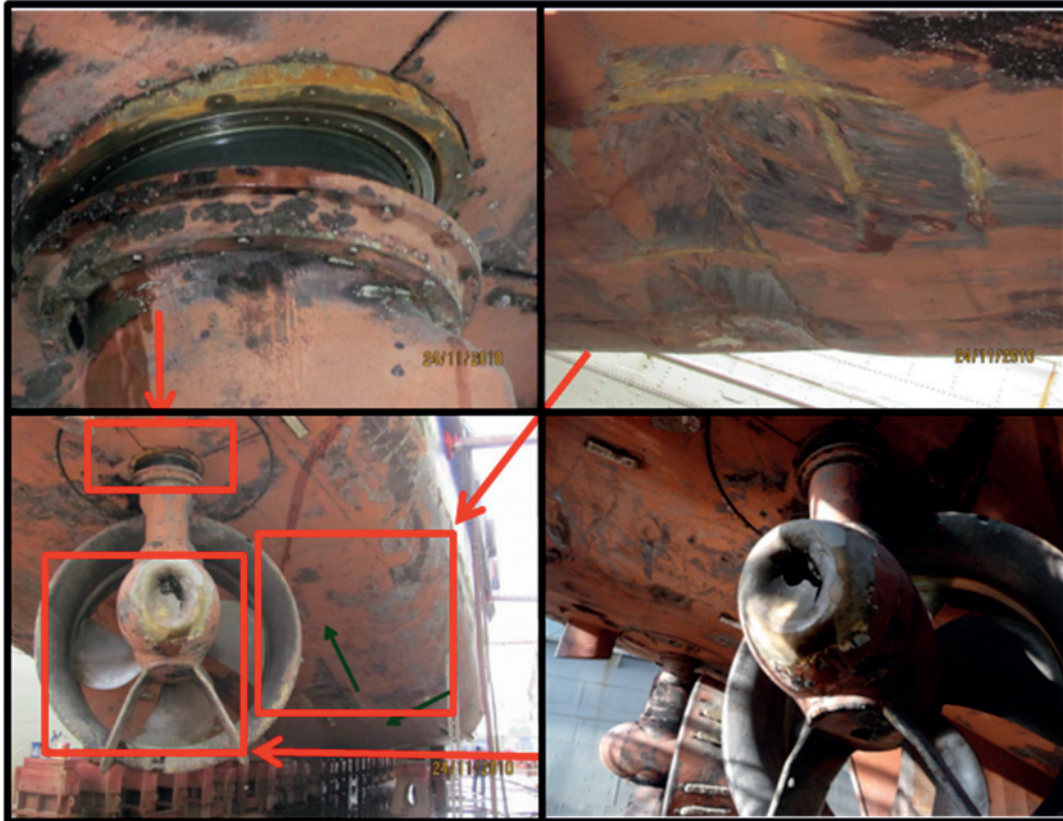
Various parts of Fairplay 22 were damaged, including the hull and the starboard azimuth thruster. The propulsion system and ship's equipment also suffered water damage. The cause of the damage to the starboard azimuth thruster could not be determined with certainty; the damage was possibly sustained during the salvage operation. The tug was not put back into service after the accident, and was sold to a new owner in Greece. Figure 8 shows the damage to Fairplay 22's underwater hull.

Figure 8: Damage to Fairplay 22 [source: Dutch National Police Services Agency (KLPD)].

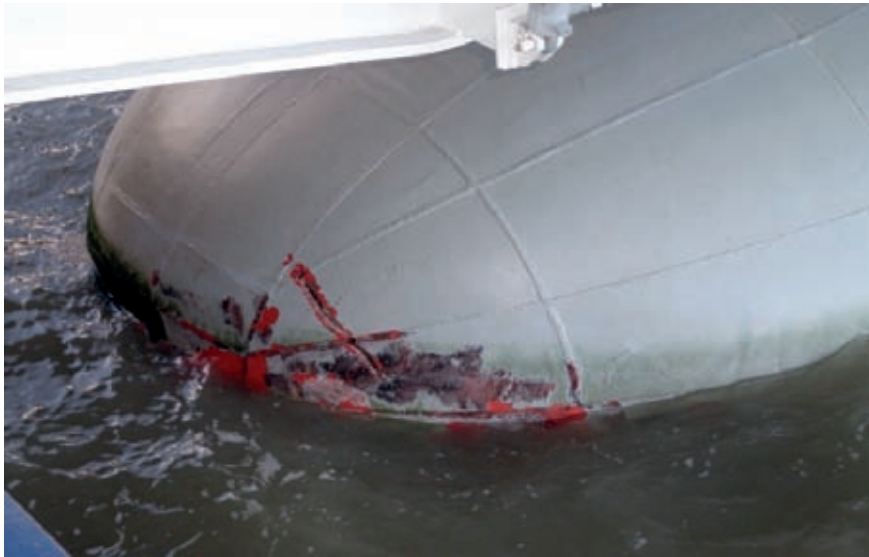
An inspection was conducted on 23 November 2010 in order to determine the extent of damage to Stena Britannica. The inspection only found damage to the bulbous bow. This damage was limited to paint damage and light scuffing. The inspection found traces of red paint on Stena Britannica's bulbous bow. Figure 9 shows the damage to Stena Britannica.

Figure 9: Damage to the bulbous bow of Stena Britannica [source: Marine Accident Investigation Branch, United Kingdom].

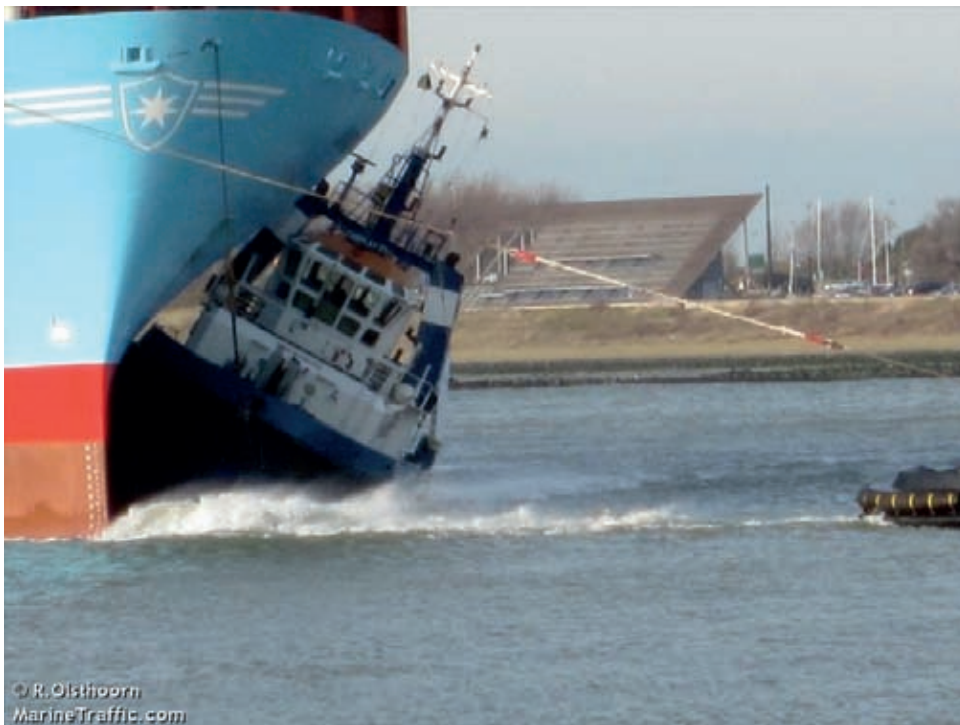
According to the investigation report issued by Smit, which was distributed among Smit crew members, Fairplay 21 was towing at full speed at the request of the pilot and had insufficient reserve power to correct the Lars Maersk's course. The tug's speed through the water was approximately 5.5 knots. According to the report the 'failure to take into account the limitations of tugs as a result of the speed of the combination and the alternative towage/assistance methods' was one of the main causes of the accident. The following recommendation was issued: 'never use full power while providing assistance. Make sure there is always reserve power for unexpected situations.'

Figure 14: Fairplay 21 after having collided with Lars Maersk [source: Smit].

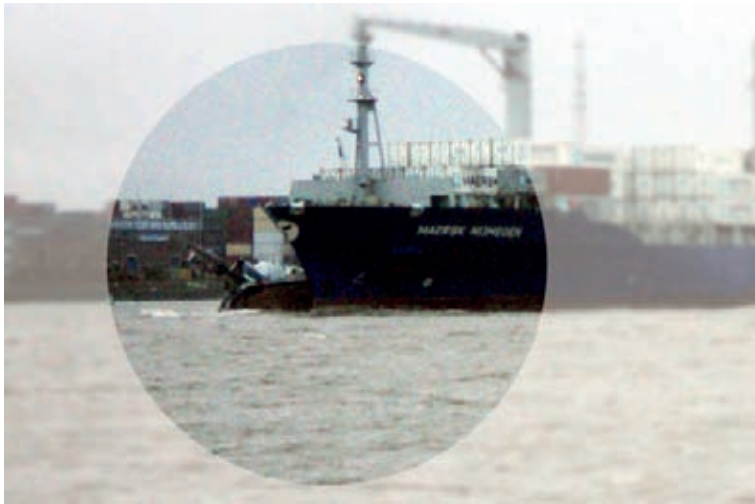
Figure 15: Tug Smit Polen after colliding with Maersk Nijmegen's bulbous bow [source: Smit].

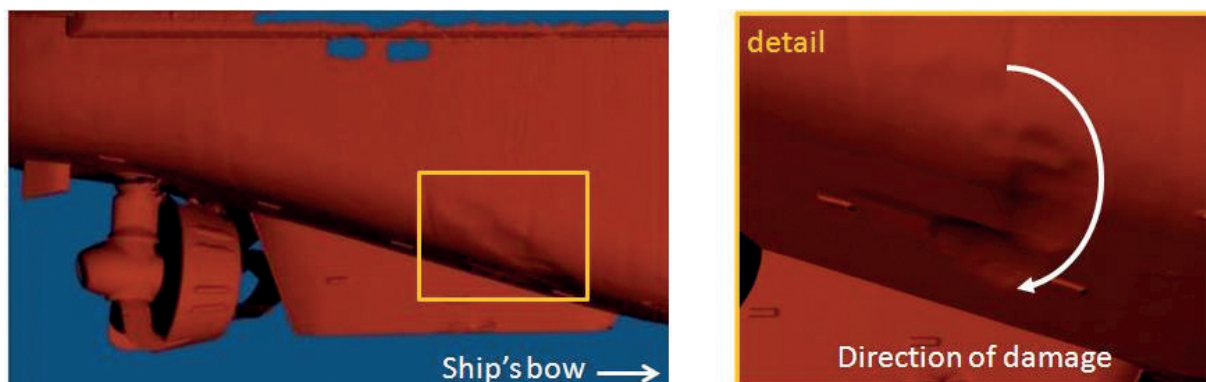
Figure 19: The damage location and direction of damage on Fairplay 22.

The damage found on the starboard side shows that Fairplay 22 rolled and ultimately capsized. The depth of the impact damage, which has set in, starts from aft and extends forward. The damage also turns or curves towards the bottom of the ship. After that a second impact that has set in on the bottom of Fairplay 22 can be seen, the shape of which is round.

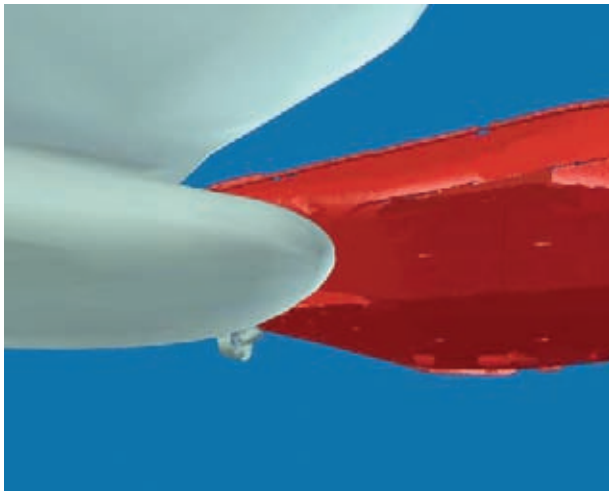
With the aid of 3D software it was found that the shape and dimensions of the second impact imprint match the shape and dimensions of the bulbous bow of Stena Britannica. Figure 20 shows the impact of Stena Britannica's bulbous bow on Fairplay 22.

Figure 20: The impact of Stena Britannica on Fairplay 22.

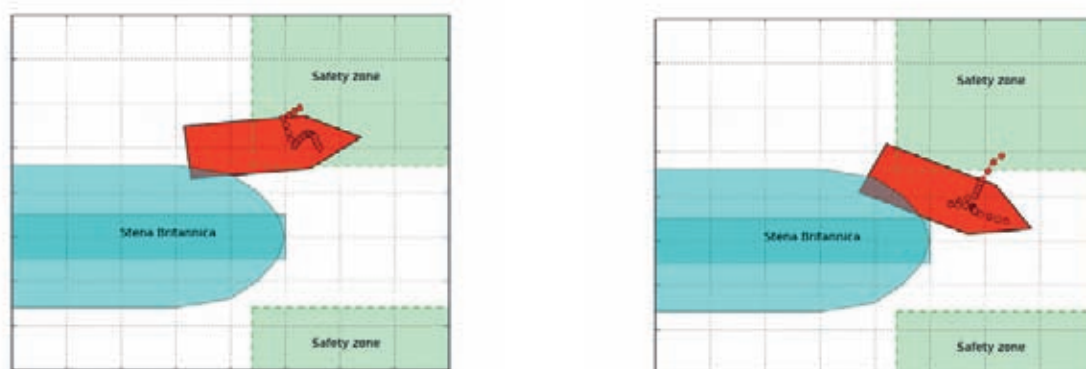
Fairplay 22 left the Safety zone during the second attempt. The reconstructed position of Fairplay 22 now falls within Stena Britannica's breadth. The direction of the bow also pointed inward during the second attempt. The hydrodynamic interaction near the bulbous bow will amplify the turn towards the bulbous bow.

Figure 23 Reconstruction of Fairplay 22's positions (red) in relation to Stena Britannica (cyan) during the first attempt at 15.47:37 (left) and during the second attempt at 15.49:10 (right).

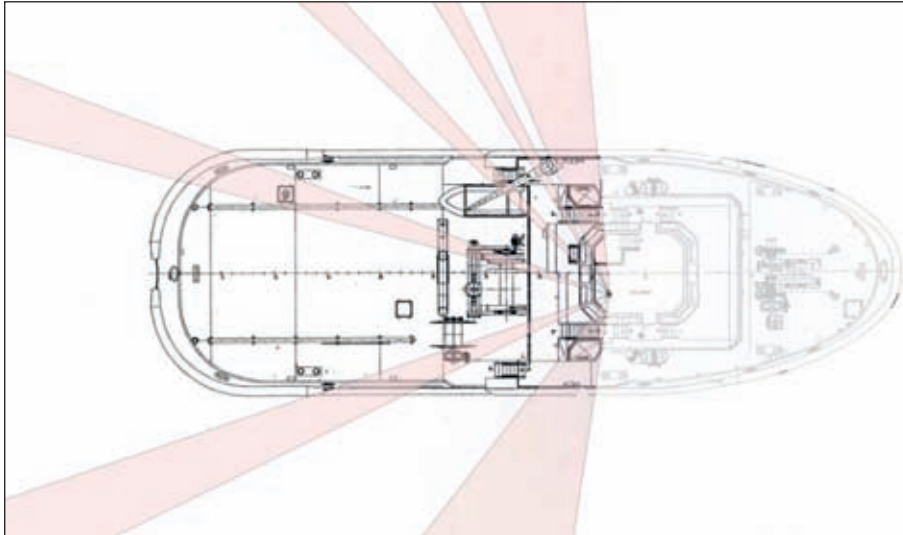
During the attempts to take in the heaving line, the captain of Fairplay 22 was standing at the control panel located on the aft of the bridge. The captain was standing with his back facing the tug's sailing direction. The stern of Fairplay 22 and the bow of Stena Britannica were visible to the captain from this position. The tug's funnels and window mullions restricted the view from the rear control panel. Figure 27 shows the restricted view. The degree to which the captain of Fairplay 22's view was restricted depended on the angle of Fairplay 22 relative to Stena Britannica and the movements of the two ships as a result of the wind, current, waves and stability.

Figure 27: The view, shown in white, from the rear control panel on the bridge of Fairplay 22.

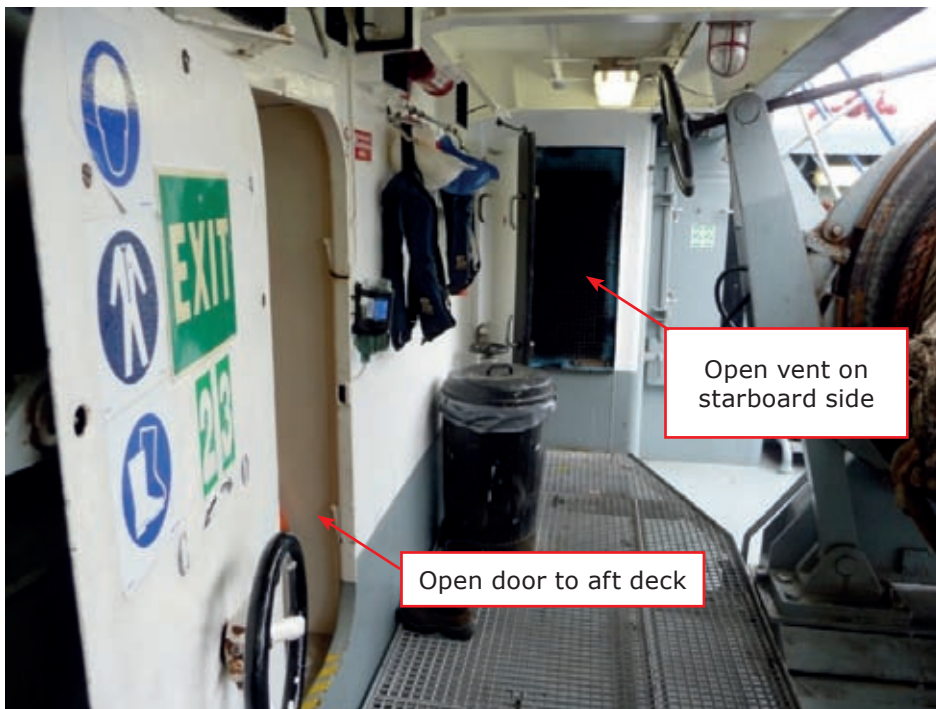
A watertight opening is an opening capable of preventing the passage of water through the structure in either direction, with a proper margin of resistance under the pressure due to the maximum head of water which it might have to sustain. A weathertight opening is an opening capable of preventing water from penetrating into the ship in any sea conditions. Fairplay 22 has a number of weathertight openings, including the engine room vents and a door leading to the aft deck. It was found during the investigation that vents and the door leading to the aft deck were open at the time of the accident involving Fairplay 22. Figure 28 shows the door leading to the aft deck and the open vent (on sister ship Fairplay 23).

Figure 28: The door leading to the aft deck on Fairplay 23 (left), which was open on board Fairplay 22 at the time of capsizing, and the open vent on starboard side.
