Report on the joint investigation of the collision
between the LNG Carrier
mts **AL ORAIQ** and the mv **FLINTERSTAR** off
the coast of Belgium on 6 October 2015 with the
total loss of the mv **FLINTERSTAR**

Federal Bureau for the Investigation of Maritime Accidents

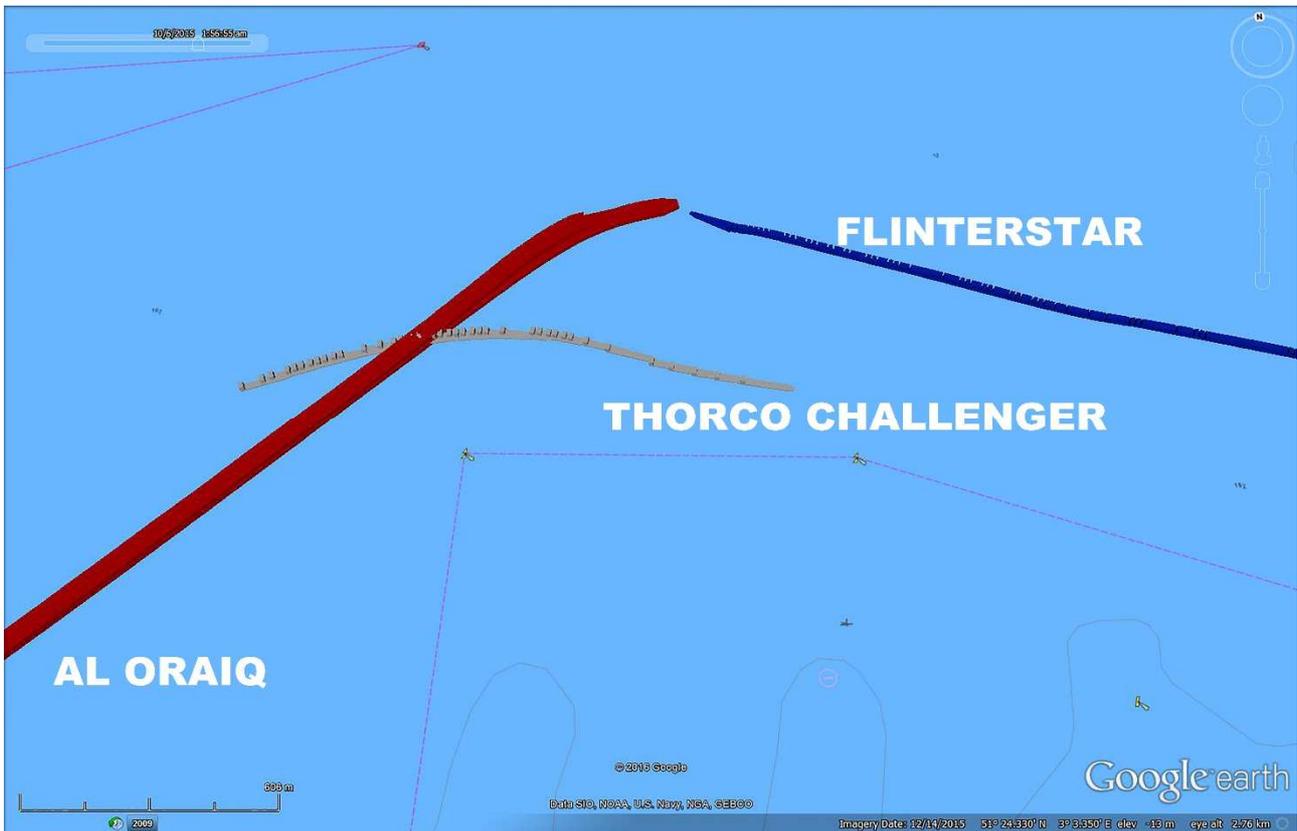
Figure 2 - Tracks of last minutes before the collision

At 0357 both vessels, the mv FLINTERSTAR and mts AL ORAIQ, collided in the vicinity of the S3 buoy.

For preventing mv FLINTERSTAR to sink in the confined fairway, it was agreed between the Pilots on both vessels that the mts AL ORAIQ would push the mv FLINTERSTAR onto a sand bank, which subsequently happened.

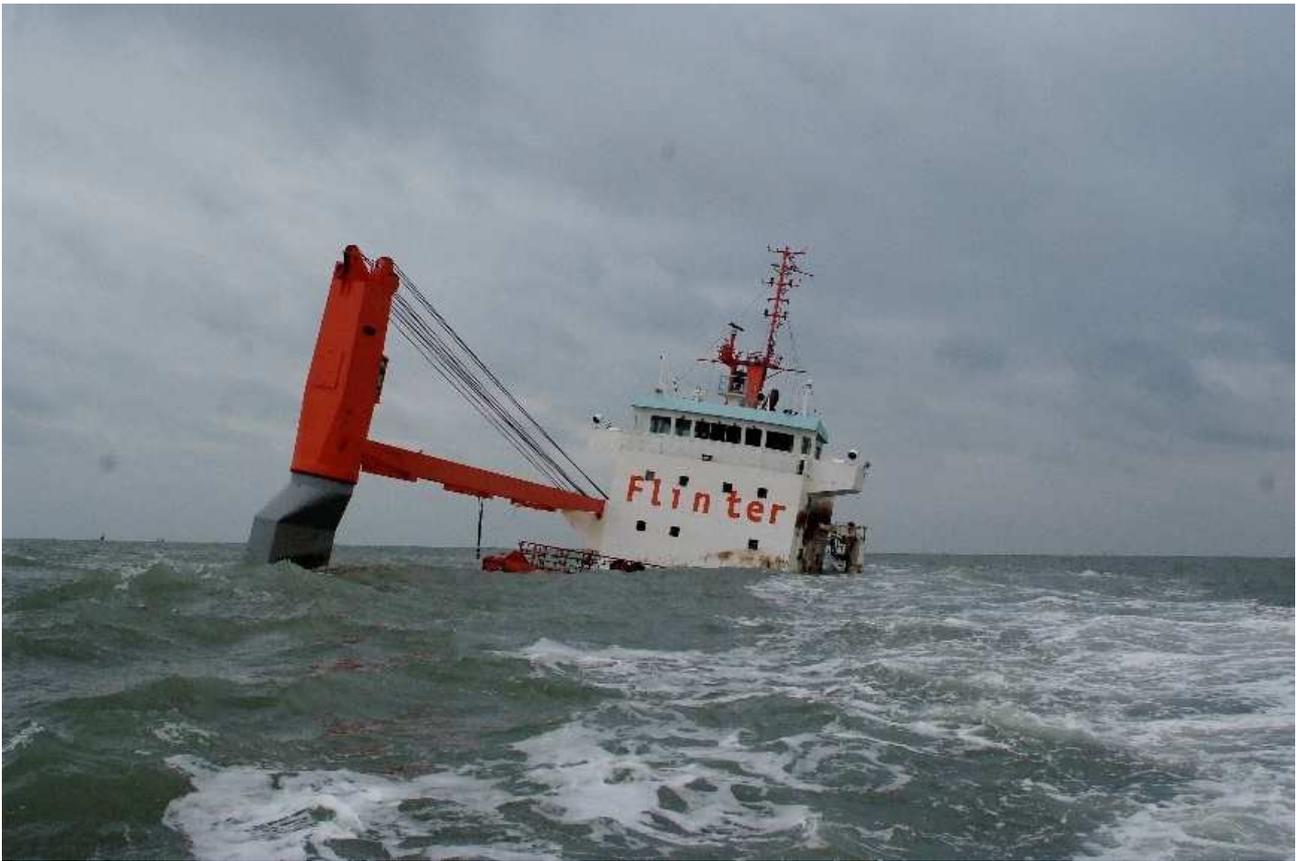
Figure 3 - Mv FLINTERSTAR after the collision lying on a sand bank

The damage to the mv FLINTERSTAR was to such an extent that the vessel sunk almost immediately after the collision onto a sand bank. Only the superstructure of the mv FLINTERSTAR remained above water level, after the vessel had sunk.

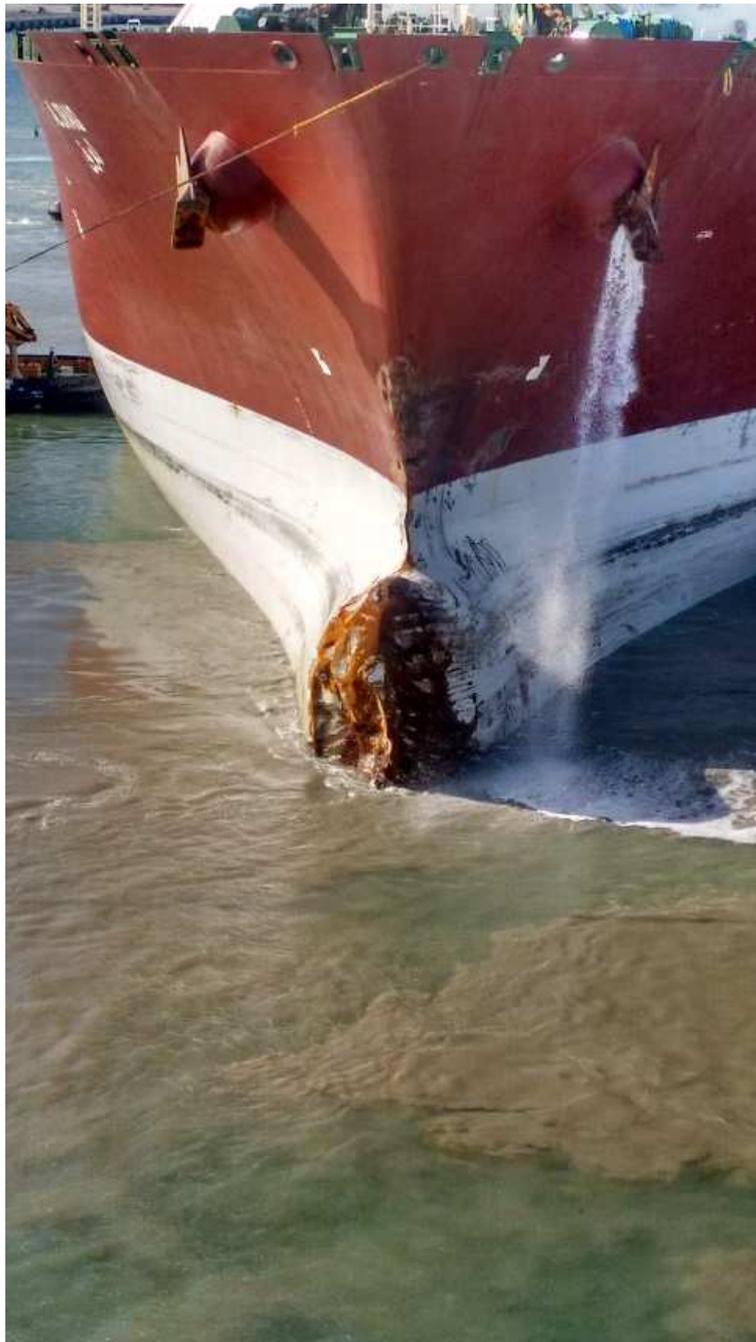
Figure 4 - Damage to the mts AL ORAIQ after the collision

The mts AL ORAIQ, which had suffered relatively minor damage, proceeded, after the collision, to an anchorage off the Port of Zeebrugge and was later that day allowed to proceed to its intended berth, quay 615, at the Port of Zeebrugge to unload the cargo of LNG, where the vessel safely berthed in the afternoon of 6 October 2015.

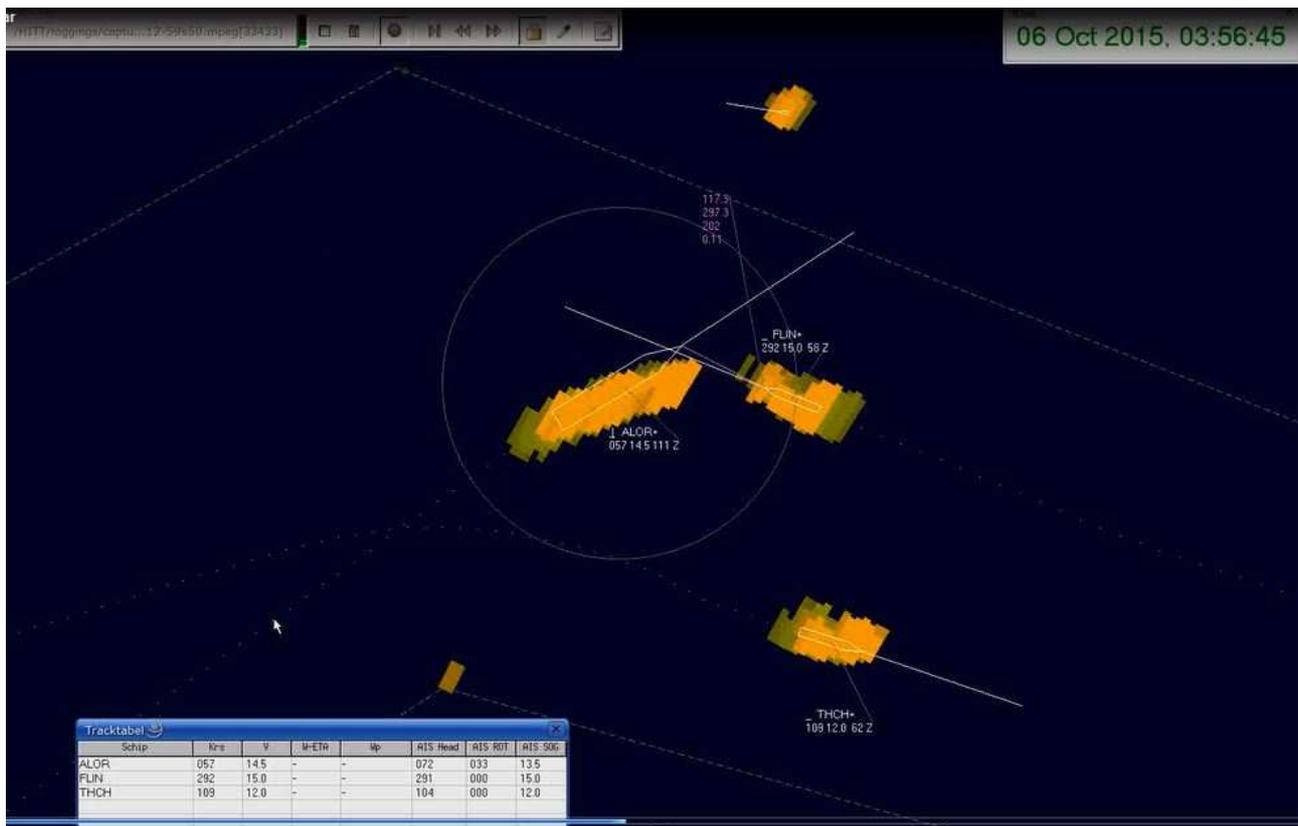
Figure 5 – Imminent collision between mts AL ORAIQ and mv FLINTERSTAR
as seen on VTS Radar Images

The mv THORCO CHALLENGER began to turn to starboard at approximately 0351. At 0354, the mts AL ORAIQ was passing the S3 buoy. By this time the mv FLINTERSTAR was less than 1.5 nautical miles off the mts AL ORAIQ's starboard bow and was approaching the S3 buoy from the southeast. There is no indication that the mts AL ORAIQ's Master, Officer of the watch or Pilots were aware that the mv THORCO CHALLENGER had started to turn, or of the proximity of the S3 buoy and the mv FLINTERSTAR.

When the S3 buoy was abaft the beam of the mts AL ORAIQ the Acting Coastal Pilot on board subsequently ordered the ship's rudders to starboard 5. By this time the mv FLINTERSTAR was less than 5 cables off the ship's starboard bow. Ten seconds after ordering starboard 5, the mts AL ORAIQ's Pilot ordered starboard 10. Ten seconds later the rudders were at starboard 10. After a period of approximately 30 seconds, the Pilot ordered starboard 20. At about the same time the mts AL ORAIQ's Master, officer of the watch and Pilots first became aware that the mv FLINTERSTAR was very close off the starboard bow. At 0357 Traffic centre Zeebrugge hailed the mts AL ORAIQ, however the call was not answered. Seconds later at approximately 0357 the mts AL ORAIQ and the mv FLINTERSTAR collided.

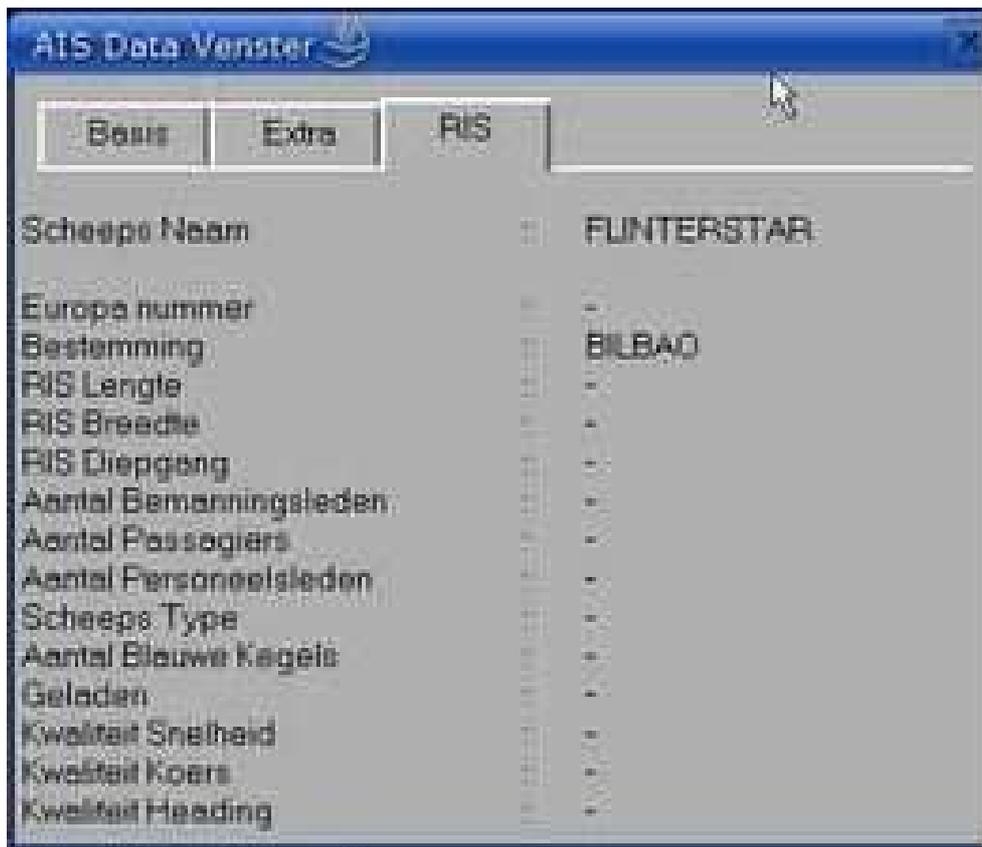
Figure 7 - Detailed Automatic Identification System data from mv FLINTERSTAR not filled out as seen on VTS radar screen

On 6 October 2015 at 0451, Traffic Centre Zeebrugge announced over VHF radiotelephone Channel 69 that the rescue helicopter was 2 to 3 minutes away from the scene. Soon thereafter at 0452 the skipper of another vessel, participating in the rescue mission, inquired with Traffic Centre Zeebrugge via VHF radiotelephone Channel 69, whether or not, all persons on board the mv *FLINTERSTAR* prior to the collision with the mts *AL ORAIQ* had been rescued from the water in the meantime. Traffic Centre Zeebrugge could not confirm nor deny since the total number of people on board the mv *FLINTERSTAR* prior to the collision with the mts *AL ORAIQ* was still not confirmed. Various sources were being consulted. Thereupon the Pilot on board the mv *SCOTT PIONEER* requested Traffic Centre Zeebrugge to consult the more detailed Automatic Identification System information from the mv *FLINTERSTAR* from which the total number of people on board, excluding the Pilot, could be derived. Traffic Centre Zeebrugge replied that they were just then busy doing that. Seconds later Traffic Centre Zeebrugge came back to the Pilot of the mv *SCOTT PIONEER* stating that the more detailed information page of the Automatic Identification System of the mv *FLINTERSTAR* had not been filled out.

- The Gemeenschappelijke Nautische Autoriteit are recommended to have the Automatic Identification System data of in and outbound vessels checked so that, in case emergency actions need to be undertaken, a correct assessment of the means

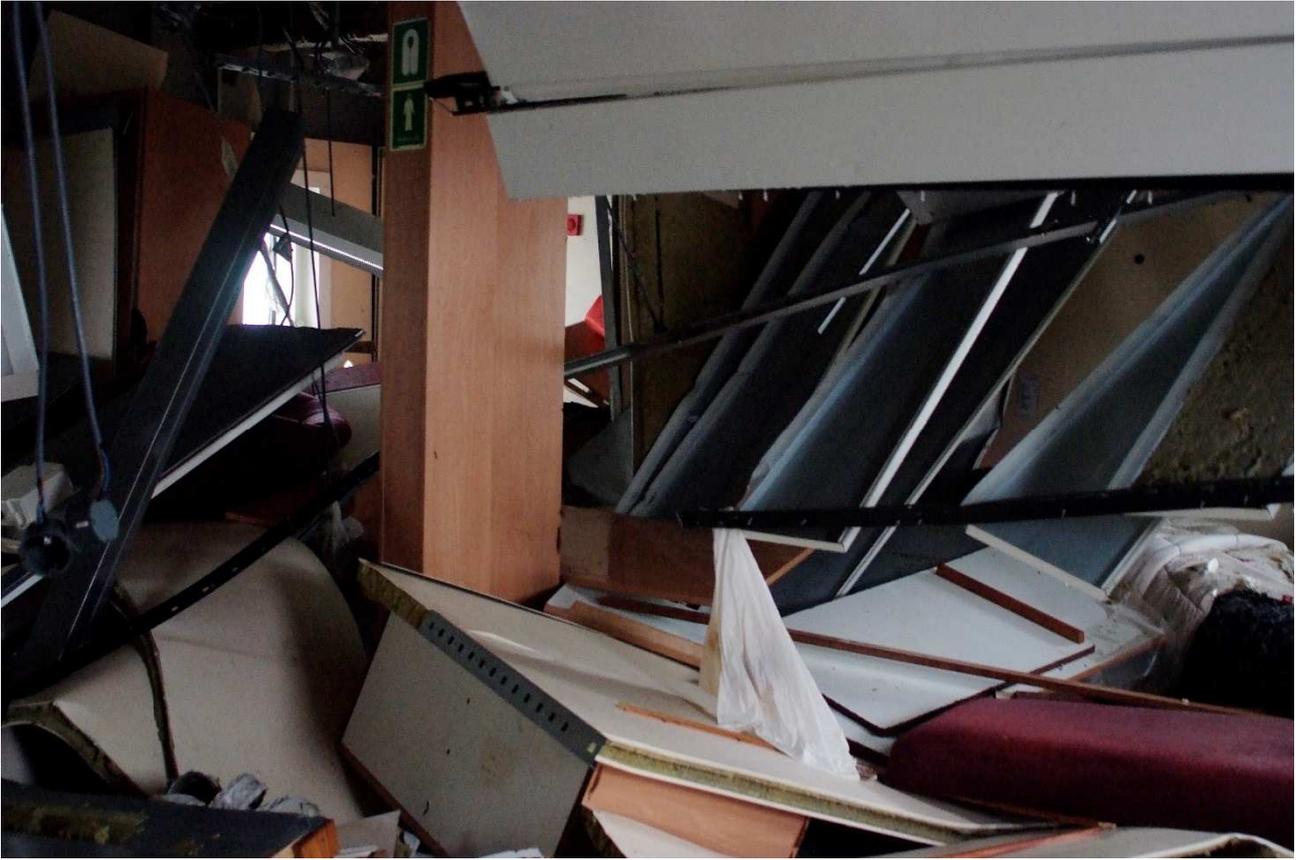
Figure 8 - Inside of the accommodation of the mv FLINTERSTAR after the collision

The mv FLINTERSTAR sunk onto a sandbank with its superstructure above water. Divers that had inspected the vessel soon after the collision had informed us that the mv FLINTERSTAR had been ripped open over a length of more than 30 meter, and that the engine bulkhead, between the engine room and the cargo hold, had been severely damaged, and a larger section of the engine room bulkhead on port side had been torn away.

The inside of the accommodation of the mv FLINTERSTAR had been destroyed on impact. Most of the non-structural bulkheads had collapsed. Most of the doors were removed from their door frames. The suspended ceilings all came loose and fell down.

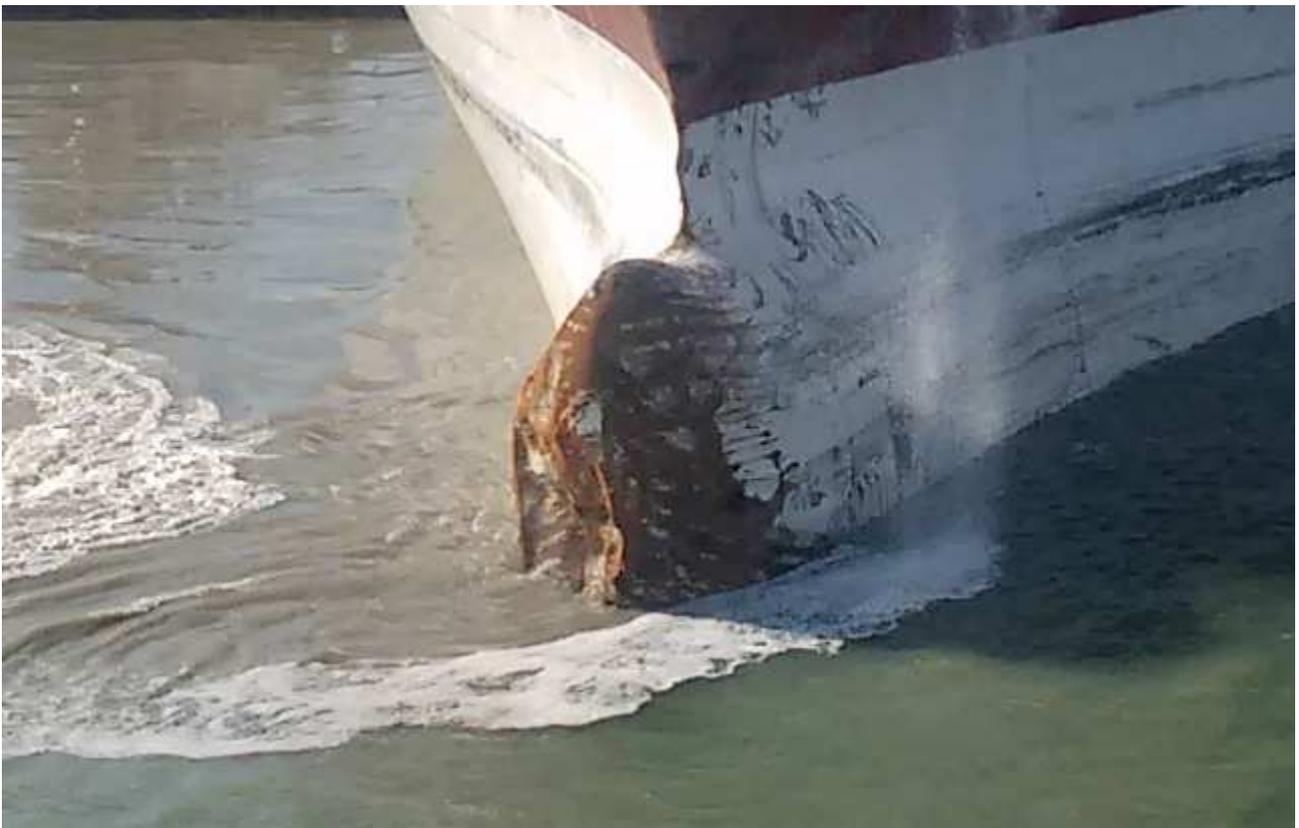
Figure 9 - Damaged bulbous bow of the mts AL ORAIQ after the collision

As a result of the collision between mts AL ORAIQ and the mv FLINTERSTAR, the mts AL ORAIQ suffered only relatively minor damage.

The bulbous bow of the mts AL ORAIQ was deformed and punctured. The mts AL ORAIQ was able to proceed under own power after the collision, first to the Port of Zeebrugge and consequently to a repair yard in Belfast, Northern Ireland.

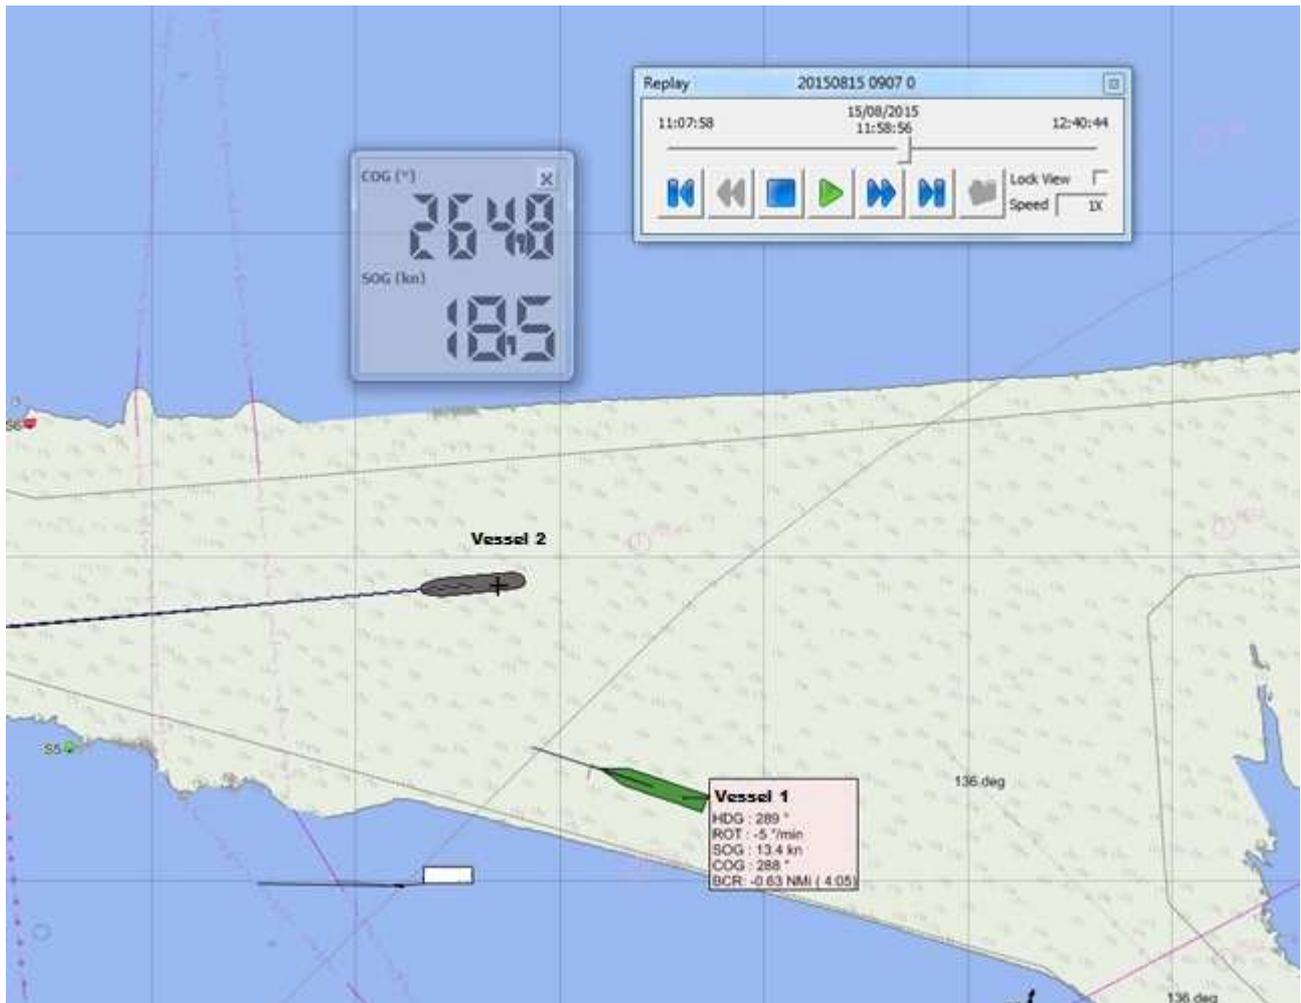
Figure 11 - Incident between VESSEL 1 and VESSEL 2 on 15/08/2015

In the past, the aforementioned rules were not always adhered to in a correct way. Since according to the LNG Shipping procedures, LNG carriers are to be considered as “oversized commercial vessels” and according to section 11.5.1 of same LNG Shipping procedures, a minimum safe distance of at least 2 cables from a LNG carrier is to be maintained at all times when overtaking, crossing and sailing in opposite directions . Earlier in 2015, on 8 August, while departing the Port of Zeebrugge the VESSEL 1 initiated an overtaking maneuver with the outbound mv VESSEL 2 based on the Pilot on board the mts VESSEL 1’s understanding that the aforementioned regulation gave the LNG carrier right of way, even though both ships were oversized commercial vessels and that the mts VESSEL 1 was overtaking the mv VESSEL 2. The Pilot on board the mv VESSEL 2 did not advise the

master of the mv VESSEL 2 accordingly and the speed of the mv VESSEL 2 was not reduced to allow for a bow passage with a safe distance of minimum 2 cables of the mts VESSEL 1 in front of the mv VESSEL 2. Instead, the speed of the mts VESSEL 1 had to be reduced to avoid a collision between the mts VESSEL 1 and the mv VESSEL 2, and to allow for the mv VESSEL 2 to pass safely in front of the mts VESSEL 1 as seen on Figure 11 on page 47.

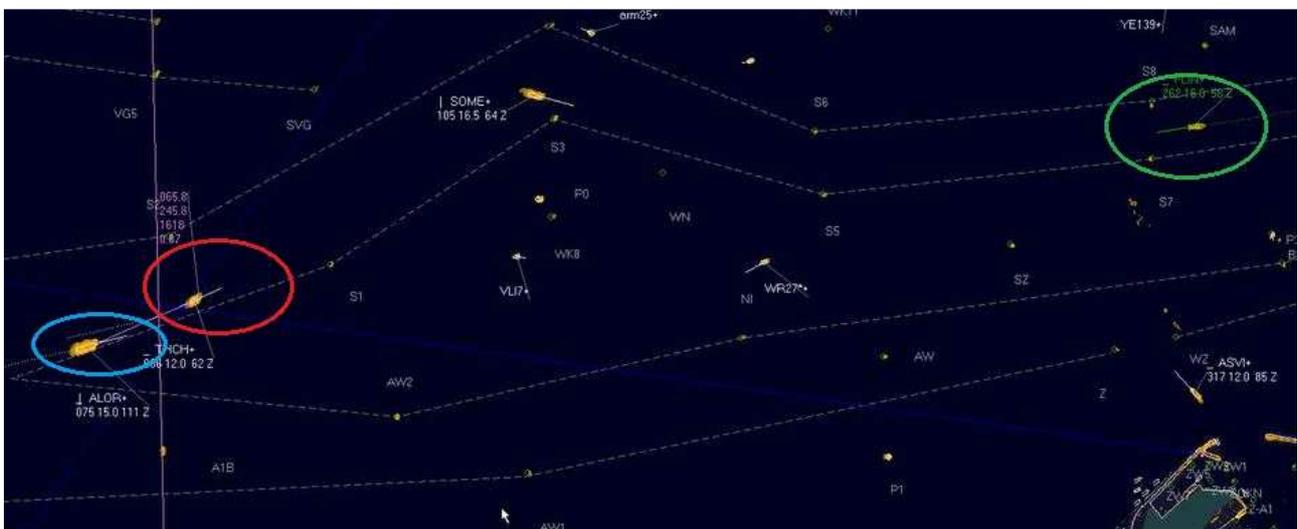
Figure 13 - Beginning of overtaking manoeuvre

From the moment that the mts AL ORAIQ hailed to mv THORCO CHALLENGER to inform the latter that the mts AL ORAIQ would be overtaking the mv THORCO CHALLENGER on its starboard side, it was clear for the trained radar at observer at the VTS coastal station that the intended overtaking manoeuvre from the mts AL ORAIQ could not be completed before either of the vessels would reach the S3 buoy as seen in Figure 13.

The true vectors of both vessels only differ very little in length. Mts AL ORAIQ 's speed over ground is only slightly higher than the speed over ground of the mv THORCO CHALLENGER. The VTS-Operators of the VTS coastal station Traffic Centre Zeebrugge have at their disposal several message markers which could have been used to inform both vessels that their intentions could lead to an unsafe situation. The VTS-Operators at the VTS coastal station, Traffic Centre Zeebrugge, could also have informed both vessels that they would encounter the mv FLINTERSTAR in the vicinity of the buoy S3, if both vessel, the mts AL ORAIQ and the mv THORCO CHALLENGER all three proceeded at the current speed.
