FIRE AT THE DETENTION CENTRE SCHIPHOL OOST

26th October 2005

The Hague, 21st September 2005, project number M2005CH1026-1

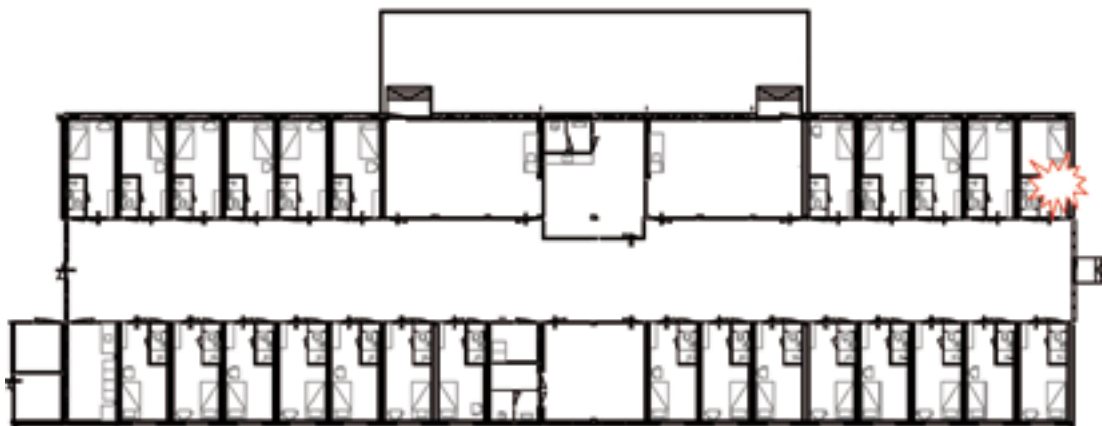
Figure 16: The initial phase of the development of the fire within Cell 11

From its initial location, probably the lower mattress of the bunk bed in Cell 11, the fire spread in stages until it eventually involved a large part of K Wing.

Following the tripping of the automatic fire alarm, the door of Cell 11 remained closed for another 2¼ minutes.

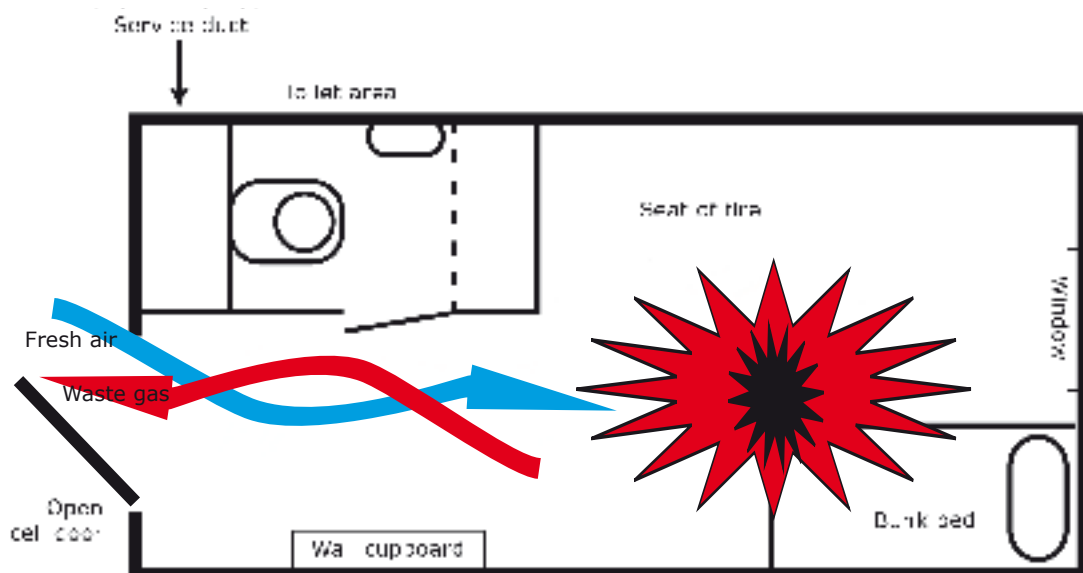
Figure 18: Schematic representation of fire in Cell 11. Outgoing flow of combustion gases "hinders" the incoming flow of fresh air.

Only a part of the waste gases released within Cell 11 was combusted. The remainder flowed uncombusted via the narrow entrance to the cell through the door opening and into the corridor. The limited supply of fresh air to the fire in Cell 11 also led to a high carbon monoxide content in the escaping smoke¹⁸³. The smoke in the corridor was therefore not only flammable but also toxic to a high degree, so that the two guards engaged in rescue work were in an extremely hazardous situation. Loss of orientation as a result of restricted visibility could have led to unconsciousness and subsequently to death in a short time.

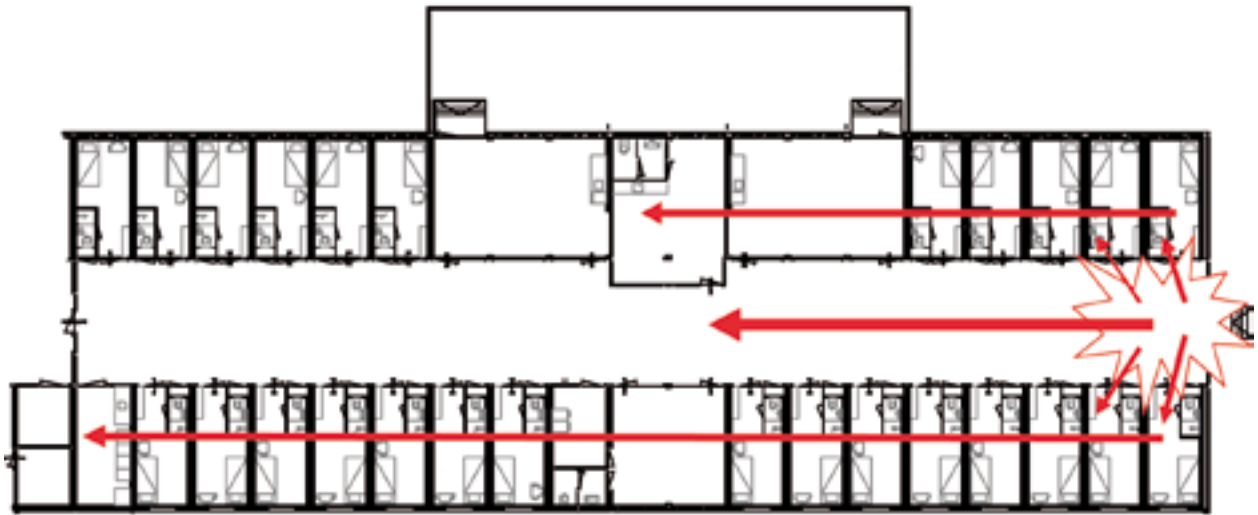
Figure 19: Spread of the fire along three routes: the corridor and the ceiling voids above the rows of cells on opposite sides of the wing.

The fire raging along the whole length of the ceiling void above the right-hand row of cells (seen from the hallway) received its oxygen via the unglazed window openings in the right-hand side wall, located close to this part of the shell void. Thanks to this supply of air the fire in the front right of the ceiling void could now develop sufficient intensity to allow it to break through the HPL panels separating the ceiling void from the corridor.

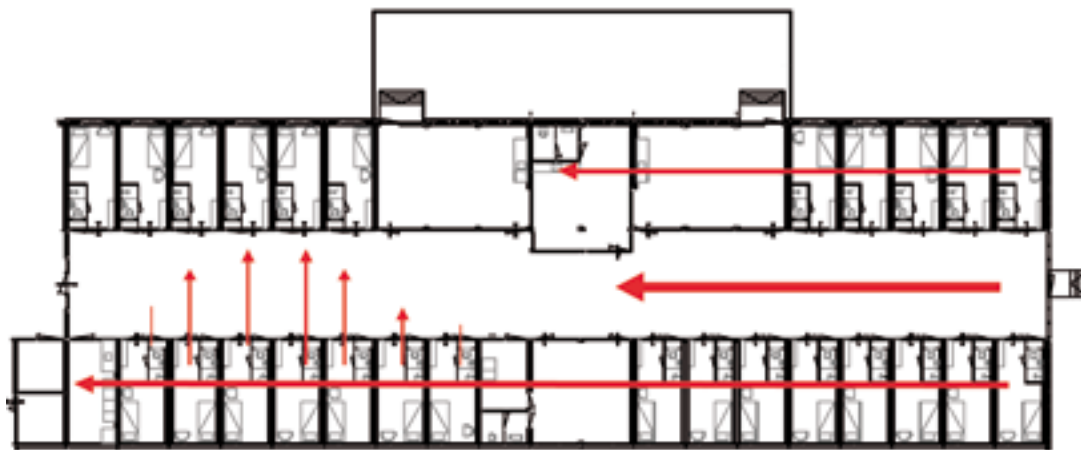
Figure 20: Last phase of the spread of the fire to the front part of the corridor

This last expansion of the fire was the first area to be extinguished by the fire brigade. Around 01.00 hours, a fire brigade unit that had forced its way into K Wing via the access door directed its low pressure water jets onto the advancing fire above the cells to the right of the wing. This intervention was necessary as passing the seat of the fire during reconnaissance of K Wing would have entailed too great a risk.

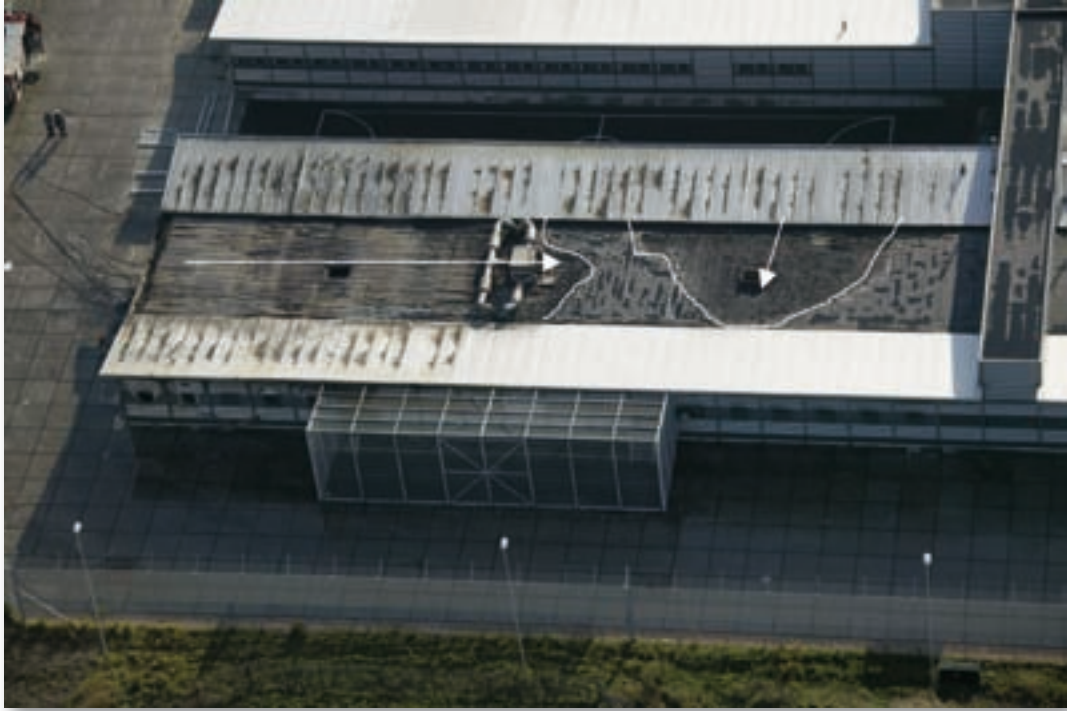
Figure 21: The roof of K Wing showing the patterns of melted expanded polystyrene

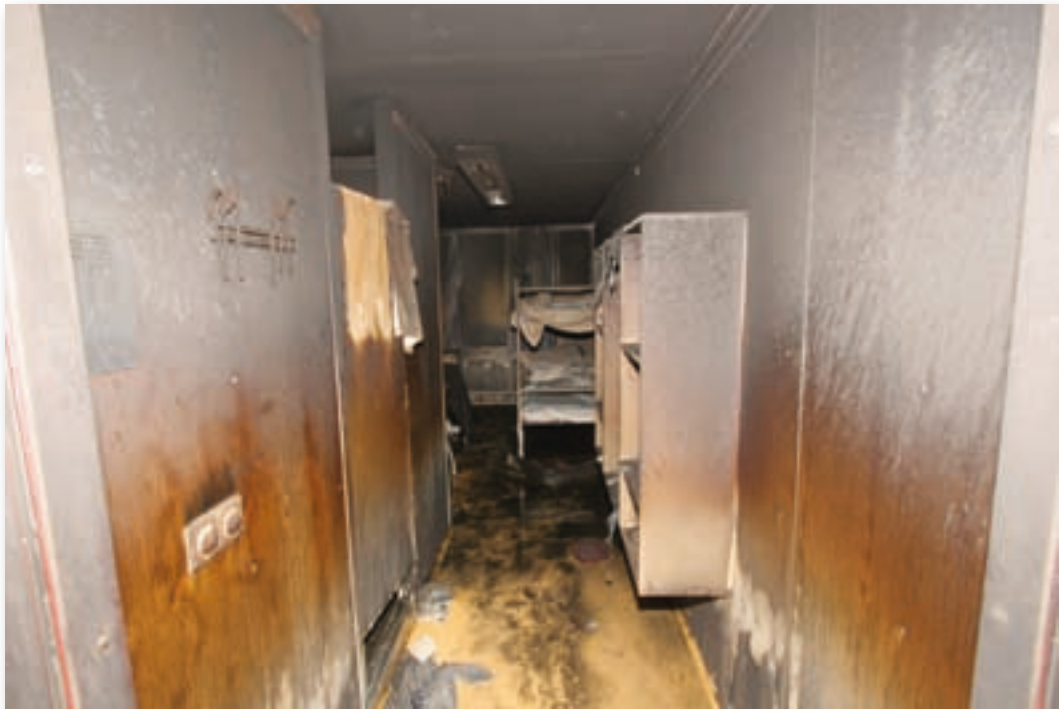
Figure 22: Interior of Cell K-1 with waste gas layer marks on walls

From the burning ceiling voids above the cells (on the left above cells 7 to 11 and on the right along the entire length of the wing) the fire penetrated the shell void behind both side walls. This caused a large number of cell windows to fail. Above the row of cells at the front on the left (cells 1 to 6) the ceiling void remained free of fire. Where the ceiling void did burn the flexible air conditioning installation connecting pipes were destroyed, so that smoke and heat could also enter the cells via the ventilation openings. Eventually most of the cells in the rearmost part of the corridor were burned to a greater or lesser degree. Notable exceptions were cells 9 and 14 which exhibited relatively minor fire damage. The cause of this may be the presence of inspection hatches in the side walls above these cells, which allowed the heat to escape and limited the thermal load on these cells.

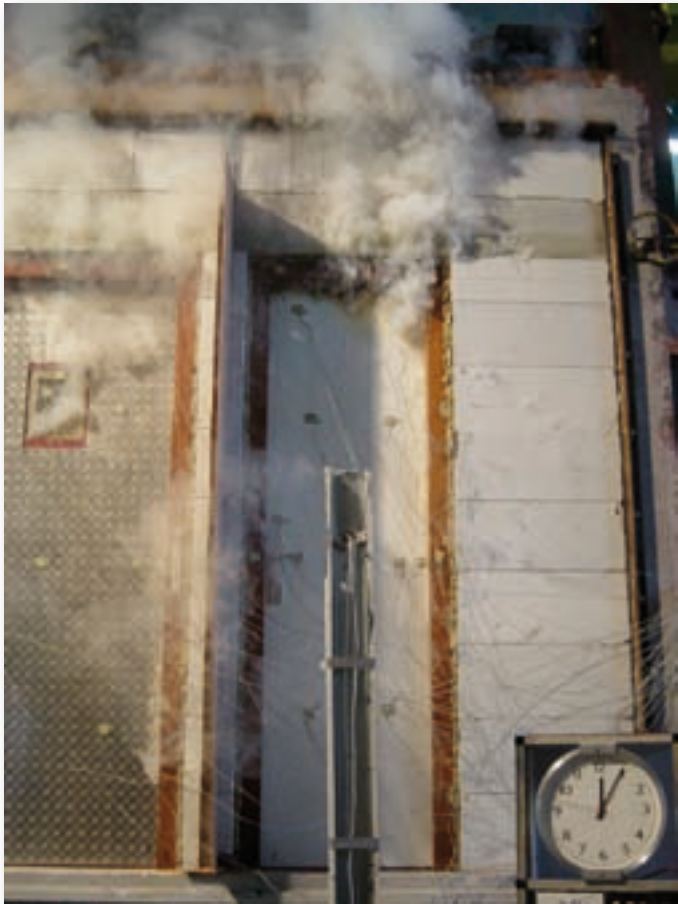
Figure 23: Smoke penetration into a cell during the fire resistance test carried out on the cell door.

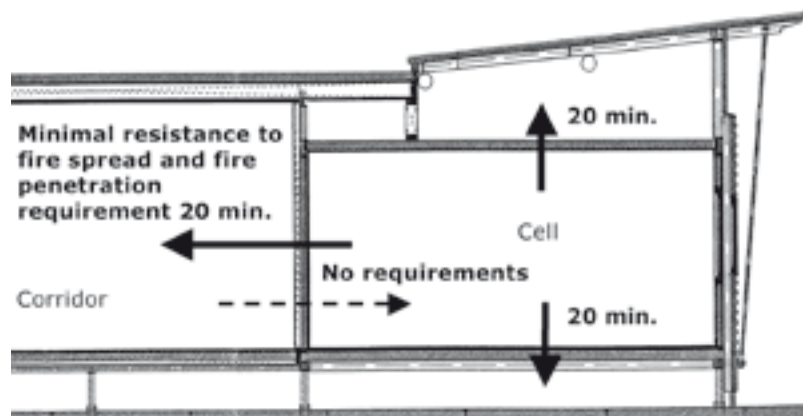
Figure 29: Schematic drawing of requirements in relation to cells, which apply only in the direction “interior to exterior”

construction plan of the possible risk in at least three areas (see below). The risks were also not adequately communicated to the user (no demonstrable “user manual”).

Firstly, the walls, doors, floors and ceilings of temporary structures are required to have a Resistance to Fire Penetration and Fire Spread to adjacent rooms of at least 20 minutes. The requirements set down apply only from the interior of the cell in the direction of another space, for example the corridor. No requirements are set down in relation to propagation from the corridor to the cell (see Figure 29). The assumption in the construction plan was that the doors of the cells would remain closed. It was also stated in the emergency response plan for the detention centre that the doors must remain closed as far as possible. Should a fire break out in one of the cells, then the cell occupants in the cell containers immediately adjacent to the burning sub-compartment would be protected against fire for at least 20 minutes. This time was to be enough to allow the rescue of the cell occupants. During the fire on the night of 26 to 27 October 2005, the door was not re-closed after the cell occupant was released from Cell 11 where the fire broke out. The fire was able to spread to the corridor. The fire sub-compartment ceased to exist once the door was opened and not re-closed. In the absence of requirements in Resistance to Fire Penetration and Fire Spread from the corridor in the direction of the cells, it is therefore possible that because of the failure to close a single cell door the entire wing would burn down, threatening the safety of the remaining cell occupants.
