# FINAL REPORT

*94-02*

*G-ZIPP, Cessna 310 Q*

*26 January 1994, Rotterdam Airport*

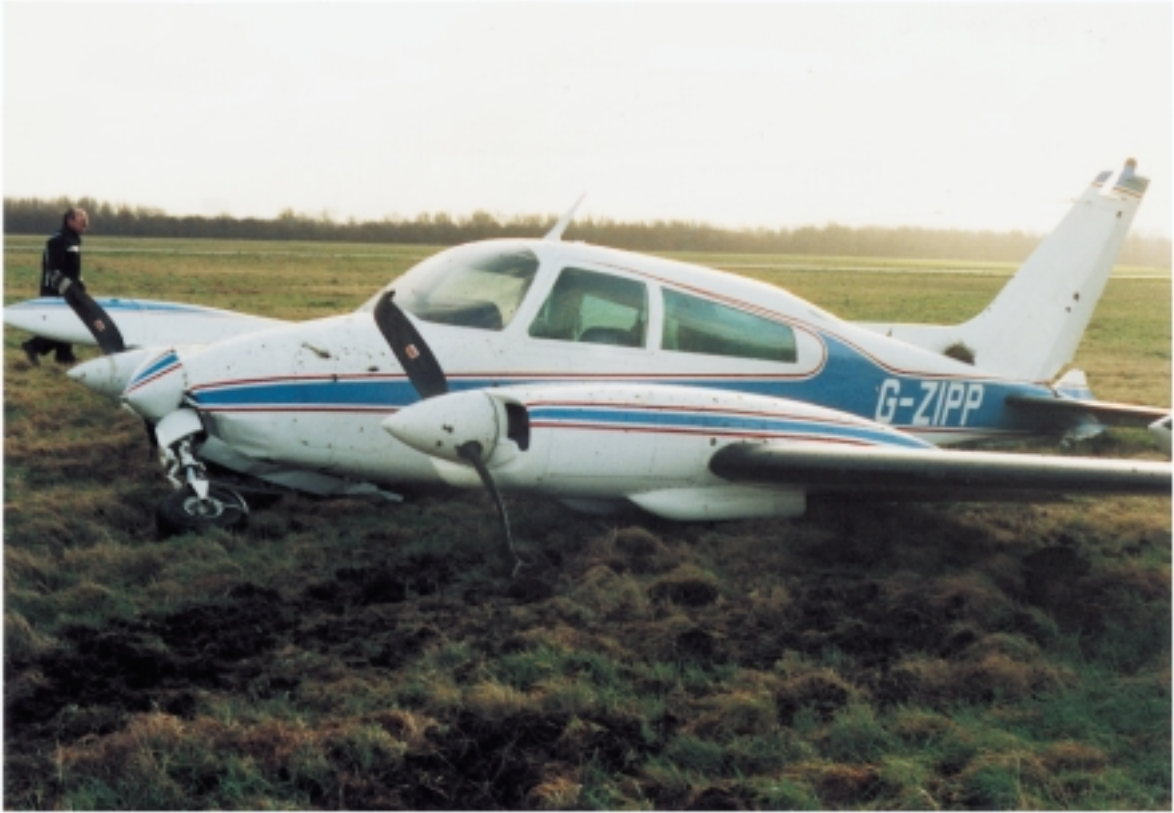
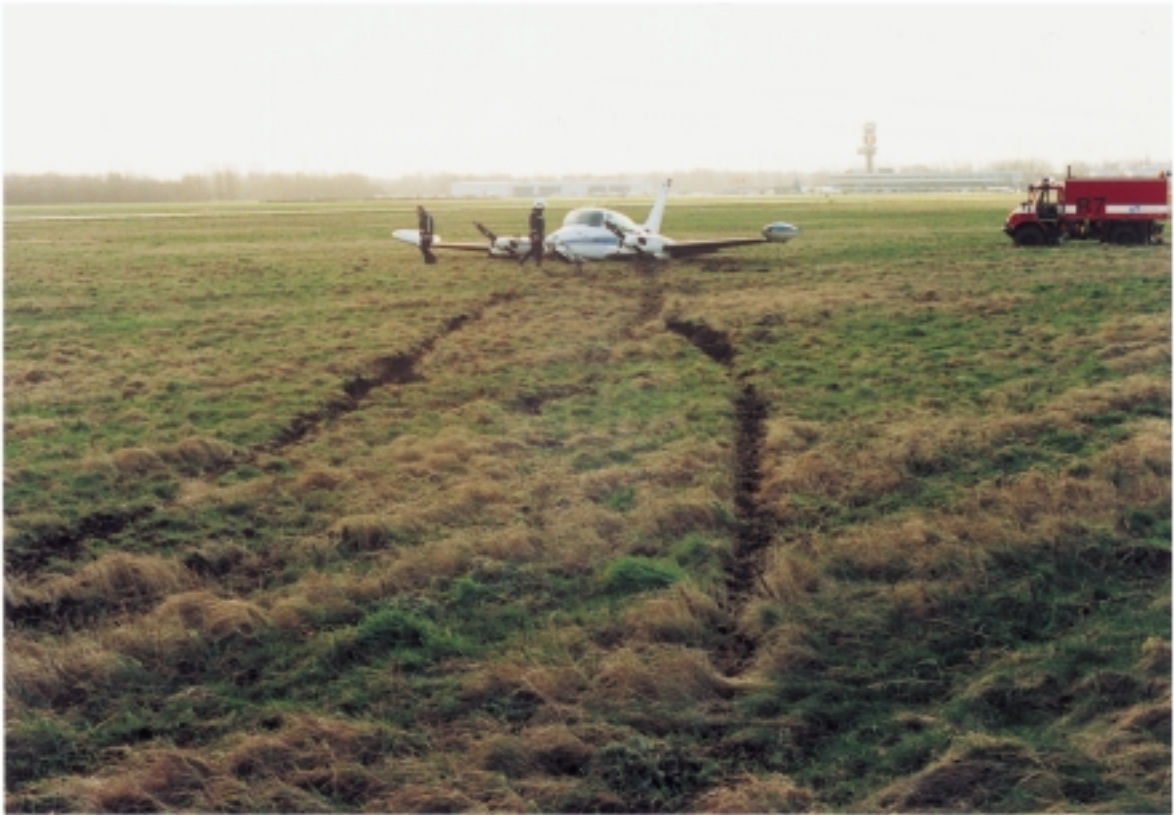
**Photographs**

The left main landing gear showed a broken attachment of the bellcrank and sidebrace lock-link, the torque tube had sheared off its mounting bracket. The uplock push-pull tube was broken, the door actuator arm was broken.

The aircrafts damage was consistent with the exposure to excessive loads on the left main landing gear during the first hard traversing crosswind landing and the effects of the subsequent left main landing gear retraction, followed by the collapse of the right main landing gear and nose gear during the ensuing ground loop.

The adverse landing conditions due to the strong crosswind resulted in a hard and traversing landing on the left main gear, damaging its actuating system.

Because of the already damaged actuating system the gear up selection after the go around resulted in breaking the attachment of the uplock push-pull tube.

During the second landing the damaged actuating system could not support the left main gear and it collapsed. In the subsequent groundloop the right main gear and nose gear collapsed.
