FINAL REPORT

98-85/S-14

N 193 DN, Boeing 767

Final report of the investigation into the probable cause of the serious incident with Delta Airlines Boeing 767, N193DN, on 10 December 1998 at Amsterdam Airport Schiphol.

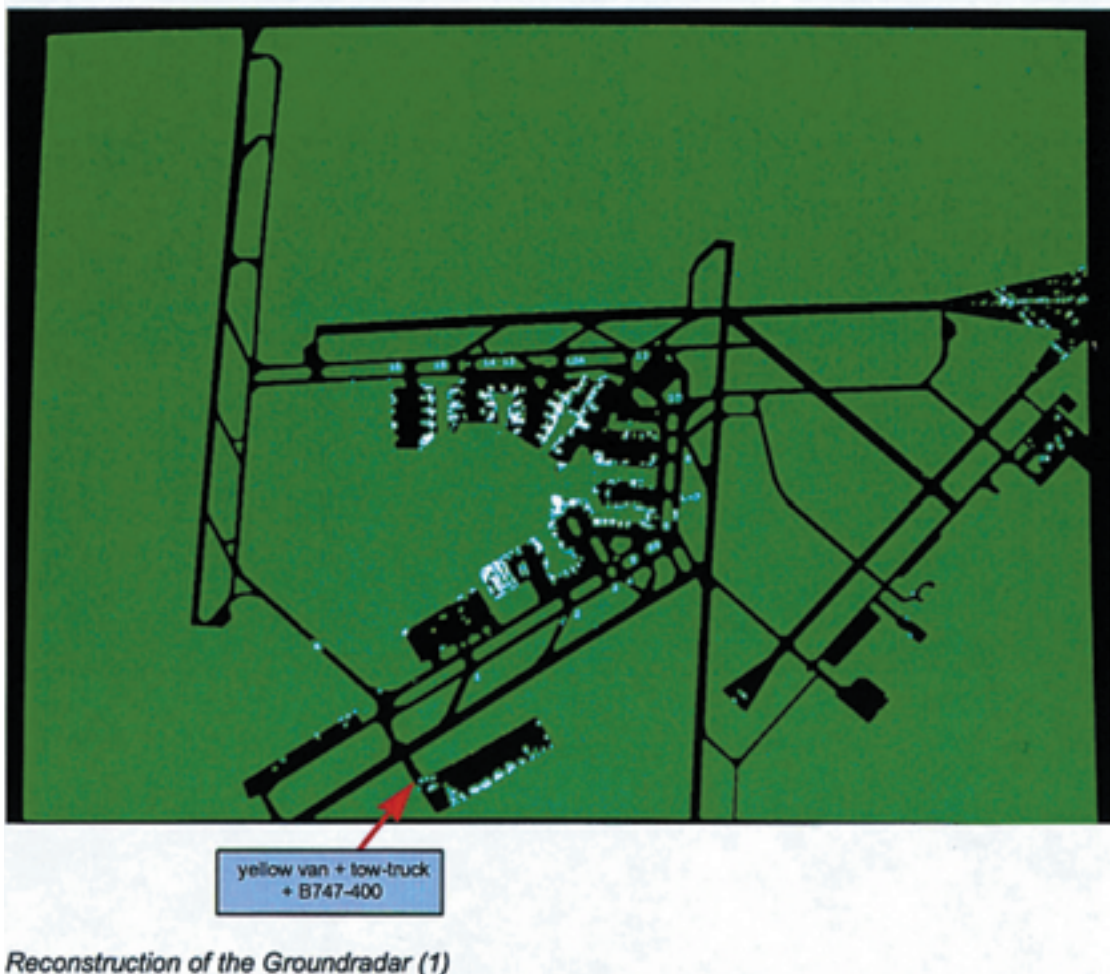
This picture (number 1) above shows T5R with the yellow van and tow holding short at exit 2 of runway 06/24, in front of the stopbar, coming from the "S"-apron. The controller at T6 was expecting the yellow van and tow from the opposite side.

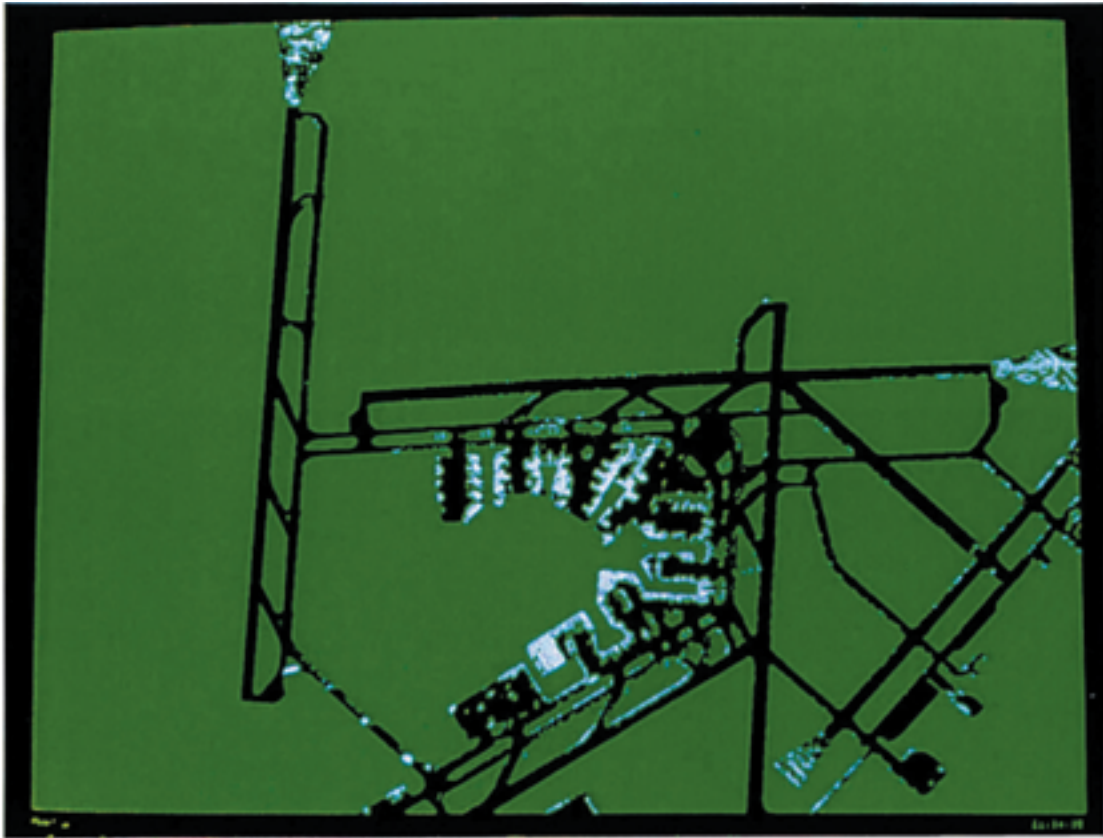
Reconstruction of the Groundradar (2)

The picture above (number 2) shows the same situation as in the picture number 1, but now on the display at T7R. Notice that the lower limit of the screen is just on the north side of exit 2 of runway 06/24. The yellow van and tow are not visible. The screen was adjusted for observing runway 09.

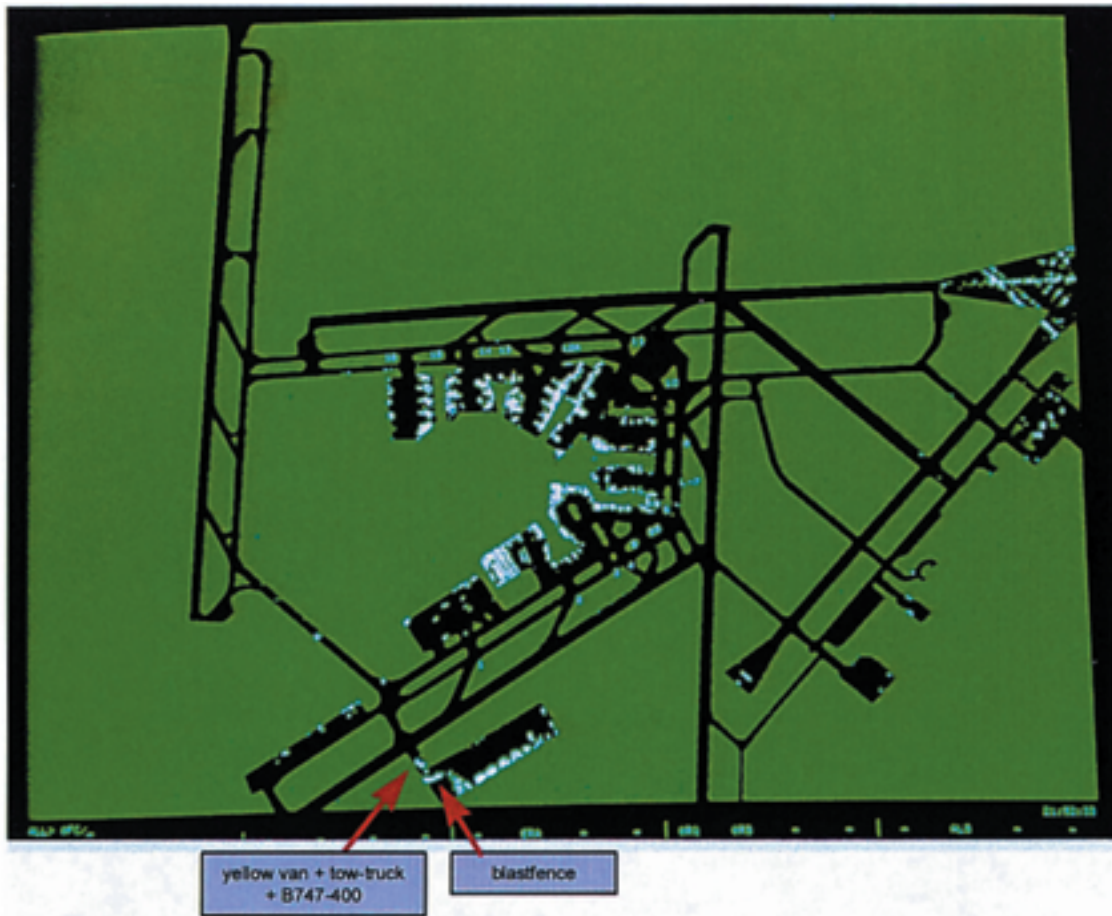
Reconstruction of the Groundradar (3)

For the picture above (number 3), taken of the screen at T5R, the investigators asked the controller to position the yellow van followed by the towed Boeing 747 the way he remembered seeing it just before he cleared Delta 39 for take-off. To get to this position, the yellow van and tow moved from the situation in picture number 1, i.e. from the “S”-apron. Just below (or south of) the yellow van and the tow the radar return of a blastfence at the entrance of the “S”-apron can be seen. This blastfence appears also in the first picture.

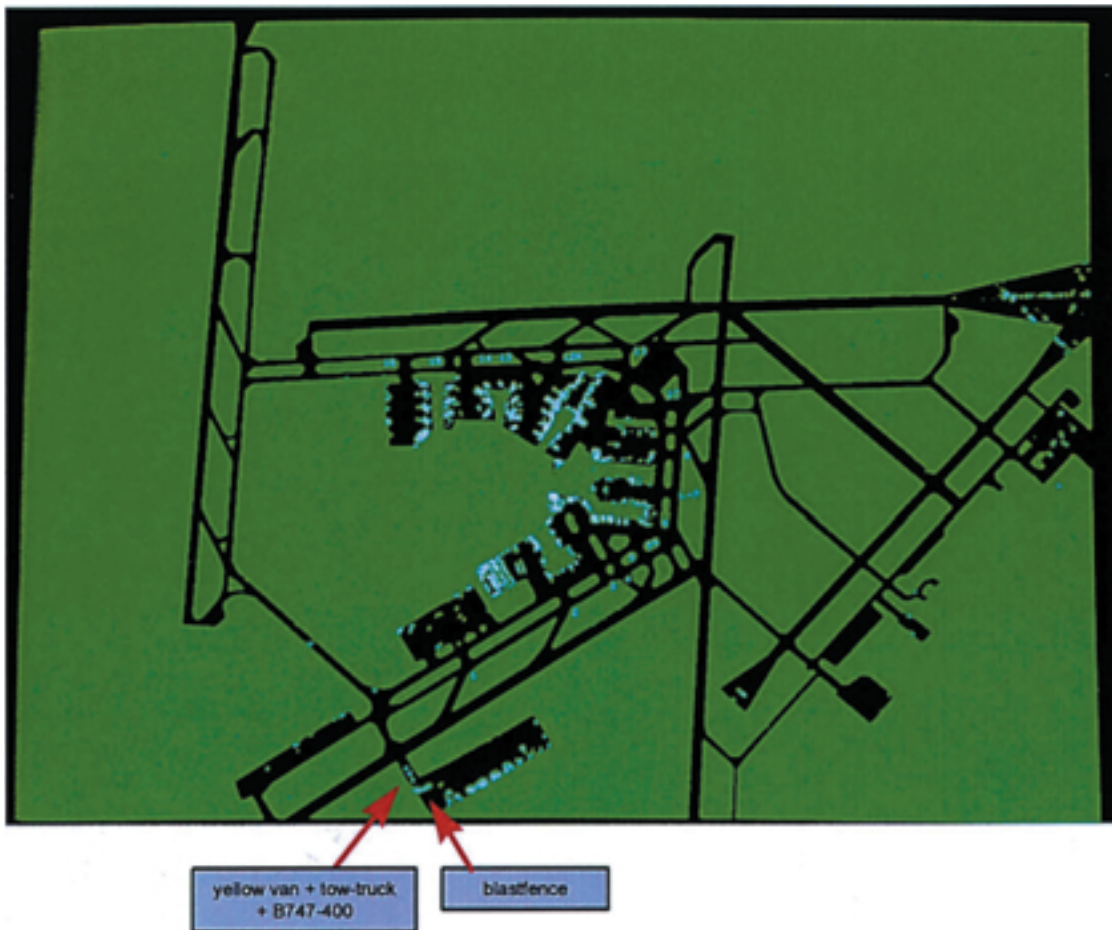
Reconstruction of the Groundradar (4)

The investigators also asked the yellow van and the towed Boeing 747 to cross exit 2 of runway 06/24 from the centre of the airport to the “S”-apron, i.e. in the direction as expected by the trainee. The car-driver was asked to stop the towed aircraft as soon as its tail was clear of the runway, or to be more exact, when the tail had crossed the yellow clearance-lines on the apron side of the crossing. After checking that the aircraft had reached the desired position, the car driver then resumed his position in front of the tow-truck.

This is the resulting picture 4 from the screen at T5R.

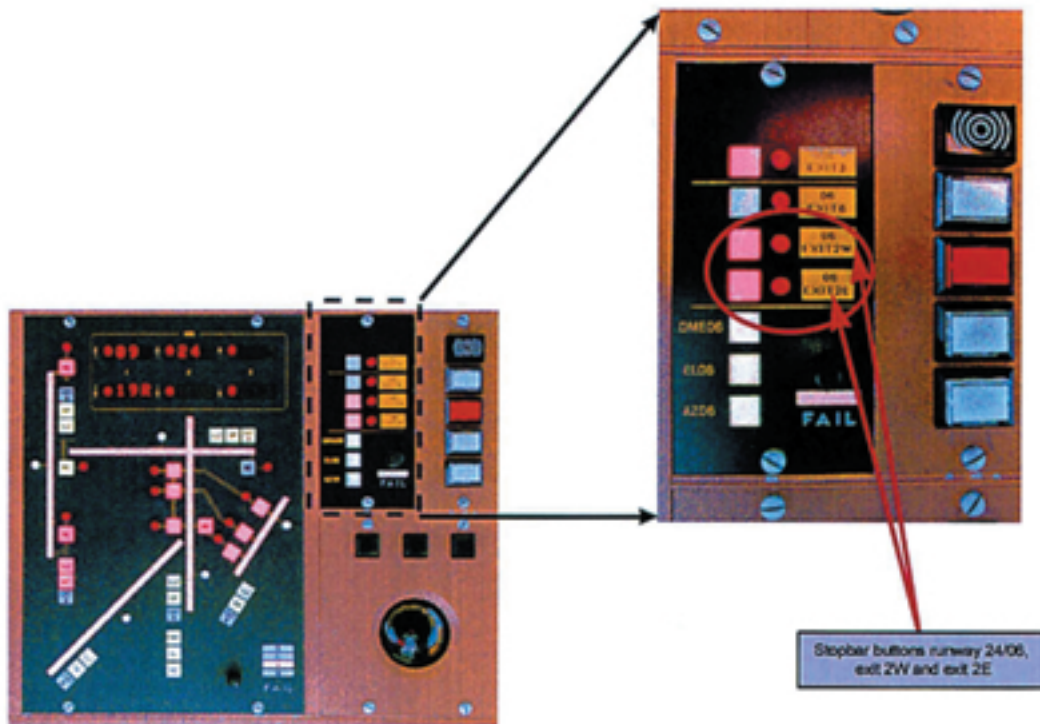
Control panel at working-position T8

The control panel comprises four sectors: North (runway 09/27), East (runway 04/22), South (runways 01 R/19L and 06/24) and West (runway 01 L/19R). The combination of the two runways in the South sector is a consequence of the permanently active stopbar at both sides of exit 1 of runway 01 R/19L (which point is also the far end of runway 06). Control of each sector may be allocated independently to any position in the control tower that is fitted with a control panel, but is usually restricted to T6 and/or T8.

The stopbar control panels were however still configured for the previous set-up of the control tower and his action had no effect. When the following actions to extinguish the stopbar for which Charlie 8 was waiting, failed, the Controller, with the consent of the Supervisor/Coach, pushed the buttons to extinguish the stopbars on both sides i.e. 2W and 2E. The possibility of a wrong interpretation of the position of Charlie 8 was not considered.
