RAPPORT / FINAL REPORT

1999011

*Aan het einde uit de baan gelopen
met de EL AL Boeing 747, registratie 4X-AXK,
op Amsterdam Airport Schiphol,
8 februari 1999.*

Den Haag, December 2001

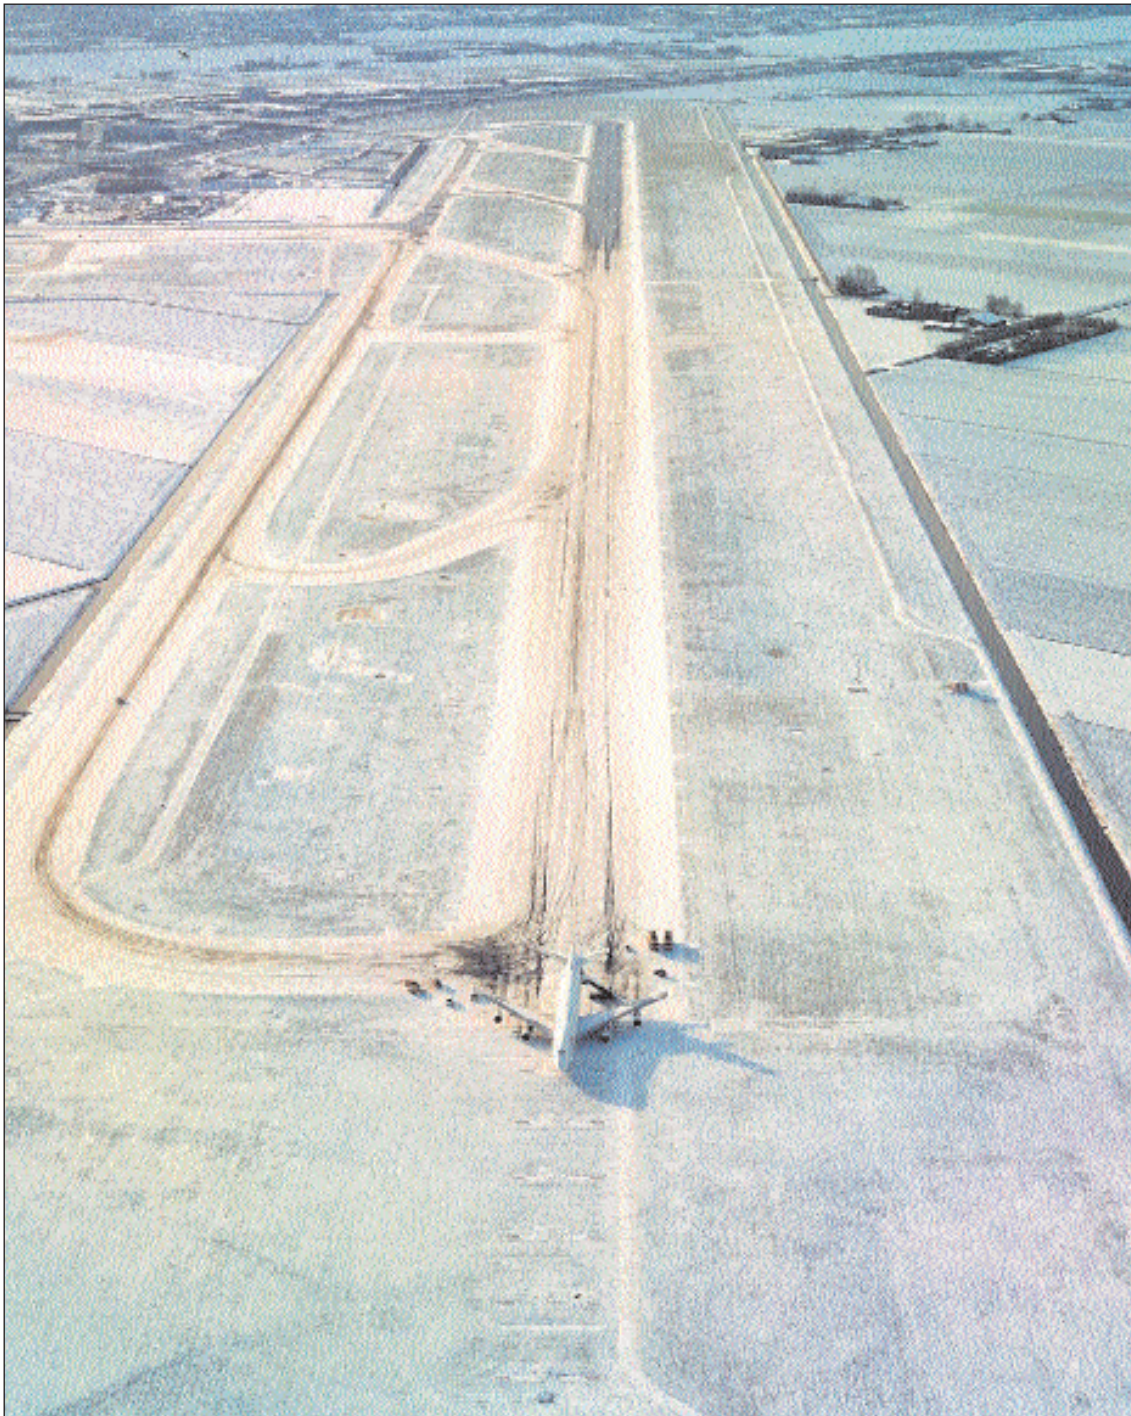
The aircraft suffered minor damage. In order to return it into service, the following work was performed:

Foto van de 4X-AXK na het incident

Photograph 4X-AXK after the incident

- replacement of the lower torsion link;
- minor repairs of electrical installations in the landing gear;
- replacement of 8 wheels.

Note: Two wheels were replaced because they were damaged when hitting the runway end lights. The remaining wheels were replaced as a precautionary measure.
