## RAPPORT / FINAL REPORT

1999021

*Verlies van remcapaciteit met de Iberworld Airbus  
A320-214, registratie EC-GZD,  
Groningen Airport Eelde op 12 maart 1999.*

*Den Haag, December 2001*

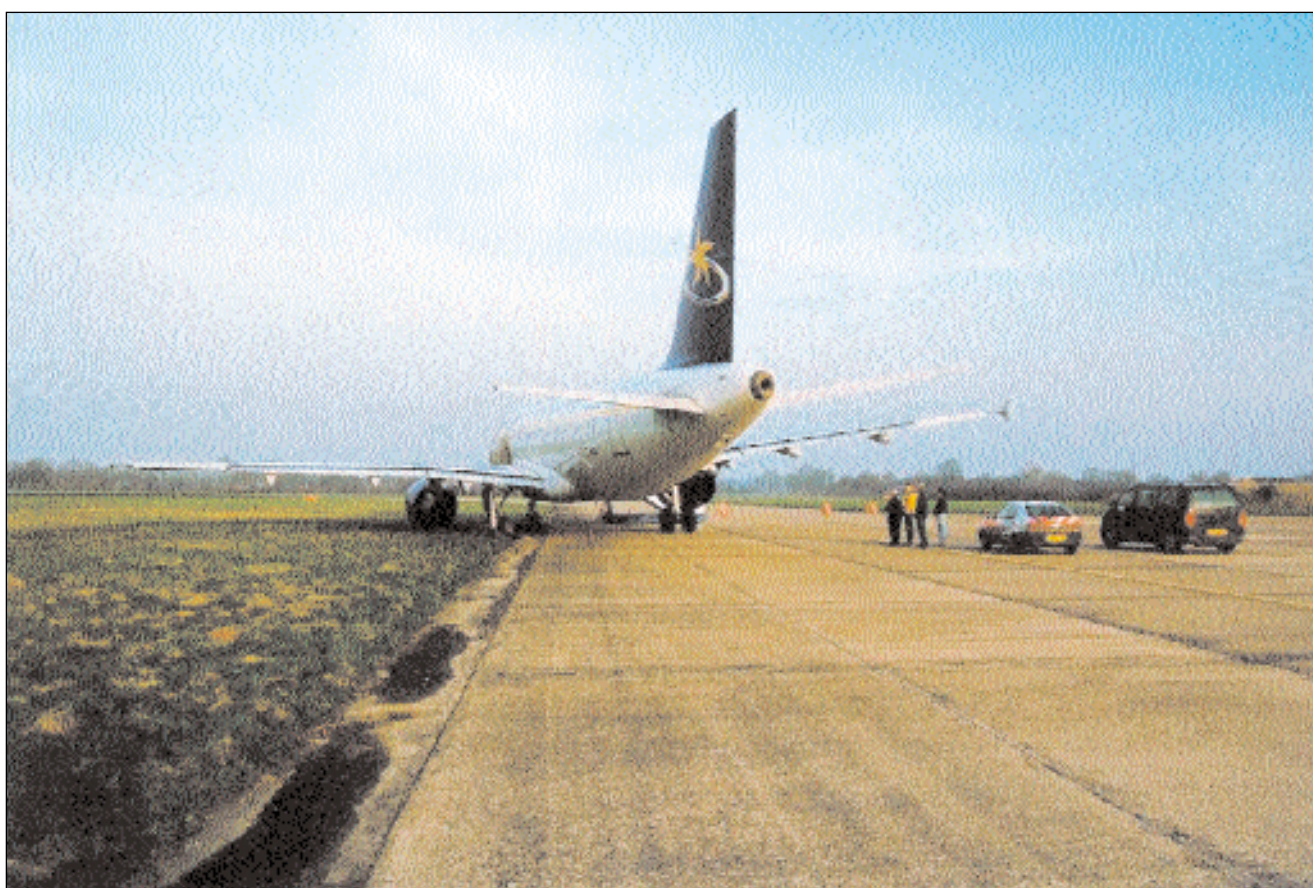
Het linkerwiel van het neuslandingsgestel en twee linkerwielen van het hoofdlandingsgestel kwamen in het gras naast het platform terecht. De twee wielen van het hoofdlandingsgestel zakten weg in de zachte grond en het vliegtuig kwam tot stilstand. Tijdens het gebruik van de straalomkeerders werd door de linker motor enige aarde opgezogen. De onderkant van de beplating van deze motor kwam in contact met de grond. Een foto en een plattegrond zijn gevoegd als bijlage A en B.

In het binnenste wiel van het hoofdlandingsgestel zaten een aantal insnijdingen. De romp naast de inlaat van de linkermotor was vervuild met aarde als gevolg van het gebruik van de straalomkeerder bij het afremmen. Er werd geen verdere schade gerapporteerd.

Foto EC-GZD na het incident

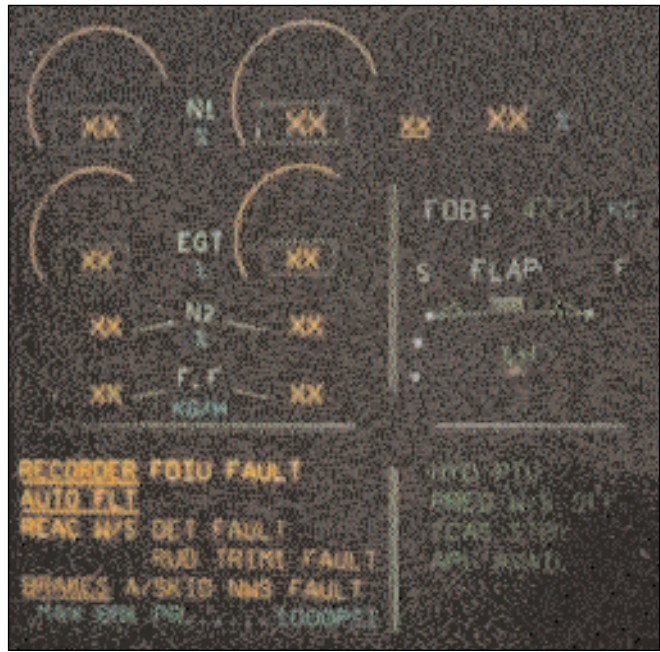
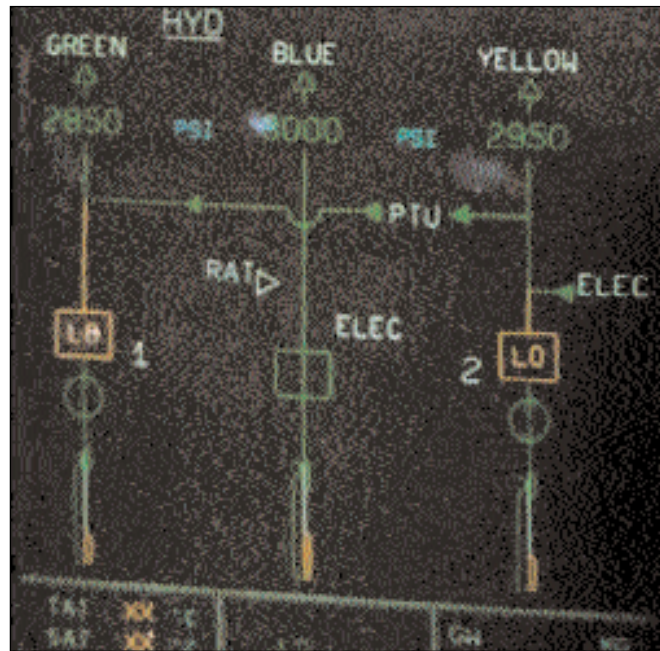
Foto's ECAM Photographs ECAM

Om 14:30 bemerkten zowel de gezagvoerder als de eerste officier dat het vliegtuig niet reageerde op het indrukken van de rempedalen door de gezagvoerder. Op de band van de cockpit voice recorder valt te horen dat de gezagvoerder de opmerking maakte: "We hebben geen remmen" [in het Spaans]. De gezagvoerder verklaarde dat hij de anti-blokkeer en neuswiel besturingschakelaar snel UIT en weer AAN schakelde. Hierdoor had de normale werking van de rem- en besturingscomputer hersteld moeten worden. Deze actie bleef echter zonder resultaat. Er verscheen in de cockpit geen waarschuwingsindicatie van een mogelijke storing van het remsysteem.

ECAM motor/waarschuwingsscherm (boven) ECAM engine/warning display (top)  
 ECAM systeem/statusscherm met hydraulische pagina (onder) ECAM system/status display with hydraulic page (bottom)
