# DUTCH TRANSPORT SAFETY BOARD

<b>Occurrence #:</b>	<b>2000141</b>	<b>Classification:</b>	<b>Accident</b>
----------------------	----------------	------------------------	-----------------

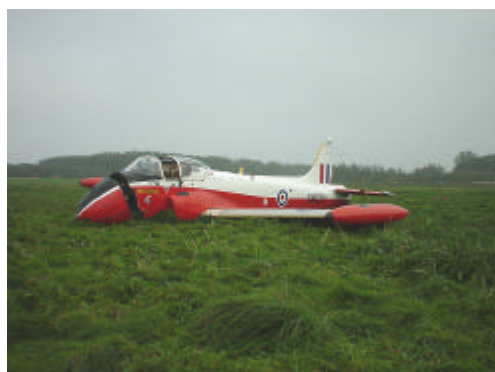
Technical investigation revealed a torn hose of the windscreen heating and de-icing system, which caused hot engine bleed air entering the cockpit. The pilot responded by selecting a lower power setting and returned to the departure runway as quickly as possible. No indications of a hydraulic problem were found. Analysis of the statements of the pilot and the passenger revealed that the aircraft stalled in the turn from baseleg to finals. This can be concluded from the vibrations that were felt, the problems the pilot experienced in controlling the aircraft and the fact that it was a steep turn. Furthermore contributory to this situation was the exclusion of the use of flaps and the increasing tailwind component in the first part of the final turn.

The G-BWZE after the accident
