DUTCH
SAFETY BOARD

Fatality during mooring operation in lock

M/V Flinter Aland, Terneuzen, 9 September 2012

The Hague, November 2013

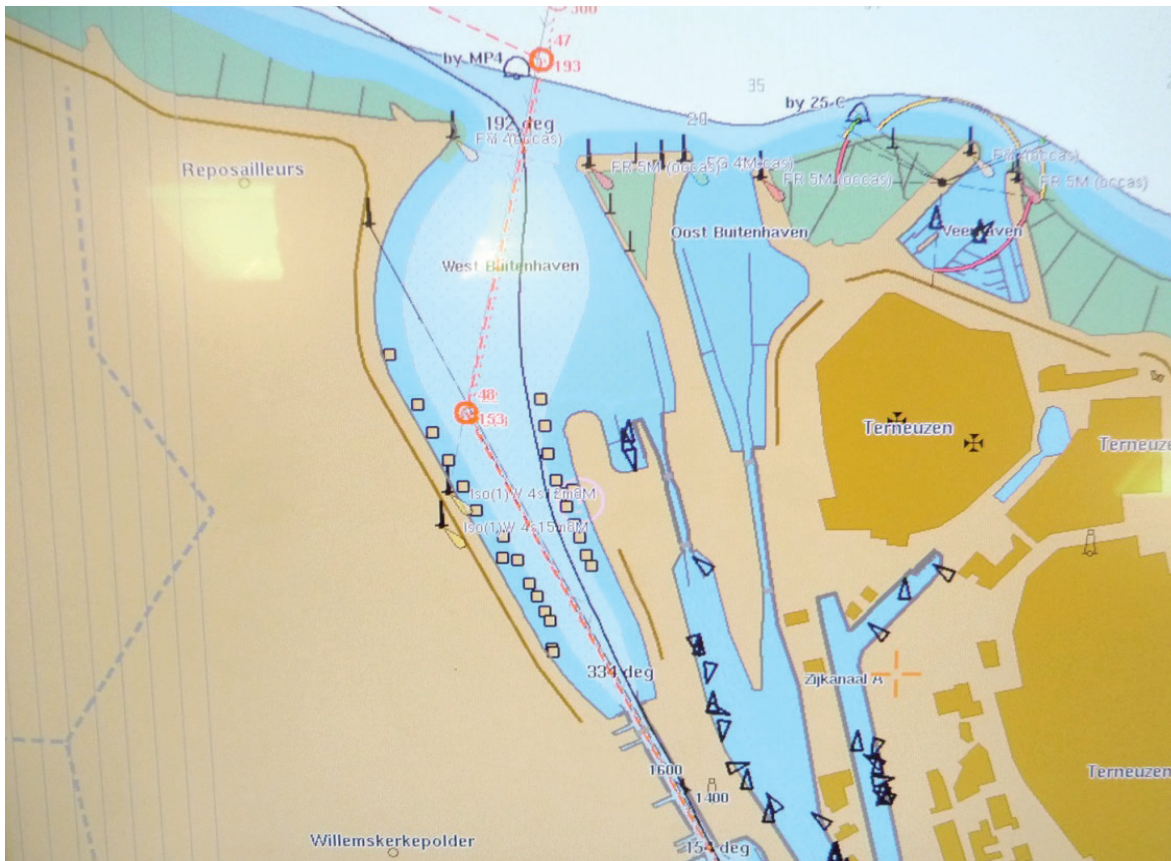
In order to enter the lock the Flinter Aland kept portside of the fairway (see figures 2 and 3). The ship entered the lock at around 12.32 with a speed of 3-4 knots.⁴ The master later stated that the ship had not been affected by the wind but that it probably had been affected by the saltwater to freshwater effect.⁵ The master subsequently stated that he had reversed the propeller shortly afterwards to reduce speed. The lockmaster noticed the ship's high speed and called the ship by VHF 'You are entering the lock at quite a high speed. Will you watch out for the inland ships at the front?' In response, the pilot stated that the ship would slow down.

Figure 2: Image of the track (in black) of the *Flinter Aland* on the display of the electronic chart system (ECS).

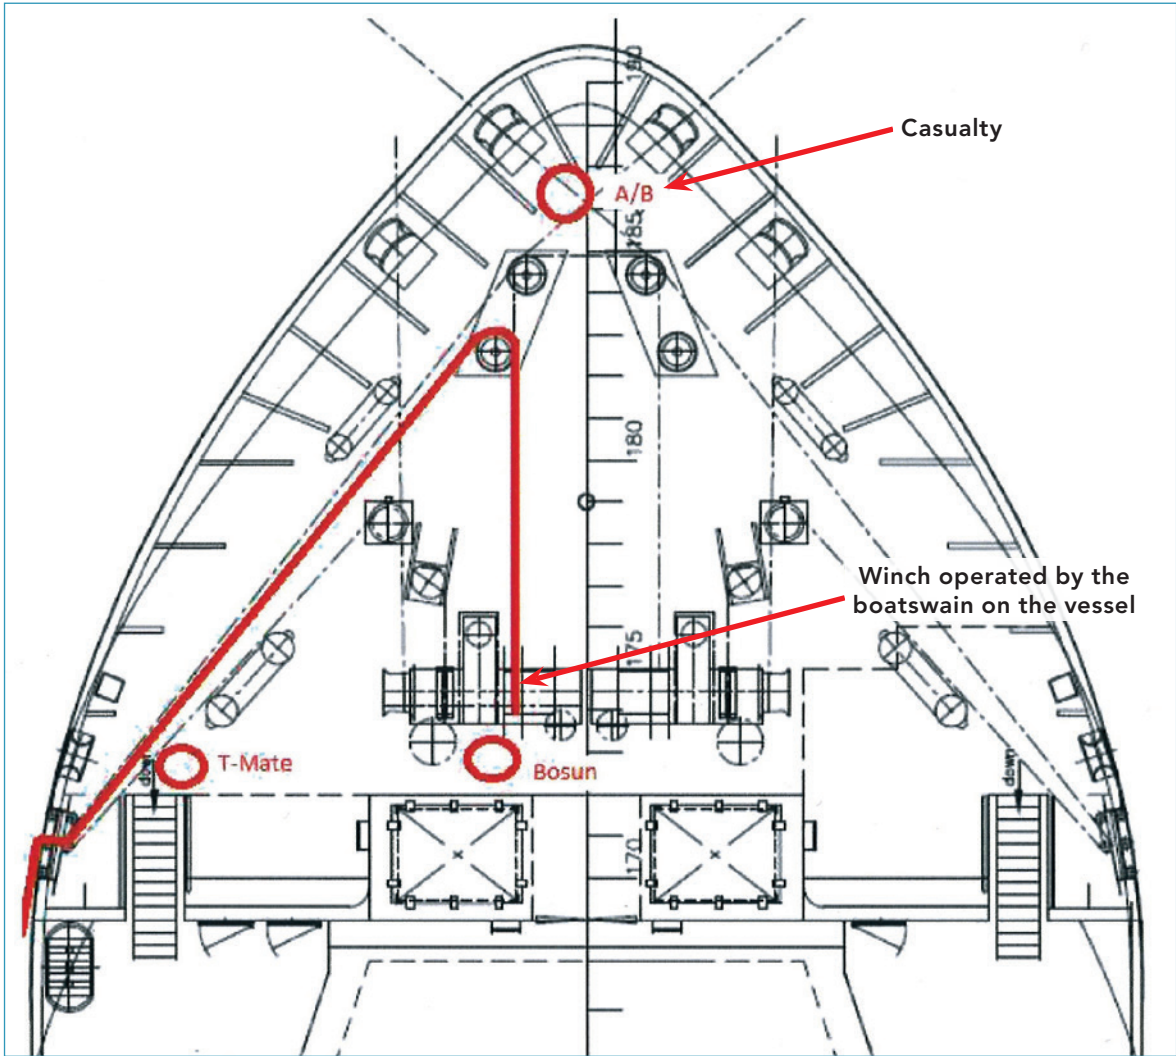
Figure 3: Location of the crew and the layout of the broken mooring line. (Source: shipping company Flinter)

The mooring line on board the *Flinter Aland* broke because the forces on the mooring line became excessive. The ship was still moving in forward direction at the time the crew fully tightened the winch brake located on the forecastle. The mooring line broke without any prior (audible) warning. The third mate, the boatswain (the winch operator) and the seaman were therefore unaware of the immediate danger they were facing. Just before the mooring line broke, the seaman was located in the mooring line snap-back zone, where he got hit by the mooring line that had snapped back.

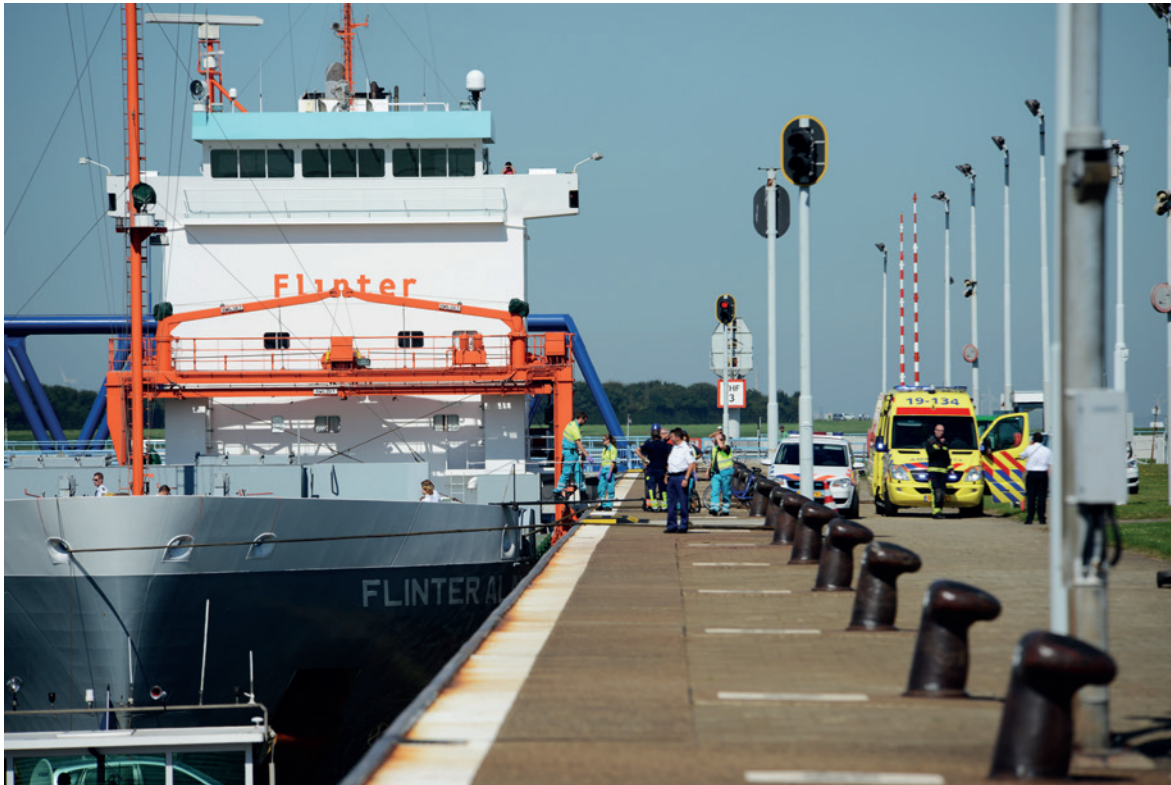
Figure 4: Flinter Aland immediately after the accident. (Source: Chris Platteeuw)

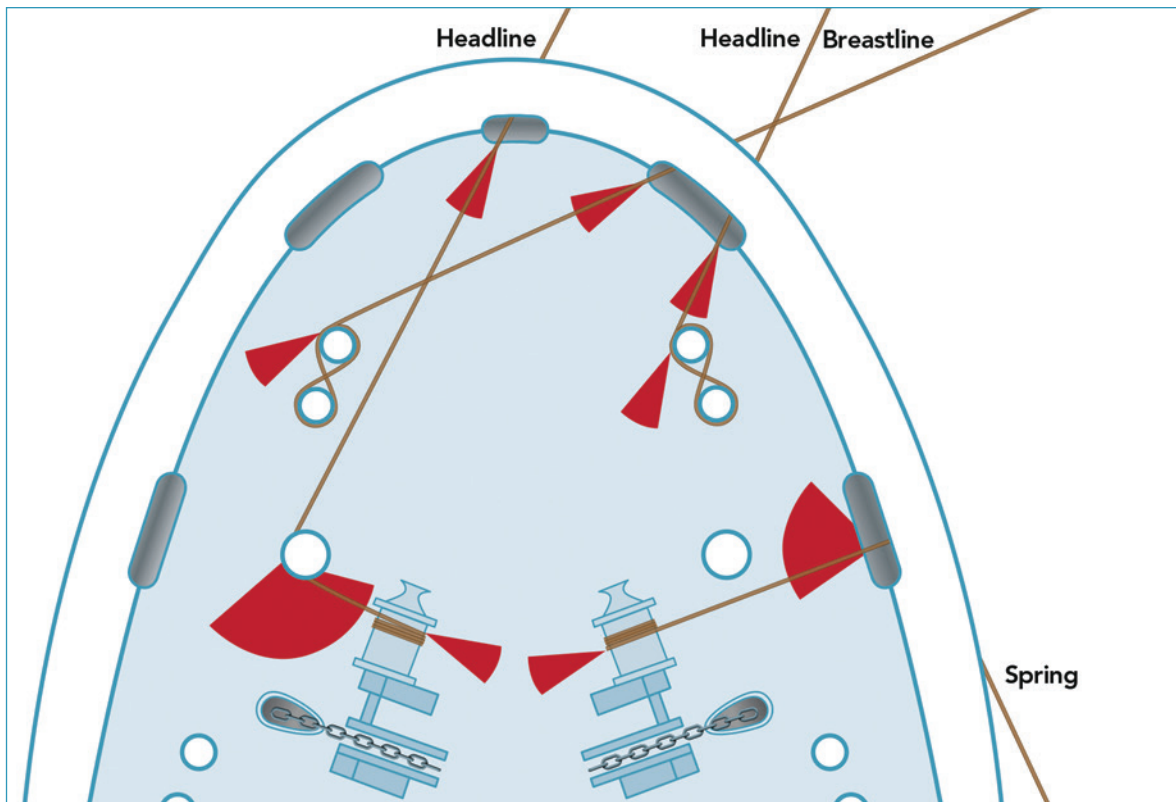
unmooring vessels. The Dutch Safety Board is of the opinion that the zones defined in this sheet provide ships' crews with insufficient insight into the actual risks they are exposed to in the event of mooring line breakage. For instance, the angle shown at which the broken mooring line can snap back is too narrow. Furthermore, only a limited number of breakage locations have been defined. The seaman was standing at a location that had not been identified as a danger zone in the Health and Safety Sheet. Lastly, the highly simplified illustration of the forecastle does not do justice to the often complex situation on board seagoing vessels where mooring lines are run around capstans. This means that the snap-back zones are significantly larger. For a more accurate picture and the risks associated with snap-back zones, the Dutch Safety Board refers to publications such as those of the English Nautical Institute and Seahealth Denmark (see Appendix 1).

Figure 6: Illustration of the snap-back zones (coloured red) in the Health and Safety Instruction Sheet.

- The snap-back zones identified in the *Mooring and Unmooring Operations Health and Safety Sheet* do not provide with crews sufficient insight into the risks they face as a result of snap-back caused by mooring line breakage.

Revise the *Mooring and Unmooring Operations Health and Safety Instruction Sheet* and to that end, use the latest insights into the risks inherent in working with mooring lines. Encourage your members to adopt the insights in their Safety Management System. In this context, particular emphasis should be placed on the mooring lines snap-back zones.
