# DUTCH TRANSPORT SAFETY BOARD

<b>Occurrence #:</b>	<b>2002083</b>	<b>Classification:</b>	<b>Accident</b>
----------------------	----------------	------------------------	-----------------

## FACTUAL INFORMATION

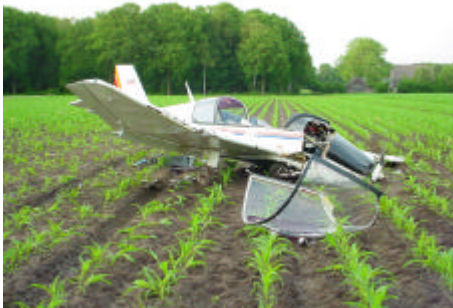
Technical investigation of the fuel system revealed no explanation why the full fuel tank was empty within two hours. According the aircraft flight manual the endurance is approximately 3 flying hours. It could not be determined if the fuel low warning system had generated an indication in the cockpit when 25 liters remained in the tank. It was also not possible to prove that the tank was full at departure. During flights in the days prior to the accident the pilot had noticed a higher fuel consumption than he was used to and took this into account in the fuel calculation.

The D-EHAE after the accident

The pilot stated that he did not check the fuel gauge regularly during the accident flight. When he realized that he was running out of fuel he had underestimated the situation by not declaring an emergency. That's why the air traffic controller, unaware of the critical situation, allowed the aircraft to overfly the city at a low altitude involving considerable risk. Most likely the airspeed was too low during the emergency landing causing the aircraft to stall prior impact.
