FIRE IN HIGH-SPEED TRAM

AT THE WEESPERPLEIN

METRO STATION, AMSTERDAM

ON 12 JULY 1999

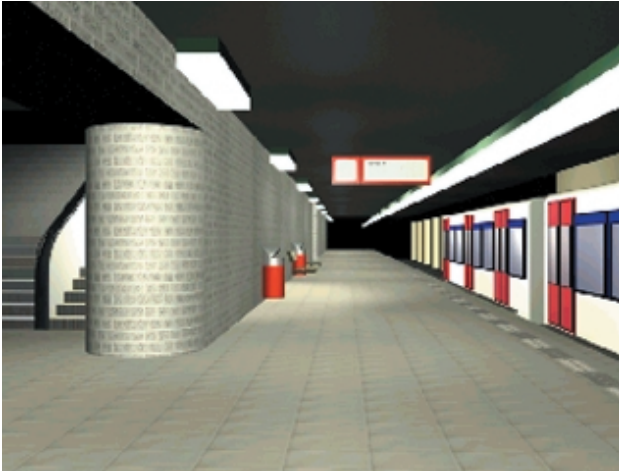
Fig. 5. Platform level, immediately following arrival of high-speed tram

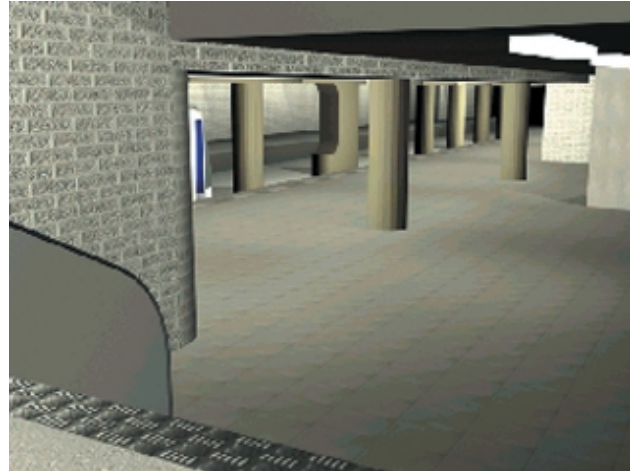
Fig. 8. Platform level access stairs, following arrival of high-speed tram

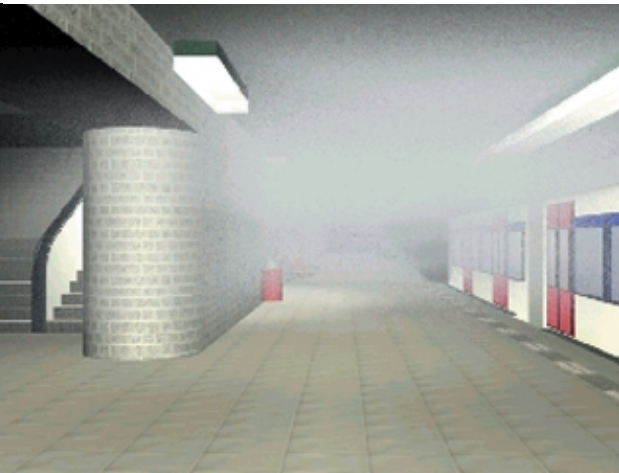
Fig. 6. Platform level after 5 minutes

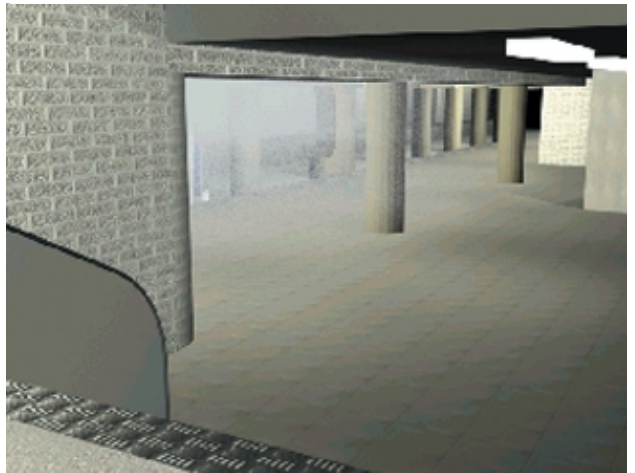
Fig. 9. Platform level access stairs, after 5 minutes

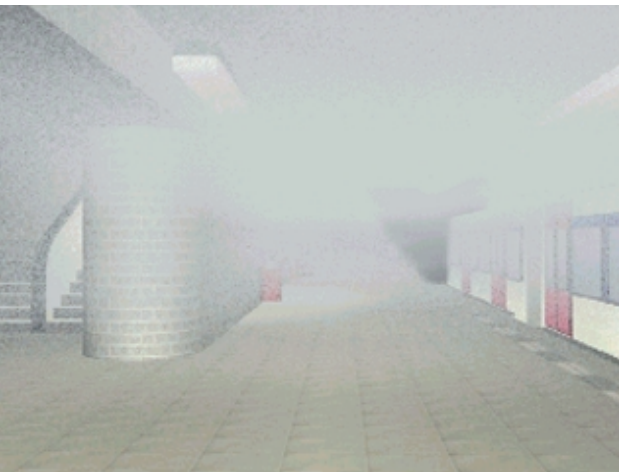
Fig. 7. Platform level after 10 minutes

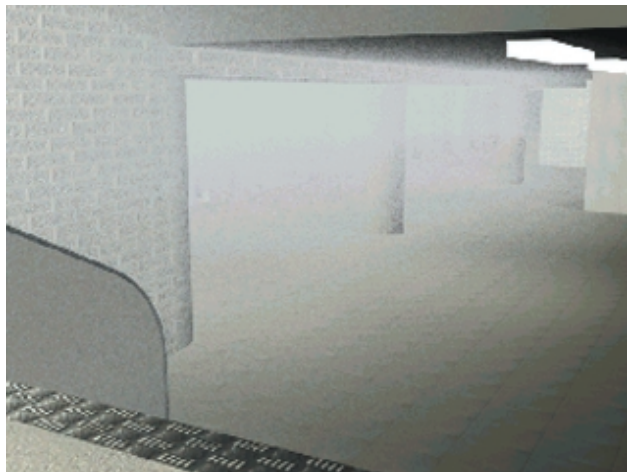
Fig. 10. Platform level access stairs, after 10 minutes

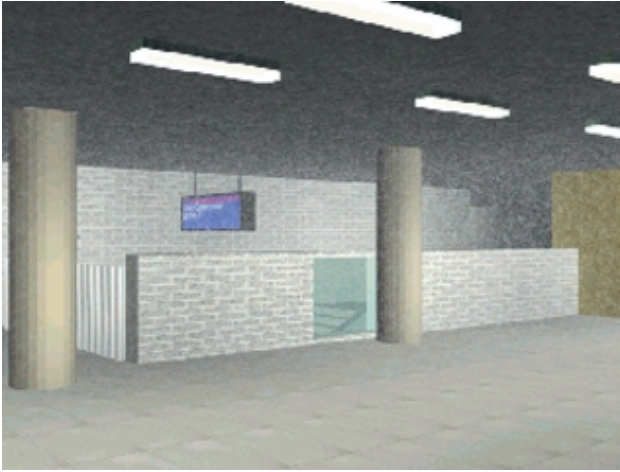
Fig. 11. Shop level with empty space, after 10 minutes

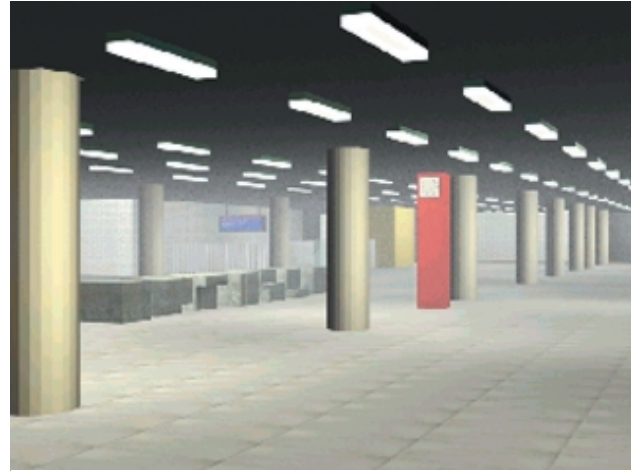
Fig. 14. Shop level, hall, after 10 minutes

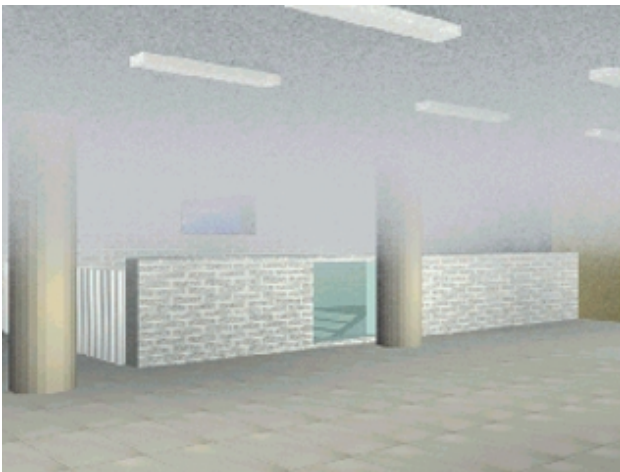
Fig. 12. Shop level with empty space, after 15 minutes

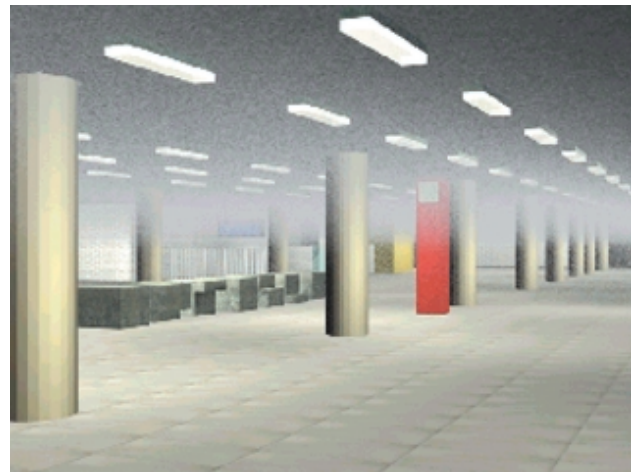
Fig. 15. Shop level, hall, after 15 minutes

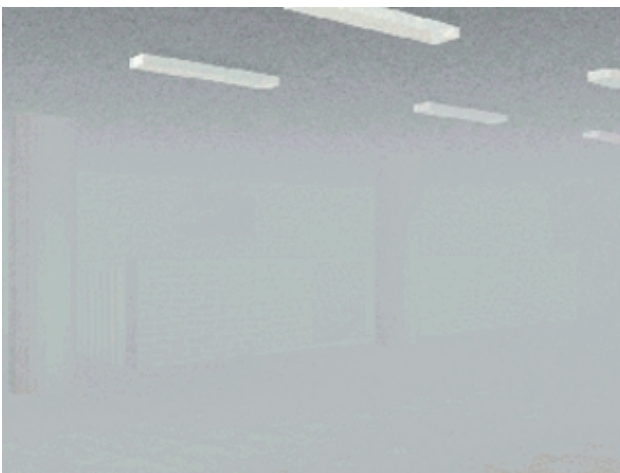
Fig. 13. Shop level with empty space, after 20 minutes

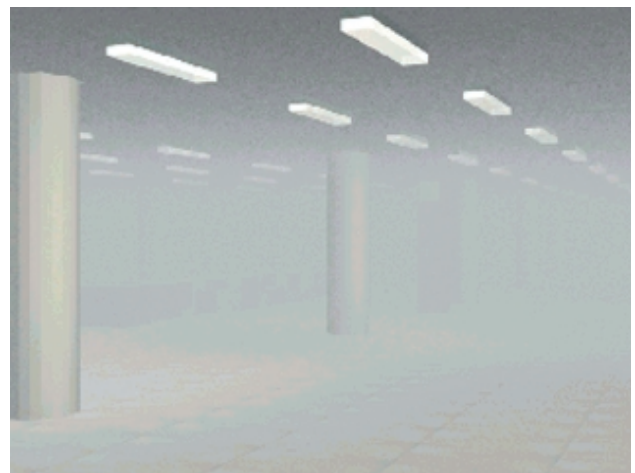
Fig. 16. Shop level, hall, after 20 minutes

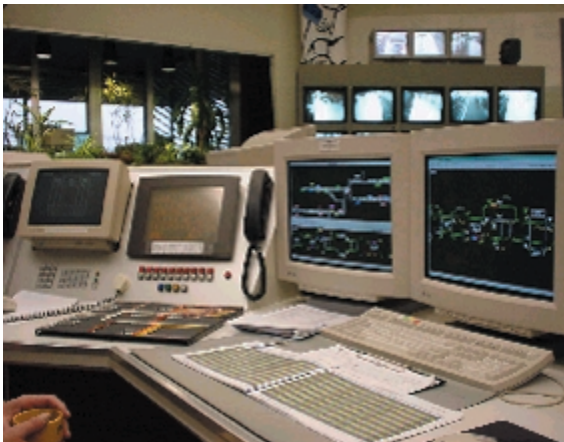
Fig. 2 Traffic controllers post. The two computer screens provide a schematic overview of the network and the positions of the metros and high-speed trams on the network. Using the keyboard, routes are selected. The adjacent system provides the link to the drivers on lines 53, 54 and the emergency services. The next piece of equipment provides a link to the drivers on line 51 (high-speed tram). To the left, outside this picture, is the installation for the station PA system. In the background, the monitors which provide a view of the stations, are just visible.

The traffic controllers are the sole people with an overview of the precise location of the metros and high-speed trams, at any given moment. This overview consists of a schematically simplified picture of the selected routes, and the positions of the metros on a computer screen. A metro itself indicates its location by establishing an electrical connection between the two tracks. The entire line is broken down into sections of several hundred metres. As a result, the traffic controller can see the section in which the metro is located. But that is the only information known. In the tunnels, which link the stations together, there are no video cameras or other monitoring systems installed. For observing fires or accidents, the traffic controller is entirely dependent on the drivers of the metros or high-speed trams. However, there are video cameras on the 33 stations. The number of cameras is far larger than the number of displays available to the traffic controllers. The traffic controller is therefore required to select what he wants to see, and then to select the cameras on the station, which provide the pictures he requires, using a computer program which is not really user-friendly.

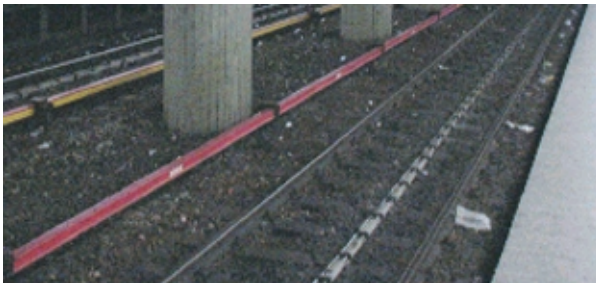
Fig. 3. The ballast bed and tracks. The red construction is the electrical power supply which first has to be short-circuited, before walking on the ballast bed, or extinguishing with water.

The system of short-circuiting, which requires waiting for an electrical engineer from the company, is a weak link in the action to be taken by the emergency services. At least in underground stations, consideration should be given to the possibility of installing permanent short-circuit facilities, which can be operated by the fire brigade, or remotely via the switch control officer. A number of railway companies are already equipped with a system of this kind.

- improving fire safety of the high-speed tram stock;
- improving the maintenance process;
- fully integrating high-speed tram line 51 into the metro system;
- developing scenarios and
- improving the third rail short-circuiting procedure.

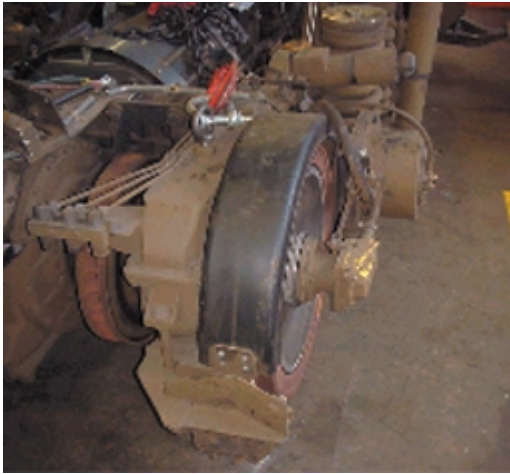
Fig. 17. The wheel below the mud guard. The brake disc is located to the left.

The disc brakes are applied via mechanical springs and released via oil pressure. The immediate cause of the fire was identified as a relay in the pump circuit for the disc brake, which is insufficient for the capacity it is required to handle. This relay became overheated and as a result was unable to switch on the oil pump. As a consequence, the disc brakes remained locked, and became overheated. The mud guards above the wheel, the plastic wiring and a wire harness above the bogie, and the approx. 2 cm-thick base plate of impregnated plywood, which serves as a floor to the tram, ignited, as a consequence. If sufficient tests had been carried out following handover of the stock, the underdimensioned

relay, a design error, would have been detected earlier. In addition, the vehicle in question was fitted with a hand-operated oil pump, with which the brake could have been released.
