# PASSENGER TRAIN DERAILMENT

*at Baarn*

*20 August 1999*

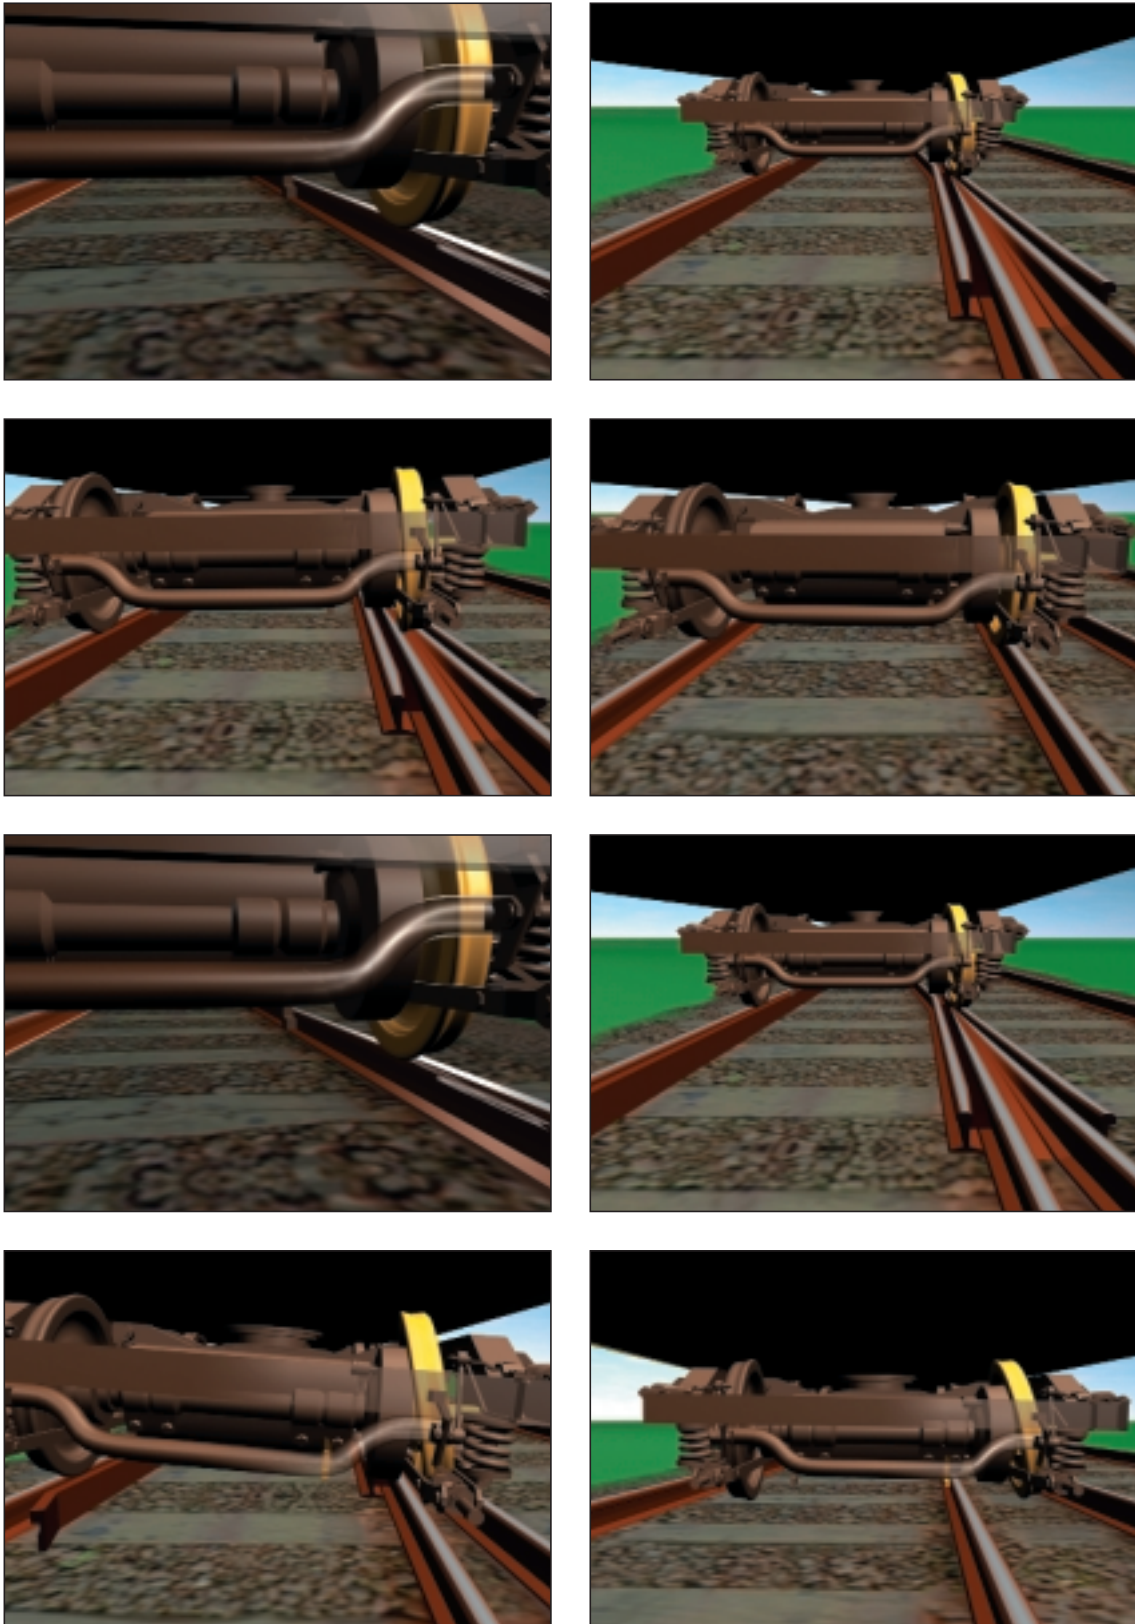
On passing the second set of points, the first – left-hand – wheel of the second motor bogie of the second carriage derailed. The wheel travelled over the end of the crossing of the set of points, and fell back into the correct track. When crossing the fourth and final set of points, the wheel became fully derailed. The passengers noted the bumping motion and guessed that the train had become derailed. Approximately 200 metres after the derailment, the driver felt that the train was no longer travelling correctly. His first thought was poor condition of the track section, and he continued at low speed. Approximately 700 meters from the set of points where the set of wheels had derailed, the train passed a level crossing with no barriers. Until this point, the first set of wheels had been travelling more or less parallel to the rails. As a result of the collision between the derailed set of wheels and the concrete foundation of the crossing, the set of wheels and hence also the bogie twisted further to the left, seen from the direction of travel. By this stage, the train had begun to shake. The driver no longer trusted the situation, also as a consequence of the unusual noises he could hear. He therefore stopped the train. At this moment, a passenger banged on the driver's cab door, calling that the train was derailed.

Fig. 2 The bogie first derailed in the second set of points on the main Amersfoort–Amsterdam line. After this set of points, the bogie returned to the rails. At the fourth set of points, the bogie derailed completely.

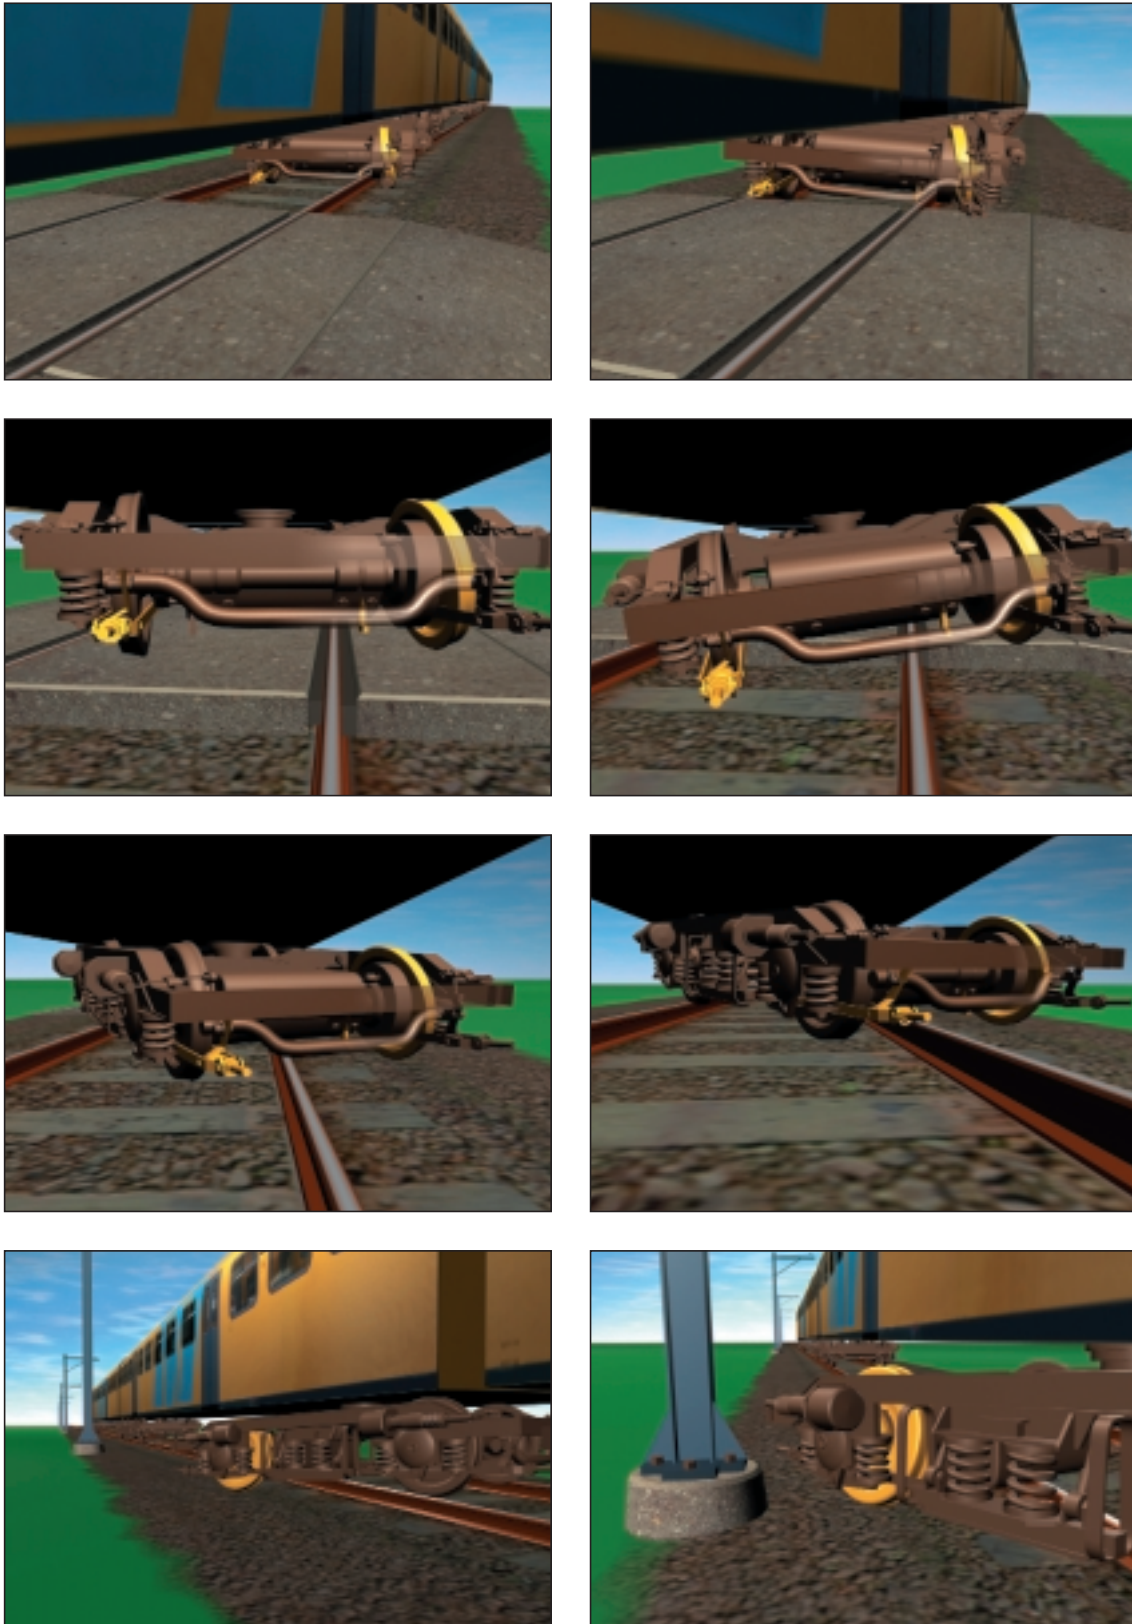
Fig. 3 The bogie collided with the foundations of a crossing, on the single-track section, turning fully out of line. The bogie then left the track clearance envelope.

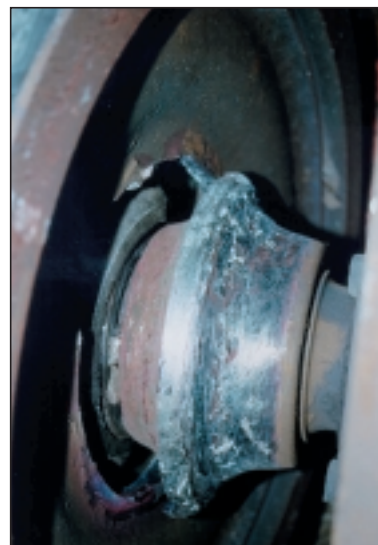
Investigations by NS Technical Research have demonstrated that a fracture in the inner wheel was the cause of the derailment of Materieel 64 in Baarn. The complete fracture was due to fatigue cracks in the inner wheel. Following the fracture, the train set travelled approximately 1 kilometre further. The bogie was able to keep the broken-off wheel in line, for a short time. During this time, the fracture surfaces continuously impacted upon one another. This resulted in tremendous friction which partially caused the fracture rim to 'disintegrate' as a consequence of which the rim is somewhat rounded off.

Fig. 7 The cracked inner wheel

The inner wheel is cracked as a result of fatigue, from the flange side of the wheel. No faults were identified in the inner wheel, which could explain the occurrence of the fatigue. The wheel is probably at the end of its service life.

Given the appearance of the fracture surface (flat, flattened), the speed of growth of the crack was not high. The crack growth speed may vary widely from months to one or more years.

The Management of NS Passengers is recommended, in the shortest possible time, to guarantee the safe running of Materieel 64, by:  
increasing the reliability of the rapid tracing of fatigue cracks in inner wheels;  
determining the speed with which cracks develop;  
complying with the periods laid down for crack investigations.

If NS Passengers fails to guarantee safe running, according to these measures, it is recommended that at least all inner wheels on type 275 bogies be replaced.

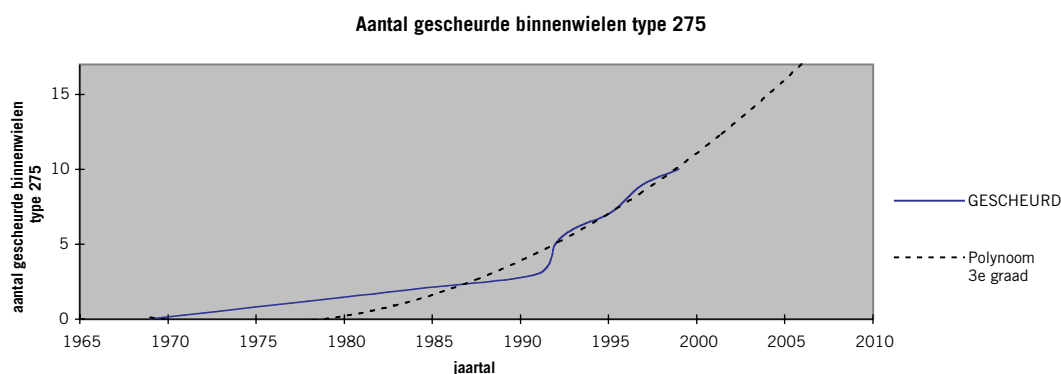
Fig. 8 Taken from the report: History of Wheel set 61 217 NS Technical Research March 2000. The graph shows cumulative data.

The table and graph are disturbing. Both clearly demonstrate that wheels do not have an infinite service life. The number of cracks increases, the closer the end of the technical service life becomes. This is precisely the behaviour of material which in terms of load, is in the difficult to manage zone of figure 6. It is no problem to make constructions in this zone, if two conditions are met: it must be possible with absolute certainty to trace fatigue cracks, and the speed with which the crack is developing must be accurately known.

From the data in table 1, we see that there is little understanding of crack behaviour. For a well-managed process, the cracks are too long and the variation in observed crack lengths too great. The absolute sizes of the cracks, observed during inspection, vary from 4 cm to 35 cm, with a random length distribution over time. In the event of sound inspections, one would rather have expected that crack length would have reduced over time, with the longest cracks having been identified immediately after 1984. In that case, the problem would have been more or less under control. However, this is shown to have not been the case. The cracks observed therefore represent a complex problem. Cracks have also been shown to occur in wheels of other types of wheel set.

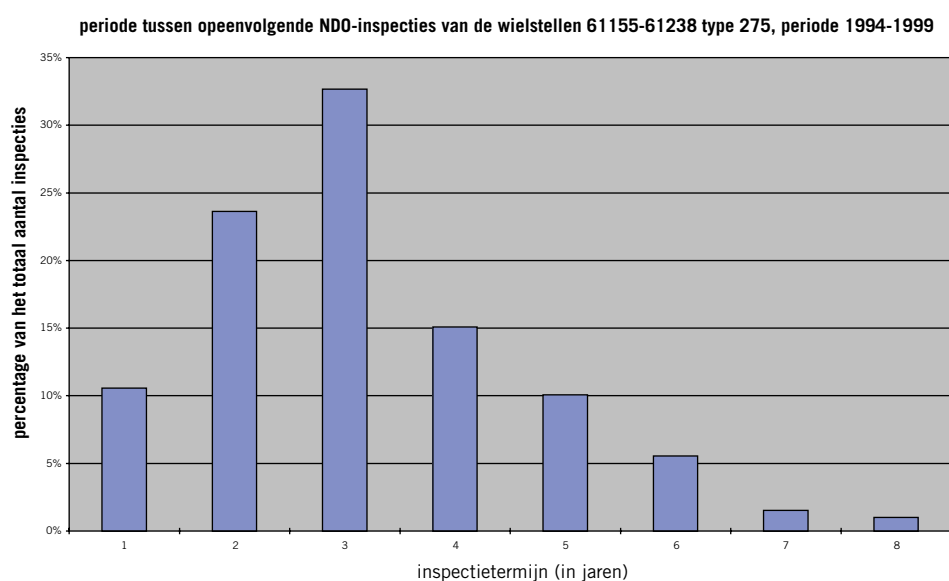
Fig. 9 Percentage distribution of crack investigations carried out broken down according to inspection period between two investigations. Data taken from the report History of wheel set 61 217 NS Technical Research, March 2000.

As shown by the graph, this inspection period, introduced in 1994, has not been achieved. The intention of the procedure was that from 1994 onwards, every wheel would be inspected for cracks at least once every two years. In the period 1994-1999, a total of 199 wheels were investigated for cracks. As the graph shows, of this number 35% (1 year: 11%, 2 years: 24%) were actually investigated within two years. The remaining 65% of these investigations were carried out too late, some of them many years too late.
