**ACRYLONITRILE LEAKAGE  
AMERSFOORT STATION  
20 AUGUST 2002**

The Hague, September 2004

## BOARD FOR TRANSPORT SAFETY

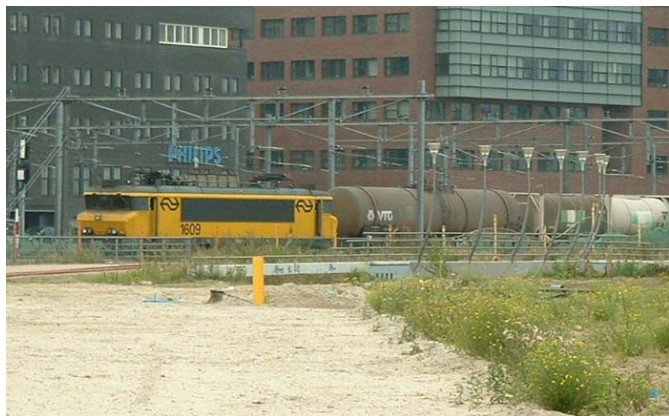
Fig. 2 The train at Amersfoort station. The tank wagon immediately behind the locomotive is the leaking wagon filled with acrylonitrile.

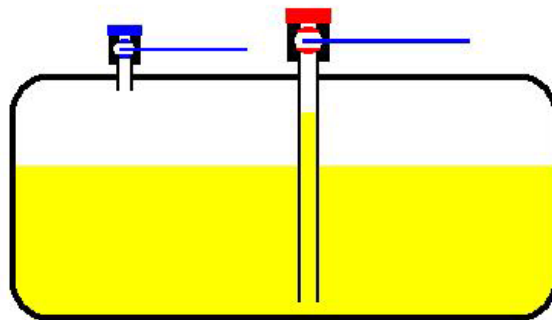
Fig. 5. Diagram of the reservoir of the tank wagon with a closed filling system. The red flange (red rectangle) closes off the filler pipe and the blue blind flange, the vapour return pipe.

The ball cock is sealed off by a steel blind flange (the red flange in figure 5 and 6), fitted with a gasket. This blind flange is connected to the tank wagon by a chain. The ball cock is manufactured from stainless steel. The top edge of this cock, to which the blind flange is attached, can therefore not corrode, and remains smooth. The steel blind flange, however, had rusted and was soiled, as demonstrated by the examination carried out, and fig. 7. The gasket found following the accident between the cock and the blind flange is not used frequently, and matched the type fitted at the last inspection.

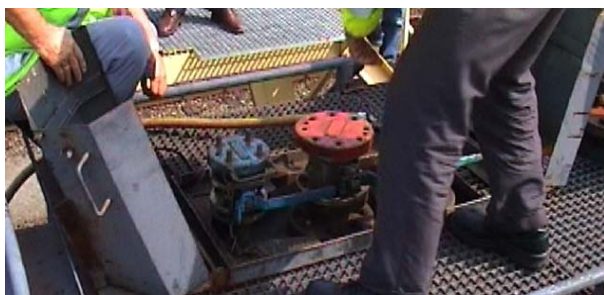
Fig. 6 Photograph of filler pipe (red) and return pipe (blue) and opened protective cover on top of the tank wagon, taken during testing following the incident (without acrylonitrile, i.e. without protective gas suits).

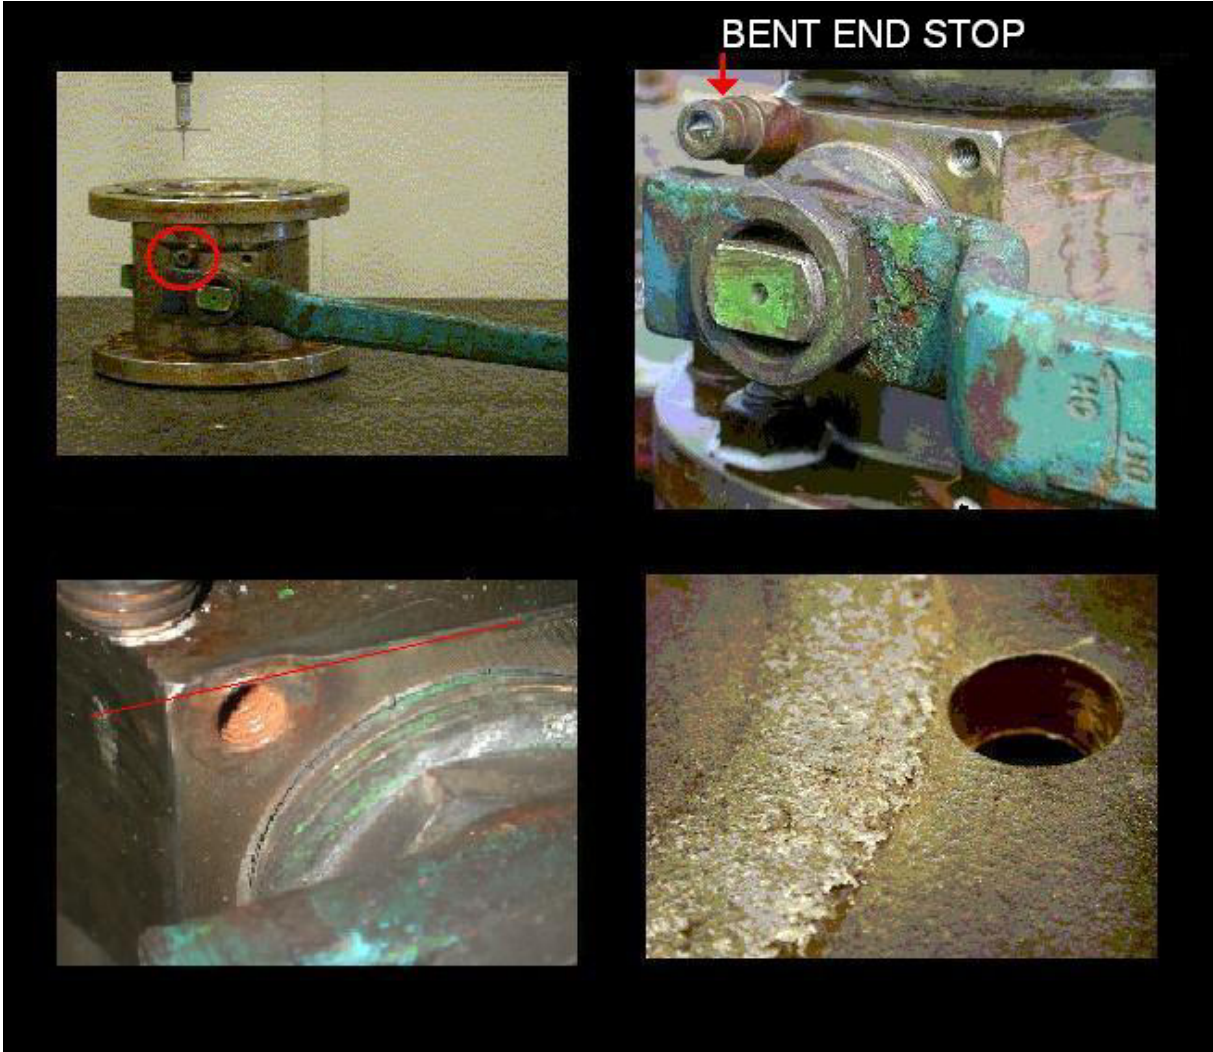
Fig.7. **Top left.** The stripped down stainless steel ball cock in a test bed. The handle has been pressed down until it comes into contact with the bent end stop. Even then, the cock is not closed. The handle is then not horizontal. In its horizontal position (closed position), the cock is parallel to the side of the table on which the ball cock is mounted. This ball cock has the special feature that there are only two positions in which the cock is closed. In all other positions, the cock is opened.

**Top right.** The bent end stop. With the handle in horizontal and closed position. The handle is now not resting against the end stop. A bent end stop effectively means a cock which can no longer be sealed.

**Bottom left.** Detail of the hole for the bolt. The bolt itself has been removed. The hole for the bolt of the end stop has been drilled too close to the top edge. The soft stainless steel has been bent out of shape. The top of the cock should be smooth. In this case, it is bent out due to the major forces applied on the bolt.

**Bottom right.** A magnification of the underside of the red blind flange. One of the bolts passes through the hole. The rough, uneven, circular strip is the location of the gasket. The flange should be even. The lighting for this photograph was perfect. Under normal light conditions, this unevenness is less obvious.

On behalf of the Board, a technical examination was carried out on the cock in the riser pipe and the accompanying red blind flange<sup>7</sup>. This examination showed that the cock (the ball valve) demonstrated two faults, as a result of which it leaked.

- Such considerable forces had been exercised on the handle for closing the cock that the end stop which guarantees the correct closed position had been bent (see figure 7). If the end of the handle was against the stop, the cock was still approximately 3 mm open.
- In addition, the inexperienced placement of a metal name plate had damaged the ball. As a result, the seal was no longer complete. The name plate had been installed to prevent theft.

The investigation carried out showed that with this flange, due to its condition as a result of the rust and soiling, a hermetic seal of the reservoir as specified in the RID was practically technically impossible. It should be noted that the RID merely specifies that the reservoir must be hermetically sealed. For substances from classes 3 to 9, which includes acrylonitrile, the RID contains no regulations for the valves and blind flanges. These are designed and manufactured in accordance with the requirements of the competent authorities for admission, in as much as they exist, and the wishes of the client who has the tank wagons built.

From a technical viewpoint, at least three barriers failed. The design of the ball cock was faulty. The blind flange was not smooth enough and the technical inspections of these aspects, required to be carried out by law every 4 years, failed to bring these faults to light.

**It is recommended that the VdTÜV terminates as rapidly as possible the type approval for the ball cock, which applies until 2004.**

**It is recommended that the VdTÜV reviews the inspection regime for tank wagons for the transport of hazardous substances in such a way that the proofness of the reservoirs is guaranteed at all times and that if relevant, at least the ball cocks and blind flanges be tested for proofness independently of one another, so that one of the two always guarantees proofness, in the event of failure of the other.**

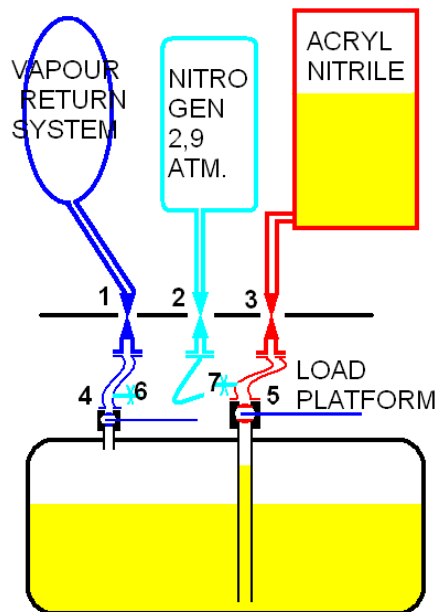
**The overpressure in the reservoir of the tank wagon may have been caused by inexperienced filling of the reservoir with acrylonitrile, or by heating by the sun. After the event it is no longer possible to objectively determine the precise cause.**

Fig. 8 Diagram filling of tank wagon.

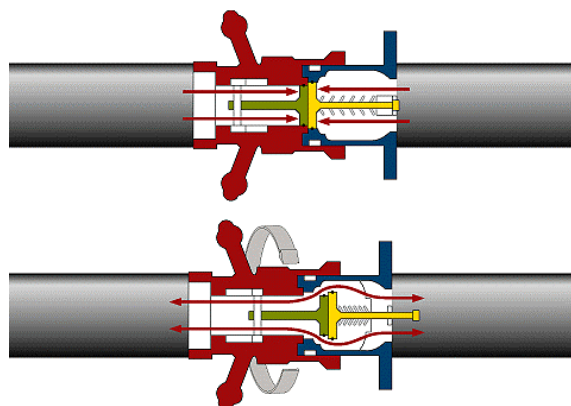
As indicated in the work instruction (appendix 2), the practice is different. The filling of the tank wagon with acrylonitrile includes a large number of complex actions, which must be carried out in the correct order. Neither the actions nor the order in which they must be carried out are described. Instructions for use by the operator are not available. At no point is a warning issued that following the incorrect order could result in overpressure. An inspection for proofness of the blind flange applied to the filler openings is not part of the work instruction. The Board judges the existing work instruction for the filling of the reservoir with acrylonitrile to be absolutely insufficient, and that the filling method using connectors is entirely outdated.

Fig. 10 An example of a modern coupling with far less risk of errors and leakage. The use of this coupling is recommended by Cefic, the European organisation for the chemical industry.
