DUTCH  
SAFETY BOARD

# Collision between a guard vessel and fishing vessel on the North Sea

7 October 2013

*The Hague, March 2015*

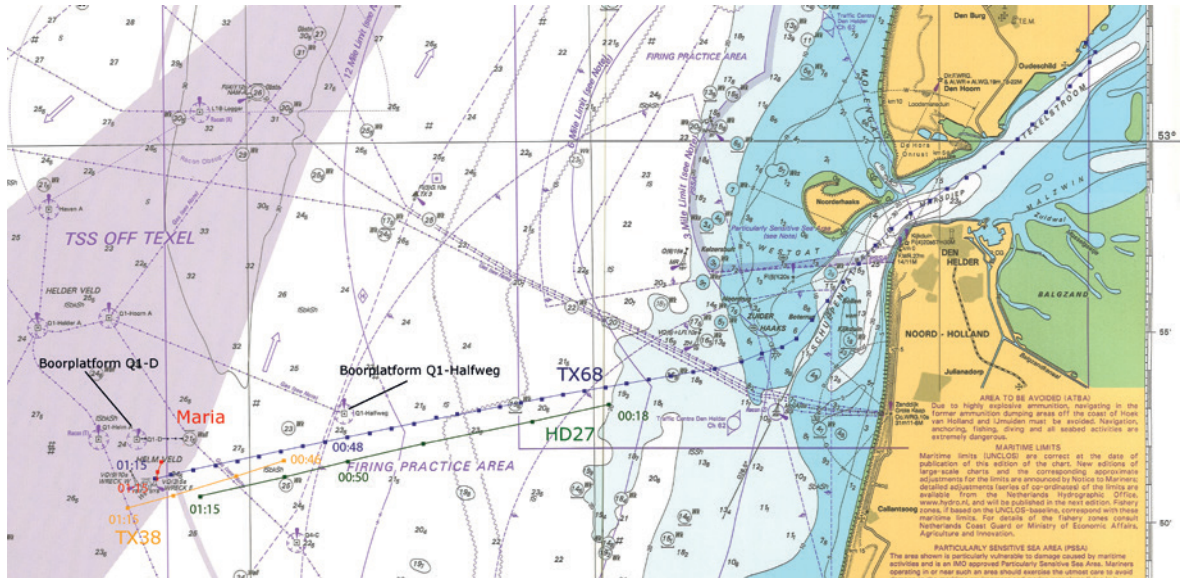
Figure 1: Chart of the area between Den Helder, Schulpengat and TSS Off Texel with the courses sailed.  
 (Source: Netherlands Ministry of Defence WGS 84 INT 1418 1631 en Dutch Safety Board)

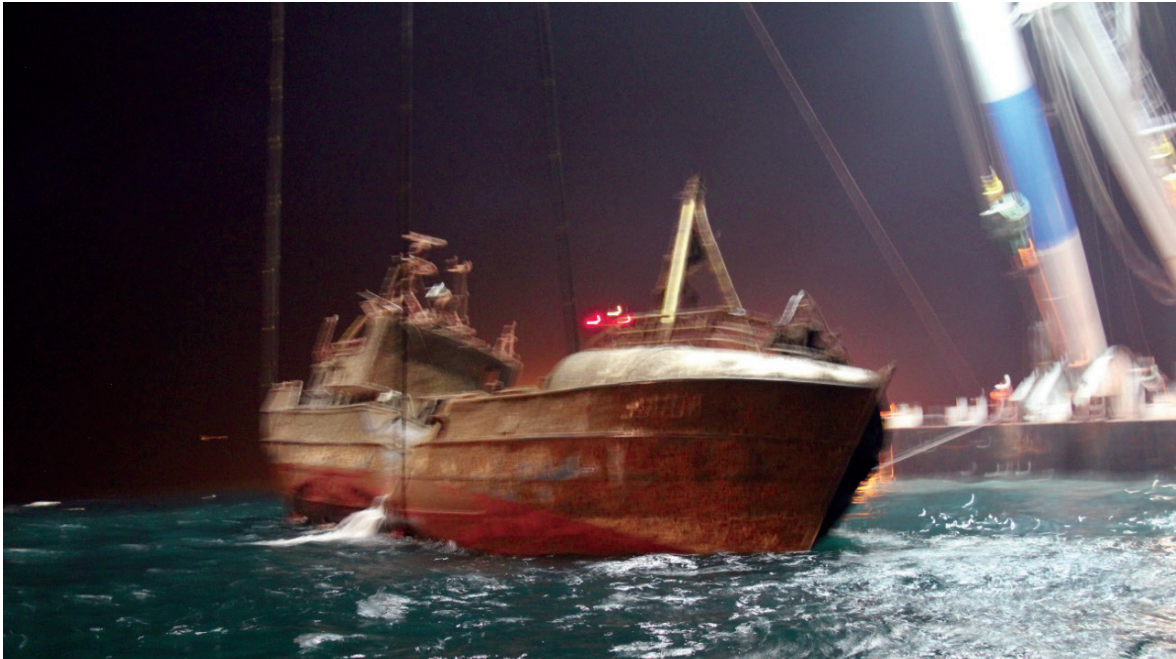
The *Maria* was seriously damaged by the collision, and water flooded into the vessel through an opening in its hull on the starboard side. This caused the *Maria* to sink. Two of its crew jumped overboard and were rescued by the crew of the *Vertrouwen* (TX68). The other three crewmen were onboard when the vessel sank, and died. The victims were recovered later.

Figure 2: Damage to the starboard side of the Maria's seen during the first salvage attempt. (Source: Berex B.V., Zevenbergen)

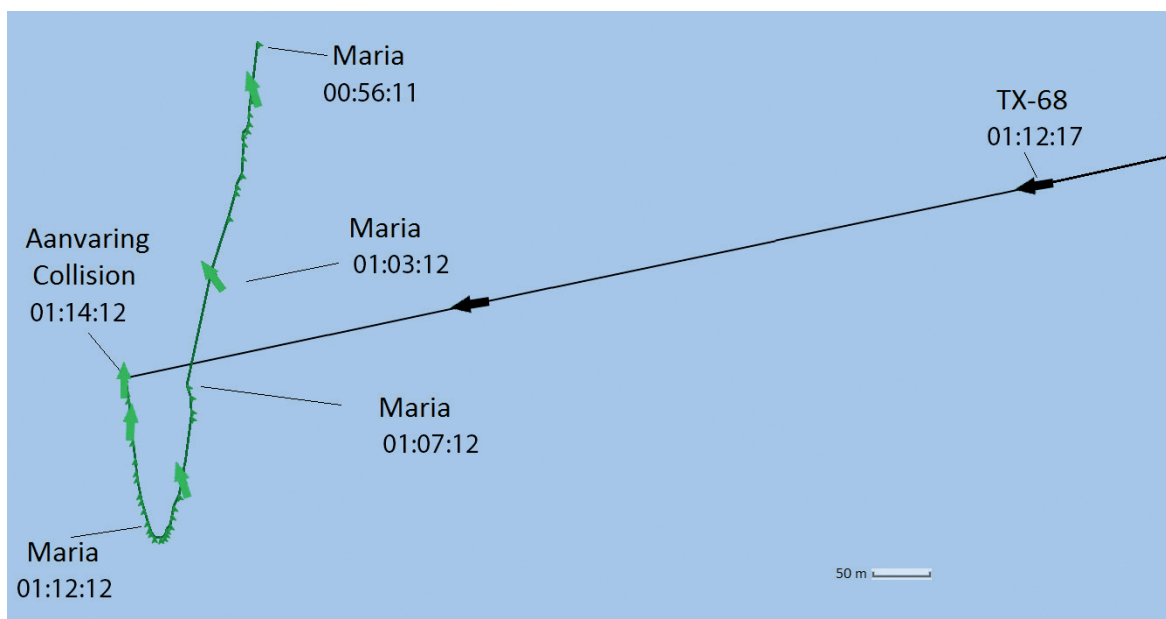
Figure 5: The tracks of the Vertrouwen (TX68) and Maria before and at the time of the collision. (Source: Dutch Safety Board)

Between 01:03:12 and 01:07:12, the Maria crossed ahead of the Vertrouwen (TX68) at a distance of between 2800 metres and 3800 metres.<sup>7</sup> For the Vertrouwen (TX68), the Maria came from the starboard side. As the Maria was moving sternwards with the current the Vertrouwen (TX68) also came from its starboard side. The interviews revealed that this was not observed onboard the Vertrouwen (TX68).

After 01:11:01, the Maria changed its heading to about 335 degrees. As a result of this change in course, the Maria's course crossed the course of the Vertrouwen (TX68) again. A further change in heading to 279 degrees was observable between 01:14:01 and 01:14:28, whilst the direction in which the Maria was pointing changed from 002 degrees

to 333 degrees. This would appear to be equivalent to a collision on the starboard side. For the *Vertrouwen* (TX68), the *Maria* came from the port side. The AIS data of the *Maria* reveal that the collision occurred between 01:14:01 and 01:14:28.<sup>8</sup>
