DUTCH
SAFETY BOARD

Hatch cover crane entrapment

The Hague, April 2016

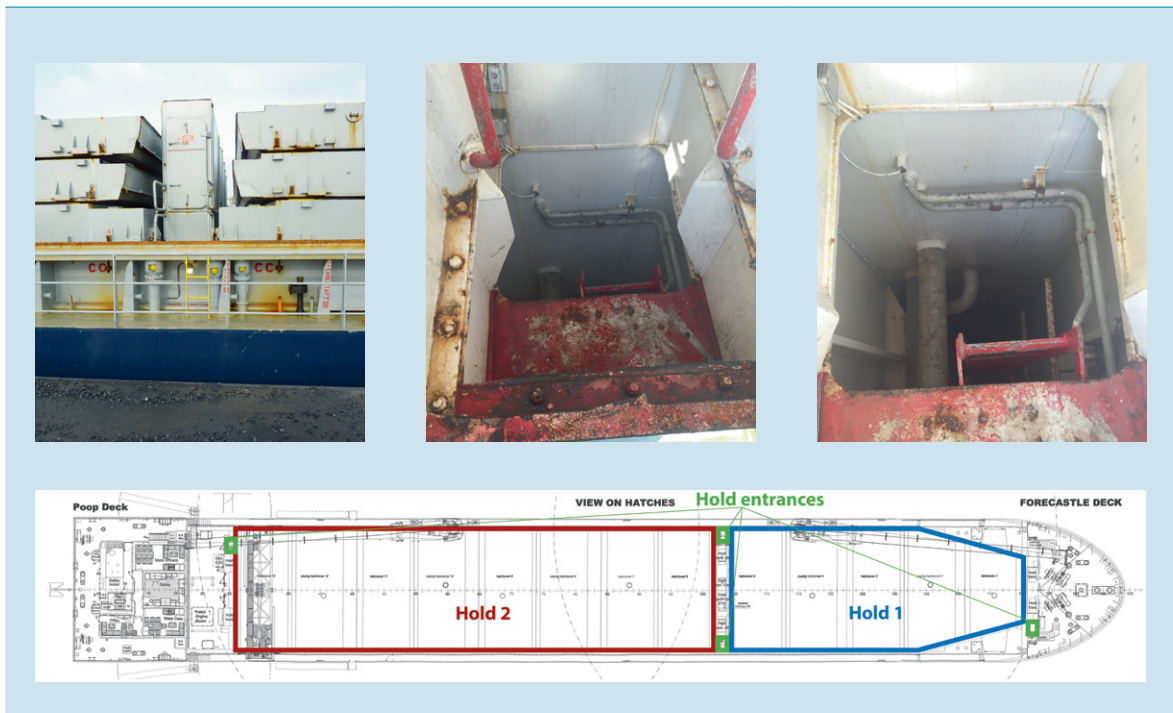
The Beauforce has two cargo holds separated from one another by a partition. The rear cargo hold (hold 2 in figure 1) can be entered via an access at the rear from the ship's accommodation and via an access starboard amidships. The front cargo hold (hold 1 in figure 1) can be entered via an access at the front from the forecastle and via an access port amidships (marked in green in figure 1).

The accesses amidships on both the port and starboard sides have 8-metre high vertical ladders. There is a narrow landing above the ladder in a covered portal that gives access to the outer deck through a door. A single-level floor measuring roughly one metre must then be crossed to get to a set of steps that give access to a gangway one metre lower down.

The access to the portal has a 60 cm high sill. This height accords with the International Convention on Load Lines³ and is intended to give the ship a safe freeboard.

Figure 1: Below: ship's configuration. Top left: access to hold amidships via portal. Top middle and right: View looking down ladders from portal and platform above ladders. (Photo: Dutch Safety Board)

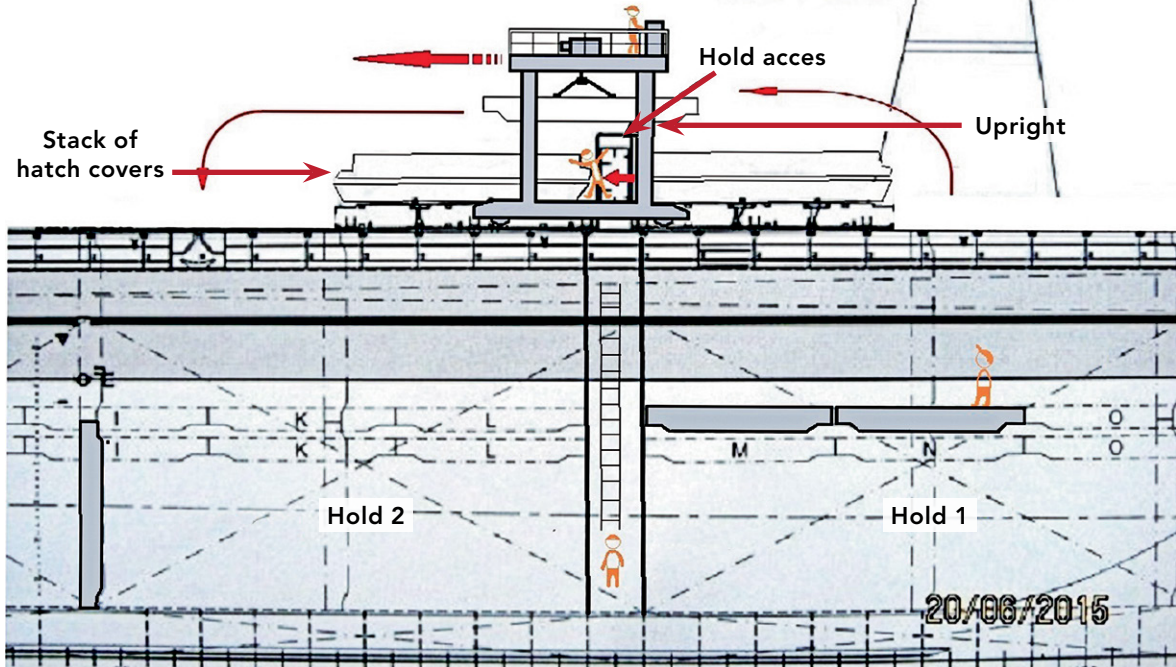
Figure 4: Illustration of the accident and the hatch crane. (Source: Focus Shipmanagement)

No one on board the ship actually saw the accident take place. Even the crew members who were standing closest to the victim at the time of the accident did not see it take place. The crew member who was working with the victim in the hold was standing in the hold under the ladder. The crane driver did not have a view directly below him, and the victim stepped on deck at precisely the moment the hatch crane was passing.

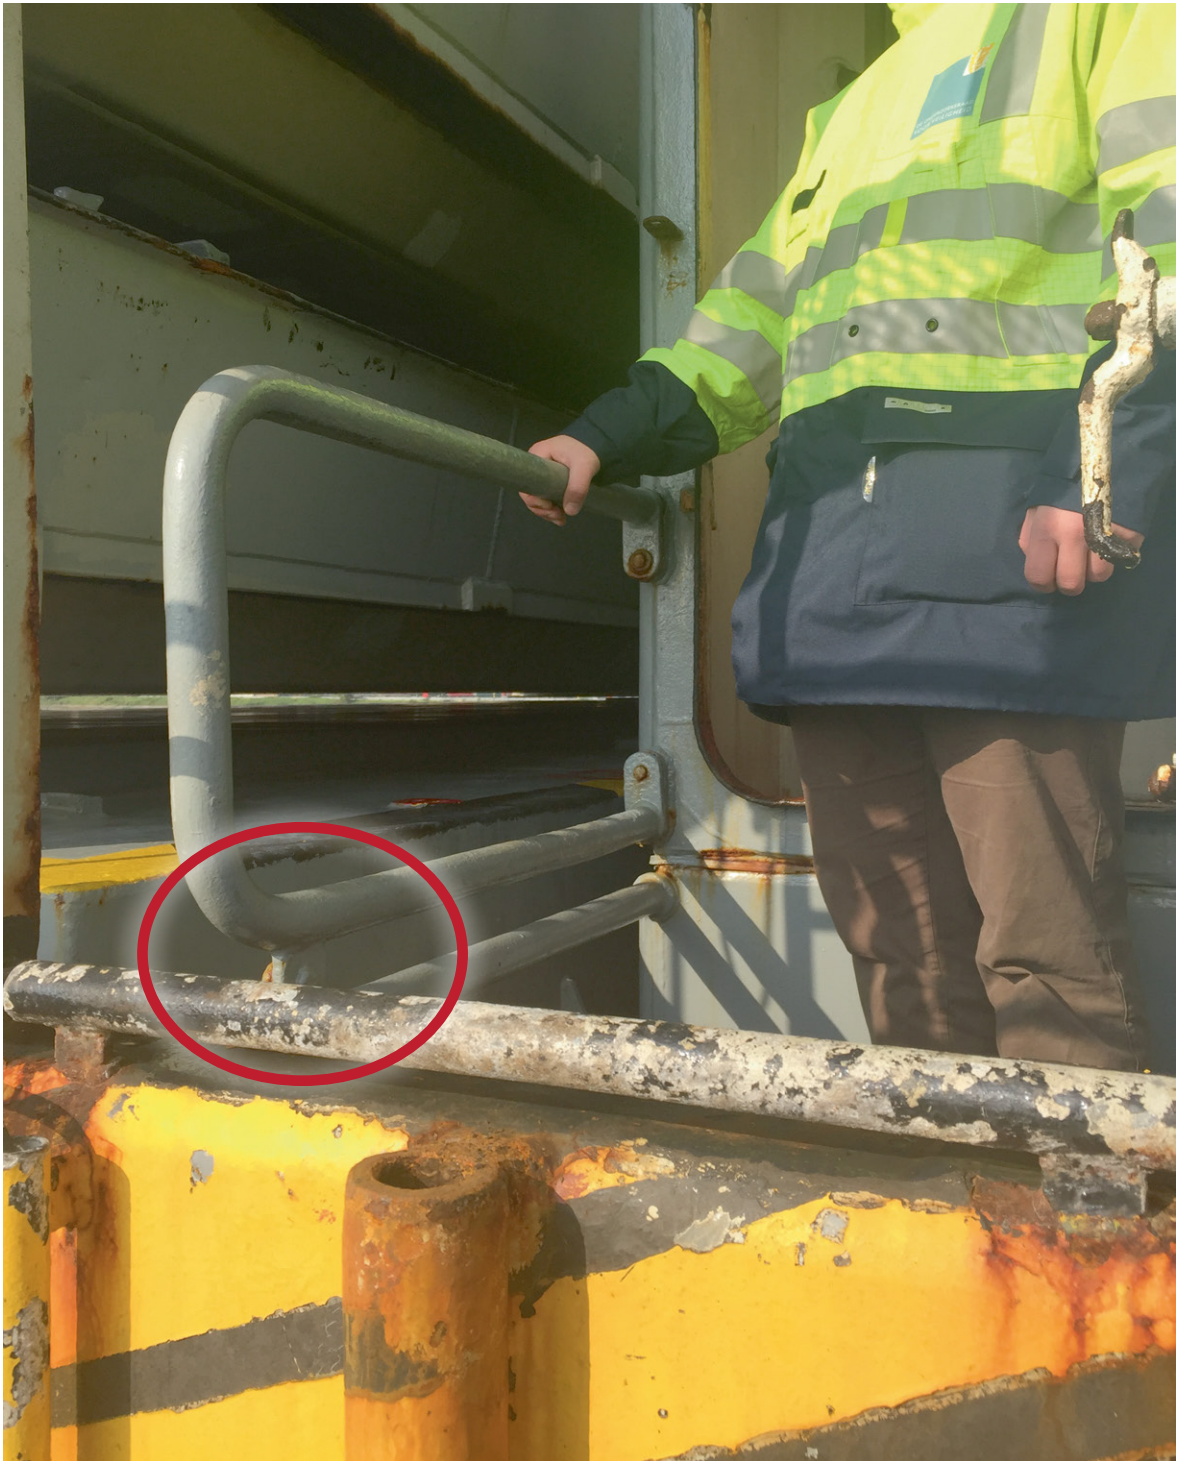
The position the victim was found in suggests that the most likely scenario is that he tripped over the sill when stepping out of the portal onto the deck. The victim was found on his side with his arms next to his head, trapped between the rear upright of the crane and the stack of hatch covers (stacked next to the portal, see figure 5). He lay with his head towards the starboard gangway.

Figure 5: Site of the accident, hold access starboard portal amidships. (Photo: Dutch Safety Board)

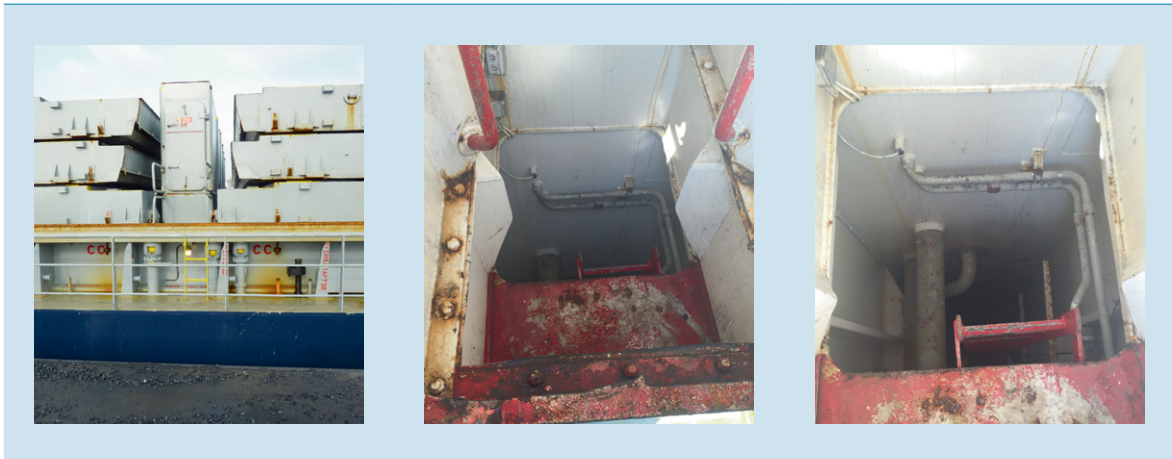
Figure 6: Photo left: access to holds amidships via portal. Photos centre and right: View looking down ladders from portal and platform above ladders. (Photo: Dutch Safety Board)

The hold access amidships would give no reason for the person to stay inside, rather all the cues are to step outside onto the deck in front of the portal. The platform above the ladder is of limited dimensions with a shaft below it approximately 8 metres deep (see photograph on right in figure 6). When stepping outside there are two grab rails to hold onto mounted one on either side as the person steps over the 60 cm high sill. This would involve leaning forwards. It is likely that the victim tripped when stepping out of the door resulting in him becoming trapped between the rear upright of the moving hatch crane and the stack of hatch covers to the side of the midships hold access.
