# Aircraft proximity

*The Hague, September 2013*

Identification number: 2012041  
Classification: Serious incident  
Date, time<sup>2</sup> of occurrence: 19 April 2012, 10.23 hours  
Location of occurrence: Southwest of the Island of Sylt (Germany)  
N54°42'18" E007°40'48", near reporting  
point LEGPI

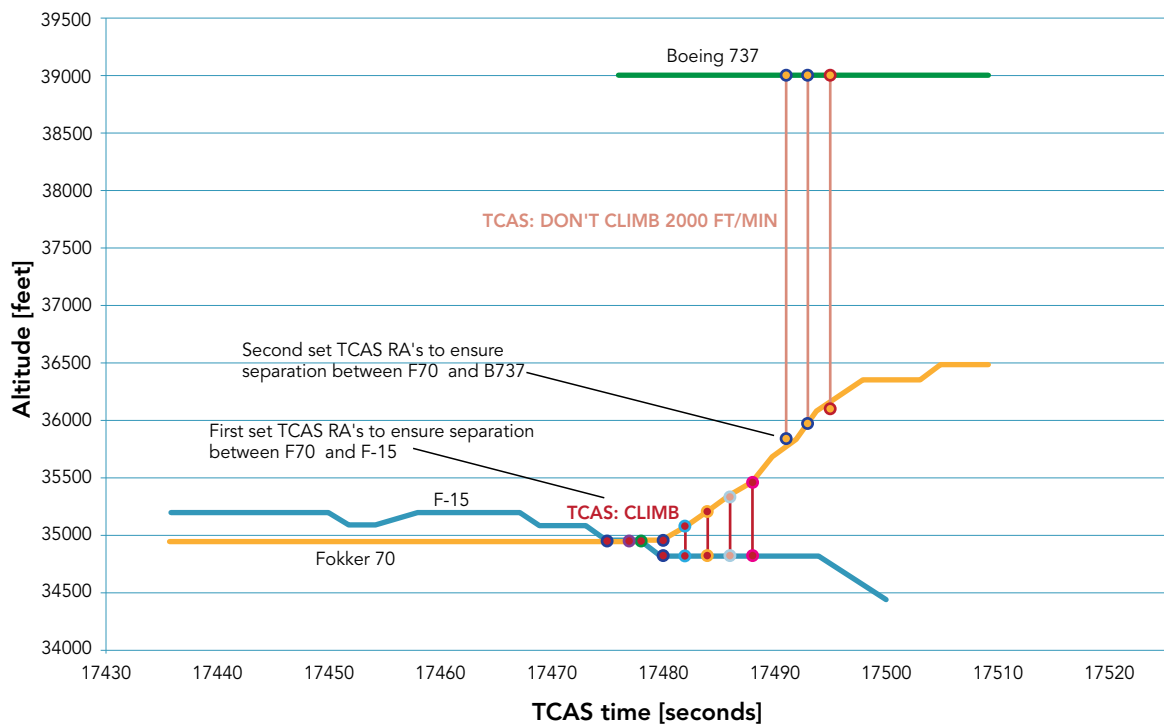
Figure 4: Vertical profile of Fokker 70 during TCAS event.

generated to maintain the present vertical speed. This to ensure vertical separation with a commercial aircraft at FL390. The minimum lateral distance between the F-15C and the Fokker 70 was 0,39 NM with a difference in altitude of 512 feet. See figure 4 for the vertical profile of the Fokker 70 during the TCAS event.
