GENERAL INFORMATION

Identification number: 2004006_088
Classification: Serious incident
Date, time¹ occurrence: 29 January 2004, 11.30 hours
Location of occurrence: Amsterdam Schiphol Airport

SUMMARY

When taxiing out to runway 36C the flight crew of a Boeing 757, inadvertently entered the active runway 36R that was being used for landing. The crew of a Boeing 737, approaching this landing runway was ordered by air traffic control to perform a go-around.

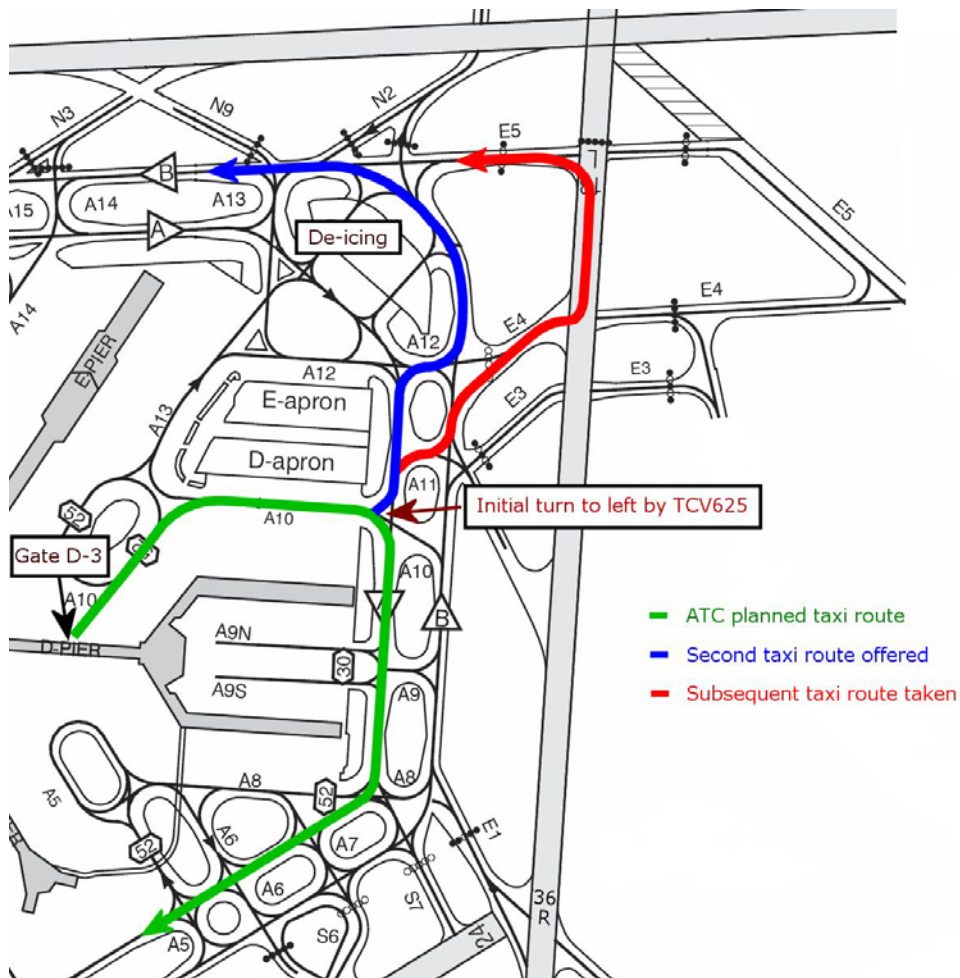
After being pushed-back from gate D3 the ground controller cleared the aircraft to 'taxi runway 36C, to leave via A10 and taxi via the south' (see green track on figure 1). When the intersection with taxiway Alpha was reached, the flight crew turned to the left instead of to the right. This was noticed by the ground controller, who subsequently instructed the flight crew 'at A12 first right now for taxiway Bravo, right and then left at A12, straight ahead' (blue track on figure 1). The clearance was read back as 'Copied, right now to A12, then taxi Bravo, Cabo Verde 625'. The flight crew made a right turn along A11 whereupon the ground controller instructed the Boeing 757 to turn left now for Bravo. The flight crew read back the clearance, turned left on taxiway Bravo and then turned right and entered the active landing runway 36R via E4 (red track on figure 1). The ground controller resumed other activities³ and did not notice that the Boeing 757 had entered runway 36R.

At the time of the incident the runway layout at entrance E4 was such that aircraft taxiing north along taxiway Bravo had easy access, by making a 45 degrees right turn, to runway 18L/36R. Entries E3, E4 and E5 were all situated in the area indicated as hot spot area⁴ in official publications and information charts at that time.

Since the last half of 2006 E4 has been changed by a bend in the entry. The junction to the runway now allows a better view from a cockpit on the runway and emphasizes that the aircraft is not longer on taxiway Bravo. In aeronautical publications⁵ only entry E5 is still within a defined hot spot area.

Figure 1: the planned and actual taxi routes for this flight⁷
