## GENERAL INFORMATION

Identification number:	2004176
Classification:	Incident
Date, time <sup>1</sup> of occurrence:	23 September 2004, 09.05 UTC
Location of occurrence:	Amsterdam Schiphol Airport
Aircraft registration:	EI-DBF
Aircraft model:	Boeing 767-3Q8 ER
Type of aircraft:	Passenger aircraft
Type of flight:	Commercial air transport
Phase of operation:	Taxi
Damage to aircraft:	None
Cockpit crew:	Two
Passengers:	None
Injuries:	None
Other damage:	None
Light conditions:	Daylight

When taxiing out from Schiphol-East the crew of the Boeing 767 crossed the active runway 04/22 without clearance. Since the runway that was crossed was clear of landing or departing traffic at that moment there was no risk of collision.

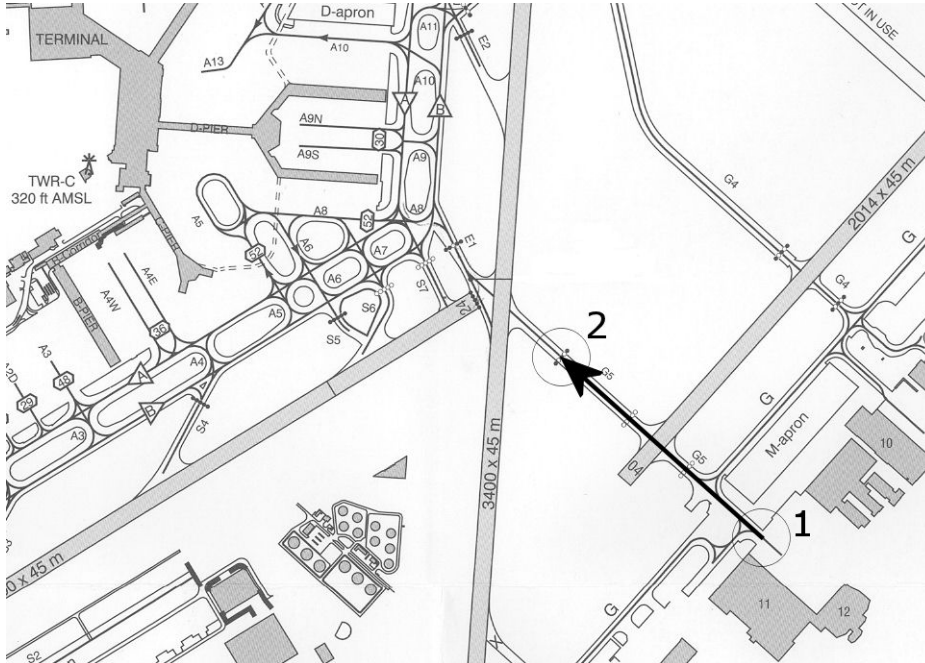
Figure 1: circle 1 indicates the position of the Boeing 767 when air traffic control was contacted for start up. Circle 2 indicates their holding position Golf 5 near runway 18L/36R.

At 09:07:16 hours the flight crew reported to ground control "TSO9768 hold short runway 36 at Golf 5". The position of the aircraft, after having crossed the runway 22 is shown as being approximately in the area of circle 2 in figure 1.
