**Goods train derailment near
Apeldoorn on 30 April 2003**

The Hague, February 2005

The Safety Investigation Board

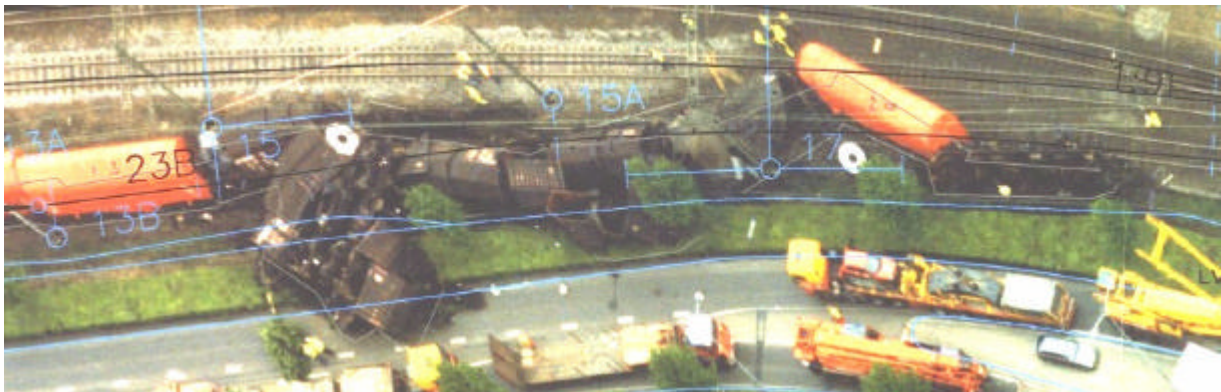
In the night of Tuesday to Wednesday 30 April 2003, at around 0.42 hours, a goods train derailed, when passing through the Apeldoorn complex. The goods train, operated by Railion Nederland N.V., consisted of an electrical locomotive and 21 goods wagons loaded with steel coils. The train was en route from Beverwijk Hoogovens Centraal to the border near Oldenzaal, with as its eventual destination Salzgitter in Germany. The derailment caused tremendous havoc, and considerable material damage. Parts of the derailed goods wagons and load ended up on the adjacent public highway.

Figure 1: Aerial photo from the National Police Agency (KLPD) of the havoc following the derailment

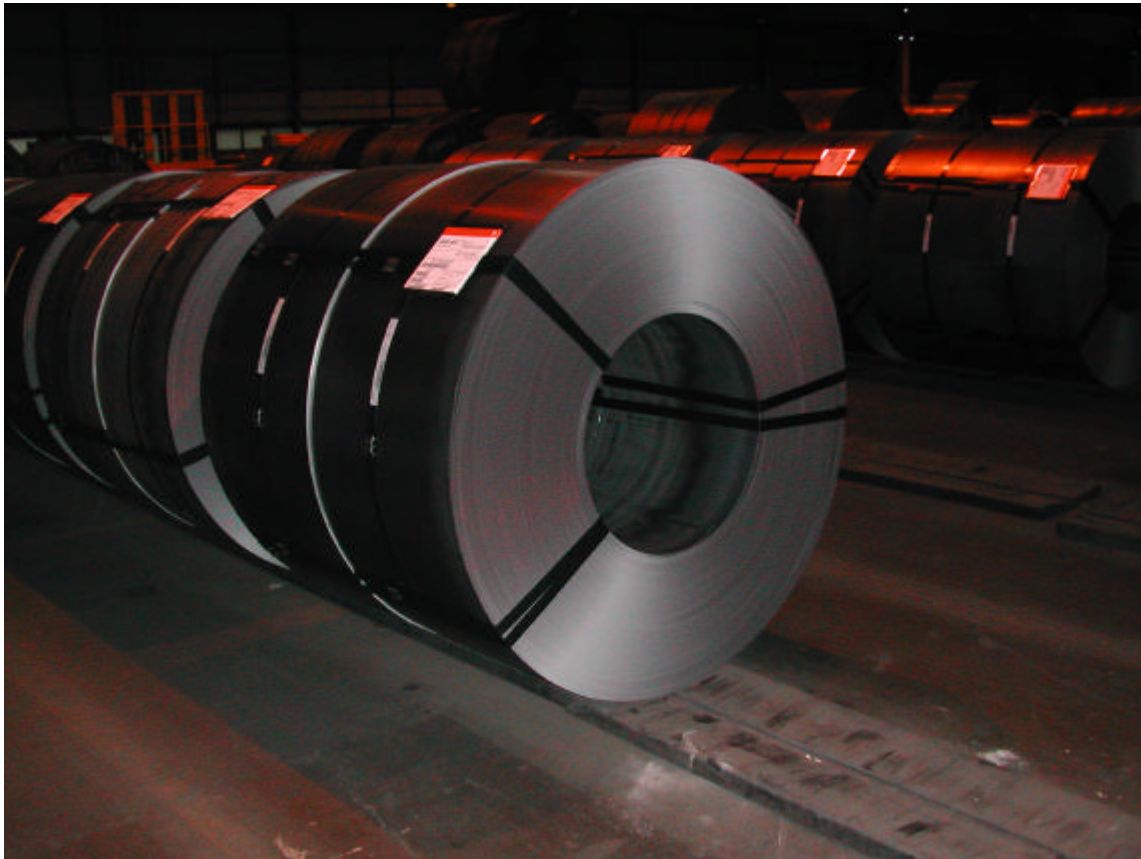
Figure 2 Steel coils; weight between 11 and 27 tonnes; cross-section between 1.5 and 2 metres.

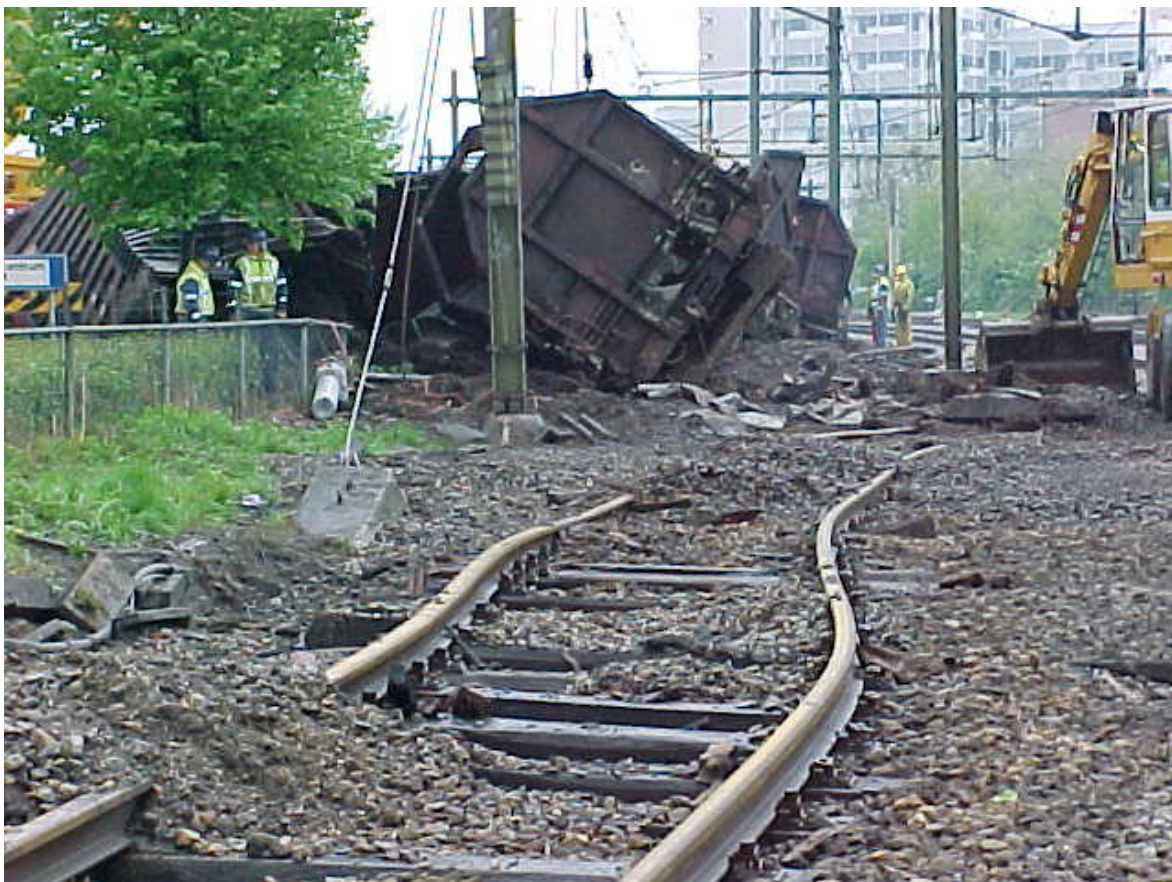
The consequences of the derailment were considerable. The infrastructure, the track between points 23a and 23b and the section of track towards the level crossing were severely damaged over a distance of several hundred metres, and had to be replaced. The damage to the goods stock was very considerable: ten wagons and the locomotive derailed. Due to the derailment, the wheels of the wagons buried themselves in the track. As a result, and because of the toppling of the first wagon, the front section of the train came to a halt very rapidly. Due to the massive deceleration, the next six wagons toppled over across and alongside the track. In respect of the direction of travel of the train, the wagons derailed to the right, next to the track, whereby coils of steel also fell from the train, and parts of the goods wagons (the steel hoods) ended up crossing the verge and finishing up on the adjacent public highway. Of the ten derailed wagons, seven were irreparably damaged. The locomotive suffered minor damage.

Figure 4 An impression of the havoc following the derailment

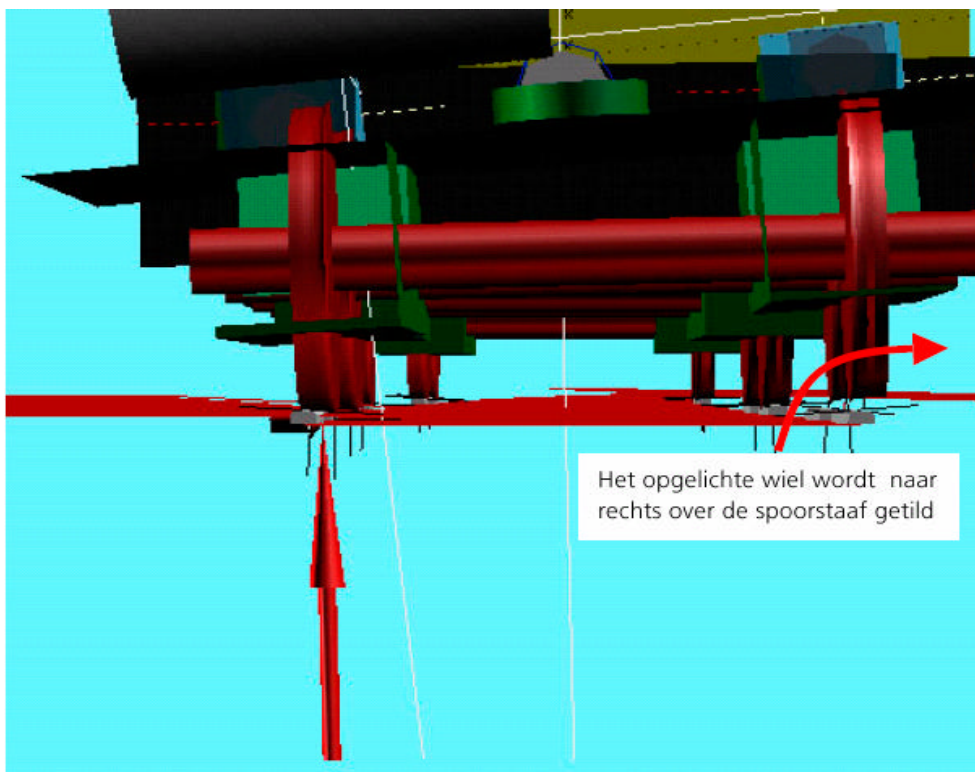
The traces found at the site of the accident demonstrate that the train derailed in a right-hand bend (right-hand turnout), in other words towards the inside of the bend. The only logical explanation which can be given for this fact is as follows. The derailment began when, in a right-hand bend, due to the high speed, one or more coils shifted entirely to the left-hand side of the wagon. Due to the combination of the high lateral forces to the left (as a result of the excessive speed) and the shift of mass to the left, the right-hand wheels of the first wagon behind the locomotive were raised. As a result, the wheel sets were no longer guided by the rails, and the front bogie was able to derail to the right.

Figure 3 The modelled moment of derailment of the first wagon behind the locomotive. In a right-hand bend, the wagon rotates clockwise around the vertical vehicle axis. Because of the high rotary inertia, this rotation was maintained for a relatively long period, and the bogie was able to derail, on the right-hand side.

In a bend, a wheel can break free from the rail, if the balance of forces is such that the vertical force on the wheel on the inside of the bend becomes zero. The result is a tilting moment. If this continues, the wheel breaks free from the rail, and the vehicle can topple. In the case of the derailment in Apeldoorn, there was a brief tilting moment, as a result of which the right wheels were lifted off the rail. The wagon did not tilt further, but the front wheel sets ended up to the right of the rail, due to the turning of the wagon⁵ to the right.

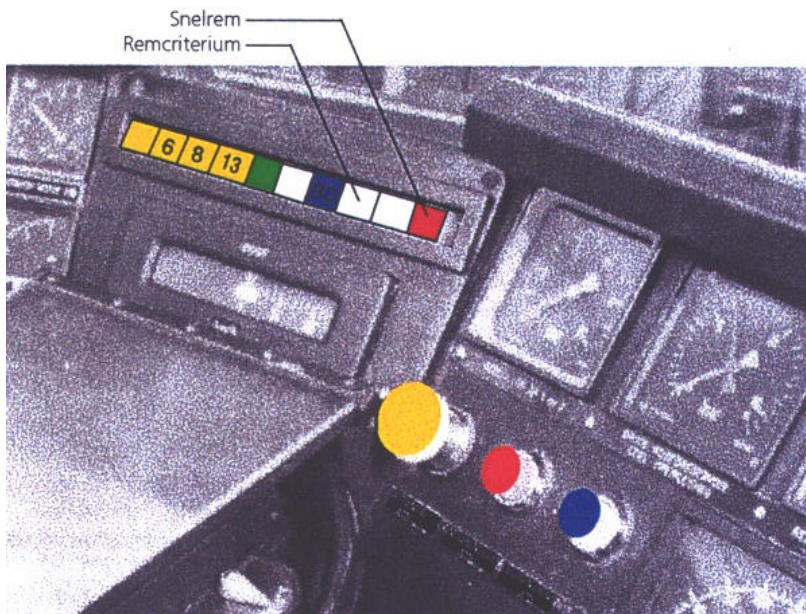
Figure 4 The workstation of a driver with ATB cab signalling

The ATB system has been designed such that neither the excessive train speed nor the insufficiently rapid reduction in speed could have been prevented. The current ATB system¹⁰ in fact only monitors the 'track-related' maximum speeds, and not the 'train-related' maximum speeds. With a goods train such as the derailed train in question, this means that the ATB system does not respond to a violation of the maximum speed of 95 kilometres per hour, but only intervenes at 130 kilometres per hour (the track-related maximum speed). This means a margin of 35 kilometres per hour within which the technical systems do not respond to a violation of maximum speed by the train¹¹. In addition, the system is 'satisfied' if the driver initiates any braking, as long as braking is continued until the required speed is reached. The system does not check whether braking is sufficiently hard to achieve the required speed before the next signal.

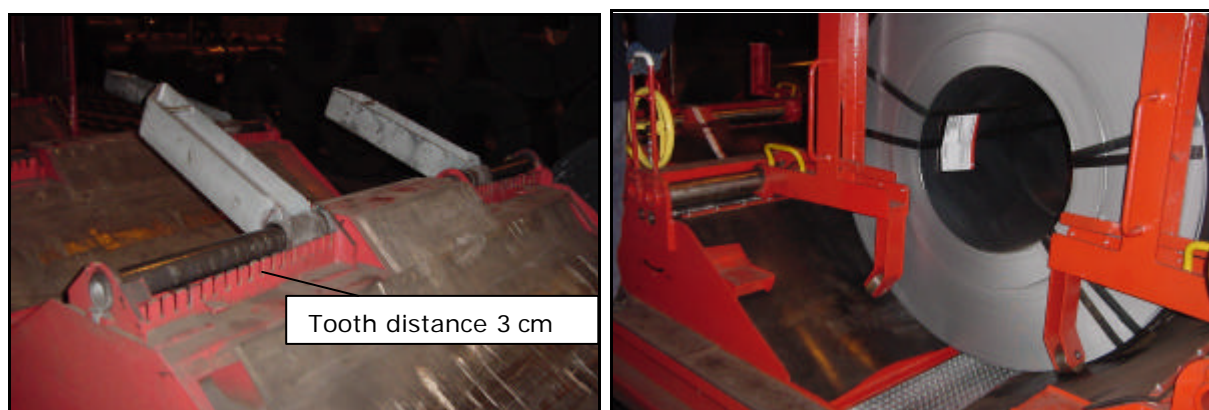
Figure 5 Different types of securing arms (tooth mechanism and slide mechanism)

The workplace instructions at Hot Rolled Steel 2 applicable at the time of the accident, state that coils/strips must be secured to the wagon 'by lowering the two securing beams as closely as possible on each side of the package'. This instruction conceals two uncertainties. Firstly, not two but four arms are available if (as is the case with the derailed wagon) two coils are placed on a single wagon. The newest type of coil wagon at least has four securing arms for each coil, irrespective of the number of coils transported on the wagon. The workplace instructions suggest that the use of two arms is sufficient. Secondly, the workplace instructions refer to the term 'package'. From interviews, it emerged that employees understood the term 'package' only to refer to a combined quantity of strips (narrow coils). The suggestion made by the workplace instructions, therefore, is that in the case of a single wide coil, the use of securing arms is not necessary.

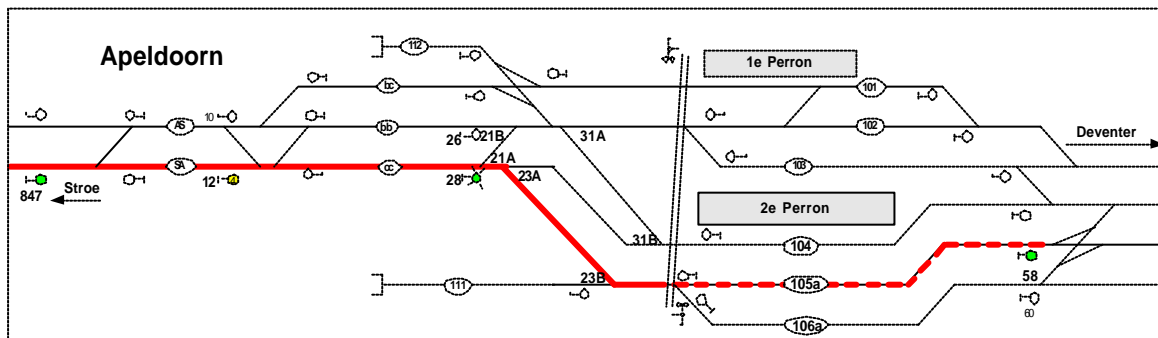
At Apeldoorn, the steel train was routed via track 105. Track 105 does not run alongside a platform and in practice is little used. This route takes in points 23A, for right-hand turnout. The maximum speed on this track is 40 kilometres per hour. The main track through Apeldoorn station is track 104; via points 23A with left-hand turnout. The maximum permitted speed along this track is 60 kilometres per hour.

Figure 6 The Apeldoorn track complex: the red line shows the selected route for the goods train. The train came to a halt in front of the dotted section.

The setting of the route via track 105 with a set of 1:9 points and a maximum speed of 40 kilometres per hour cannot be viewed as an immediate cause of the accident. Setting of such a route is a standard process, and there were no deviations. However, if a route had been selected, along the direct track (track 104), the risk of derailment as a result of excessive speed would have been reduced. This is because Prorail indicates that the design of the infrastructure is so robust, that generally speaking, on a set of points of this type, a train will only derail at a speed of between one and half and two times the set maximum speed. If we do not take into account the shifting of the load, this means that via track 105, generally speaking, the likelihood of derailment only occurs at a speed of approximately 80 kilometres per hour, and via track 104 only at around 120 kilometres per hour. This means that in this respect, track 104 offers a substantially higher safety margin.
