THROUGH RED AT AMSTERDAM CENTRAL

(21 May 2004)

The Hague, June 2005

THE DUTCH SAFETY BOARD

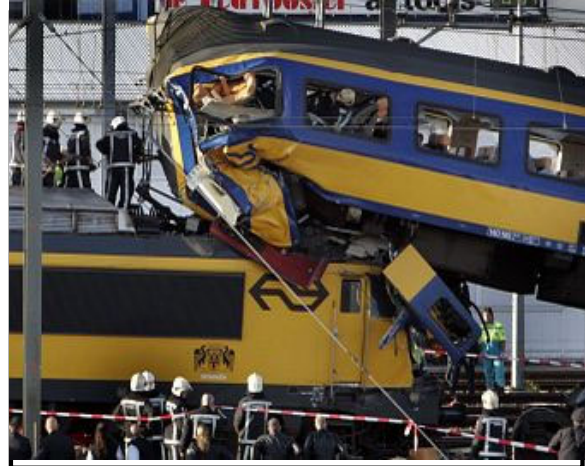
Figure 1: The first carriage behind the locomotive of the intercity train, as it came to rest.

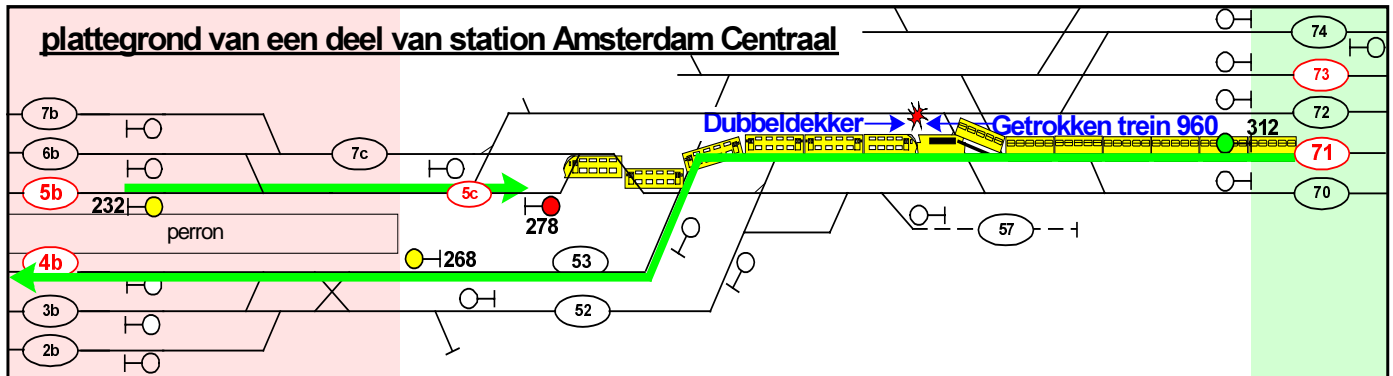
Figure 2: On 21 May 2004, an empty double decker train, following its departure, passed through signal no. 278 at red, and collided head-on with an incoming intercity from Utrecht. For the intercity, a complete route was set from track 71 (open track) to track 4b (platform track). For the double decker, a subroute was set from track 5b (platform track) as far as signal 278 (gridiron). The train was required to transfer to track 73 (open track: the continuous automatically set route to the next station).

The train traffic controller wished to inform the driver of the departing double decker train that he had only been able to set a subroute, namely from track 5b as far as signal 278 (see figures 2 and 3). At that same moment, the train traffic controller saw on his screen that the double decker train had incorrectly passed the red signal 278.

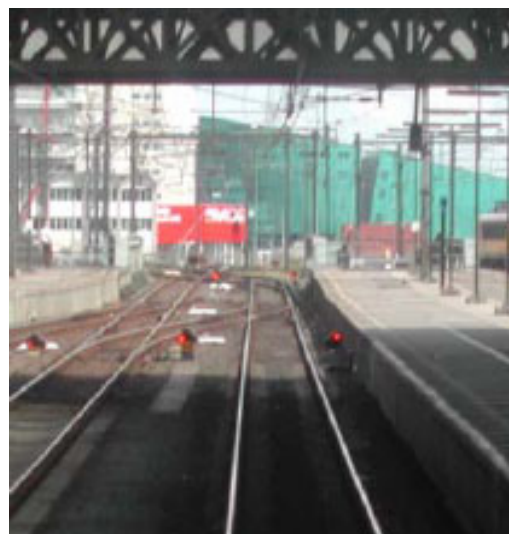
The driver of the double decker train saw signal 232 on track 5b switch from the stop setting (see figures 2 and 3). The driver set the train in motion, and switched to the permitted speed of 40 km/hour.

Figure 3: The view of the driver of the departing double decker train from the cabin, when leaving before the route setting.

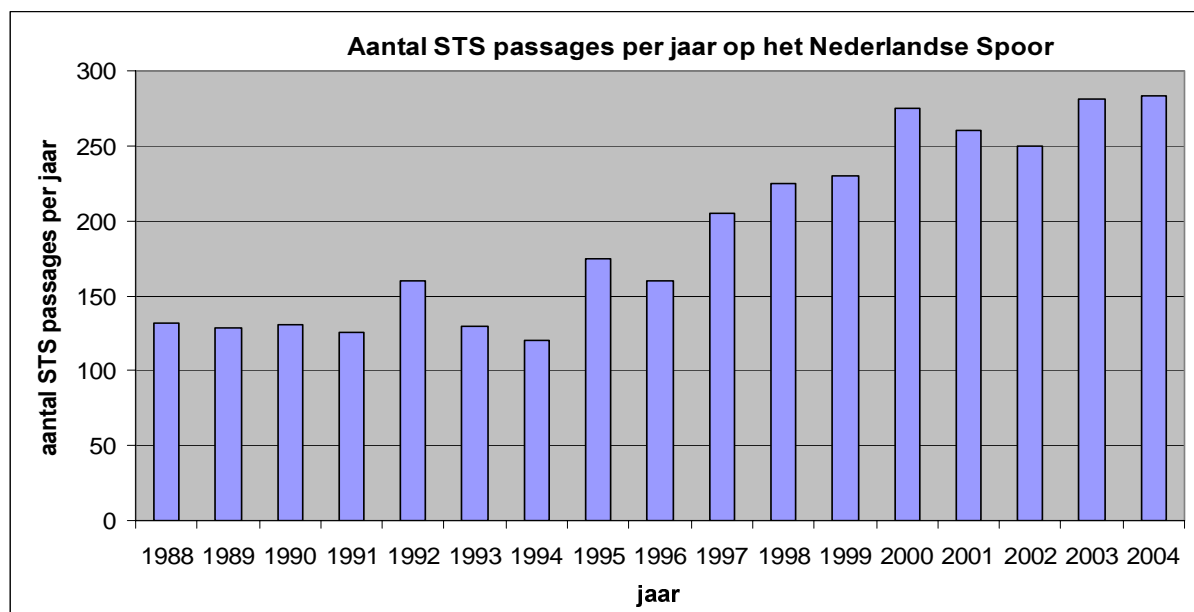
Figure 6: Number of red light passages (STS passages) on the Dutch railways in the period 1988 – 2004 [source IVW and RvTV study of Stop Signals by Railned, dated. 28-5-2001].

It may be concluded from figure 6 that a clearly upward trend is visible in the number of STS passages per year, whereby it is most notable that an alarming increase in the number of STS passages has emerged, since 1996. Over the last 7 years, the number of STS passages has almost doubled, whilst the number of train kilometres travelled⁹ has risen by only 10 percent, over the same period.

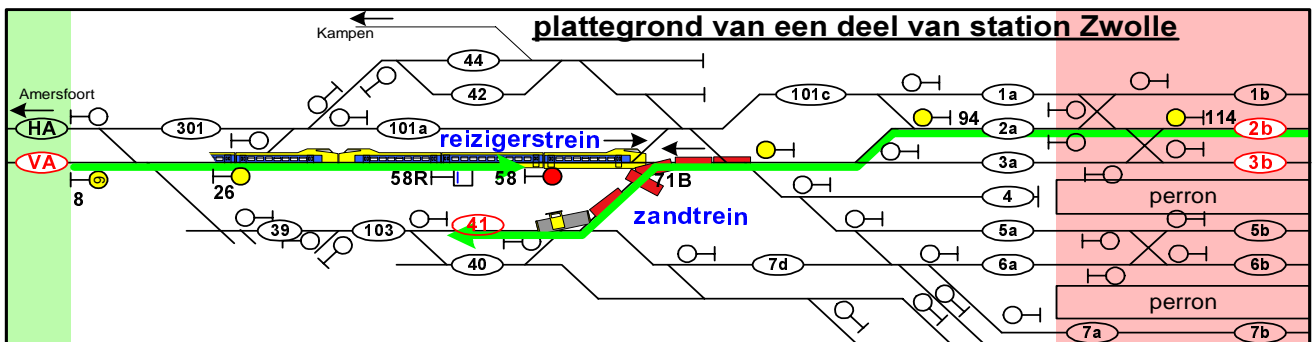
1. Zwolle 21 May 2001

Figure B2: Diagrammatic situation. On 21 May 2001, an incoming passenger train passed stop signal 58 and collided at point 71B laterally against a goods train with 22 wagons full of sand. For the sand train from Meppel, a route had been set via track 2b to track 41 and for the passenger train a route from track VA to signal 58. The train had to continue on to track 3b (the tracks and trains are not drawn to scale). **Evaluation: This was a subroute in a gridiron, which should have been avoided.**

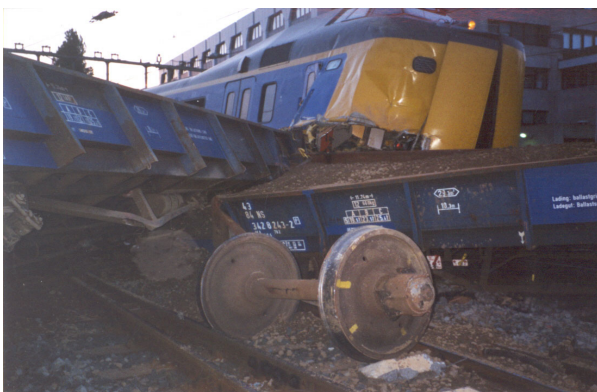
Figure B3. Zwolle 21 May 2001. Passenger train 569 passed red stop signal 58 and collided laterally with a goods train loaded with sand, travelling in the opposite direction.

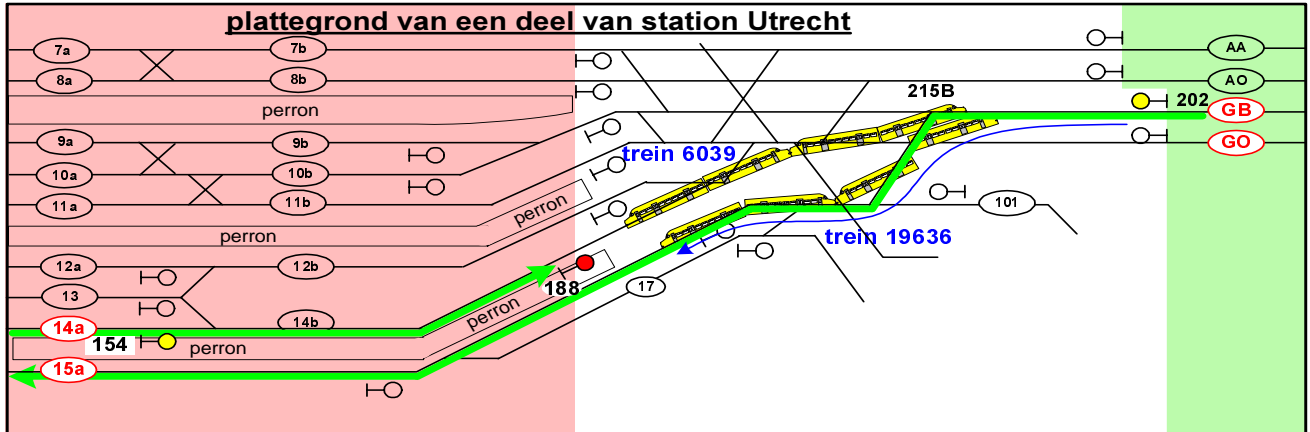
2. Utrecht 13 June 2001

Figure B4: Diagrammatic track situation. On 13 June 2001, passenger train 6039 passed stop signal 188 and at point 215B collided laterally with the incoming passenger train 19636. On the incoming train, the last carriage broke off at the bellows. For this train, a route had been set from track GB to track 15a. For the departing train, a route had been set from track 14a to signal 188. The train was set to continue on to track GO. **Accident evaluation: This was a subroute, which under no circumstances is permissible. The subroute was automatically set.**

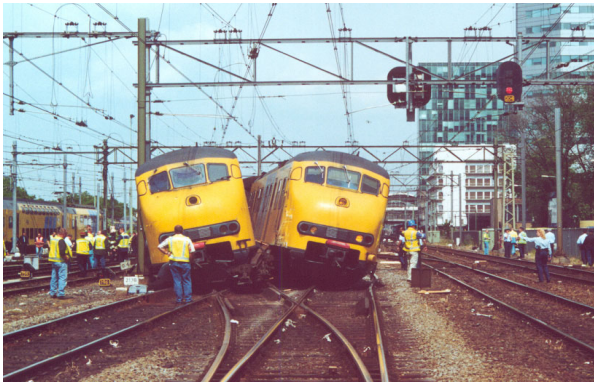
Figure B5.

Utrecht 13 June 2001. Flanking collision at points 215B. On the right the front of the departing passenger train 6039, which passed through stop signal 188. On the left the rear of passenger train 16936 for which a route had been set from outside the station to past the platform on track 15.

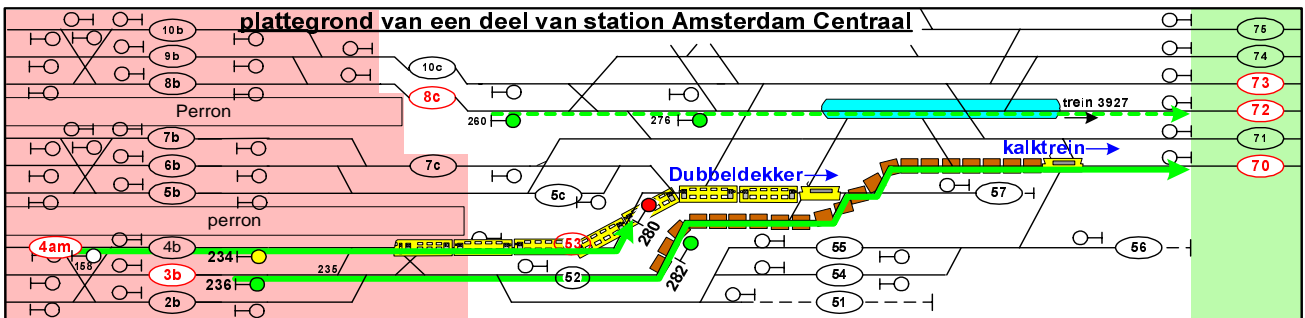
3. Amsterdam 27 November 2001

Figure B6: Diagrammatic track situation. On 27 November 2001, an empty double decker train, following departure, passed stop signal 280 and collided laterally against a departing lime train. For the lime train, a route had been set from track 3b to track 70 and for the double decker from track 4am to track 53. From track 8c, a passenger train had departed to track 72, as a result of which the double decker could not continue from track 53 to track 73. **Accident evaluation: This was a subroute, which should have been avoided.**

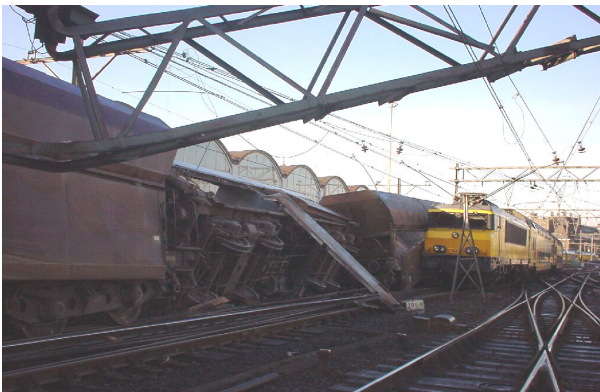
Figure B7.

Amsterdam 27-11-2001. On the right the double decker passenger train which after passing stop signal 280 collided with the unladen lime train. Wagons of the goods train derailed. The catenary was brought down.

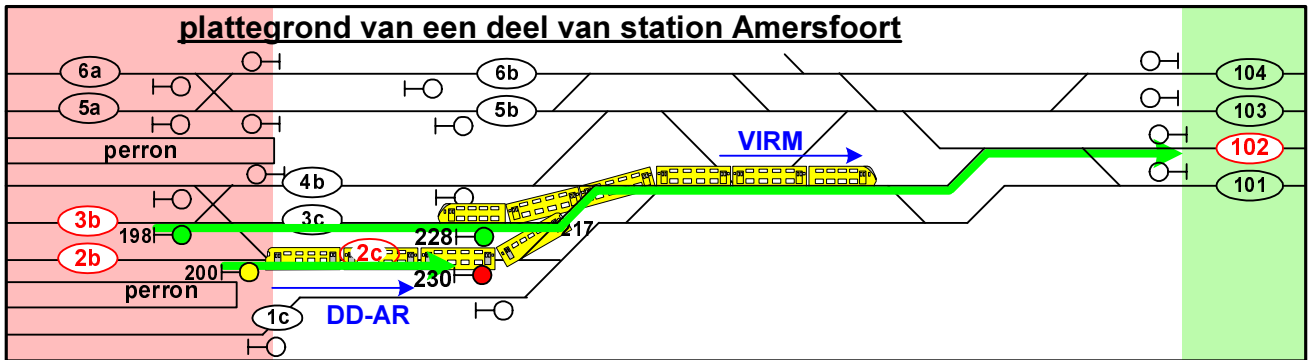
4. Amersfoort 26 June 2002

Figure B8: Diagrammatic track situation. On 26 June 2002, a double decker passenger train (DD-AR) passed stop signal 230 and collided against the flank of an empty double decker train (VIRM). In this diagram, the moment is indicated whereby the trains touched and collided with one another. The VIRM continued to travel a short distance. For the VIRM, a route was set from track 3b to track 102. The DD-AR had to travel from track 2b also to track 102. **Accident assessment: This was a subroute, which should have been avoided.**

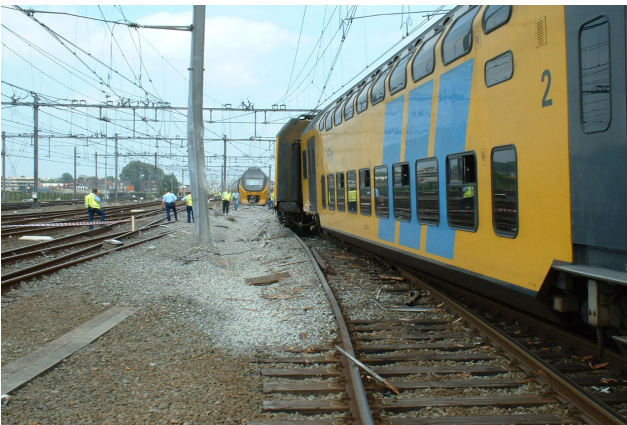
Figure B9.

Amersfoort 26 June 2002. Passenger train 5645 (DD-AR right) passed stop signal 230 and subsequently collided with the flank of test train 82172 (VIRM in the centre of the photograph). The last carriages of the VIRM derailed to the left, and found their way between the catenary support column and passenger train.

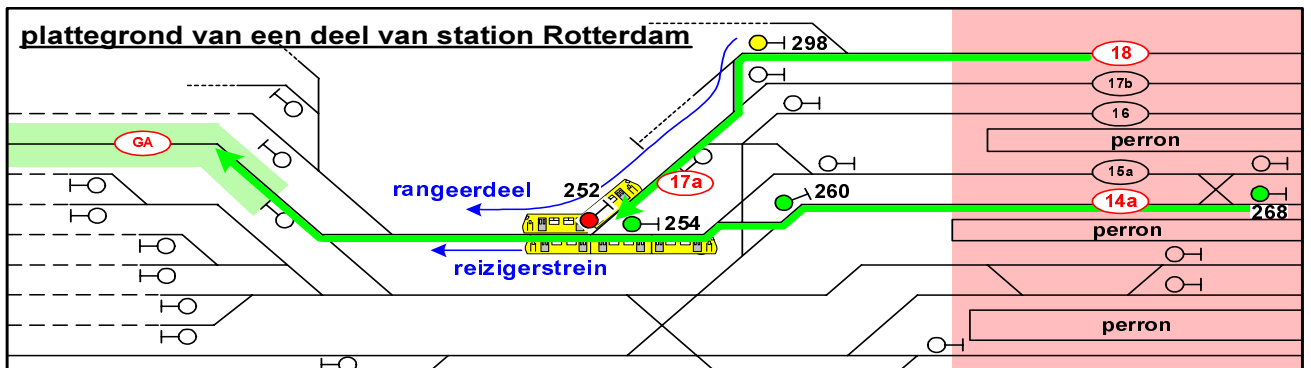
Figure B10: Diagrammatic track situation. On 16 September 2002, a shunting unit (sprinter II) passed stop signal 252 and collided at point 253 against the flank of a departing passenger train (sprinter III). A route had been set for the passenger train from track 14a to track GA. For the shunting unit, a route was set from track 18 to track 17a. The shunting unit had to transfer to track GA and then back to platform track 3. **Accident assessment: This was a subroute which should have been avoided.**

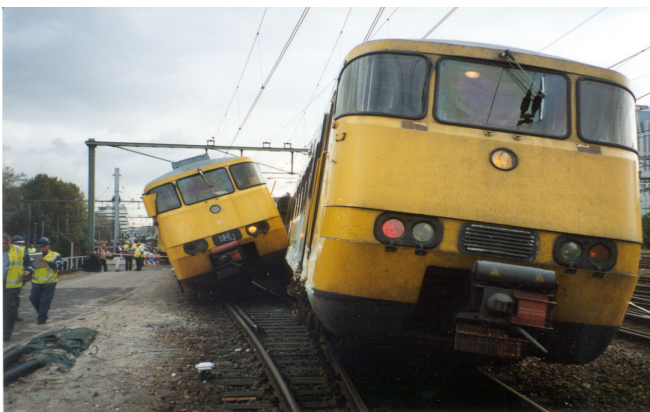
Figure B11.

Rotterdam 16 September 2002. On the left the front of the shunting unit which passed stop signal 252. On the right the front of passenger train 9731, which was hit in the flank by the shunting unit.

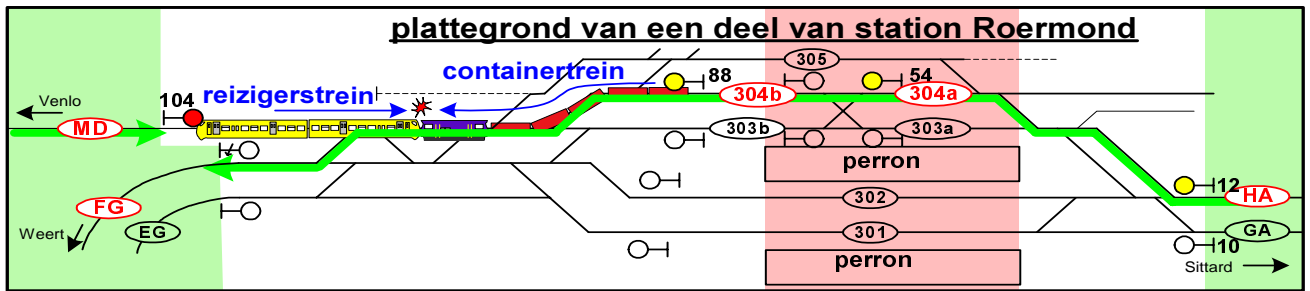
Figure B12: Diagrammatic track situation. On 20 March 2003, a passenger train passed the station entry signal 104, at red. For a goods train with containers, which arrived 4 minutes early, a route was set from track HA via track 304ab to track FG. The passenger train collided head on with the container train. In these accidents, "Roermond" was added, but no actual subroute was set. However, a pre-programmed route was used in this case. **Accident assessment: Use was made of a planned route via track 304ab, not a subroute. There was an alternative route available via track 301 (302 was not available).**

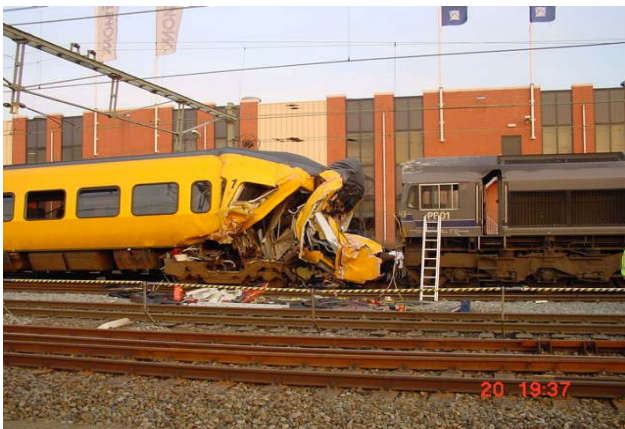
Figure B13.

Roermond 20 March 2003. Passenger train 16337 passed stop signal 104, and collided head on with a laden goods train.

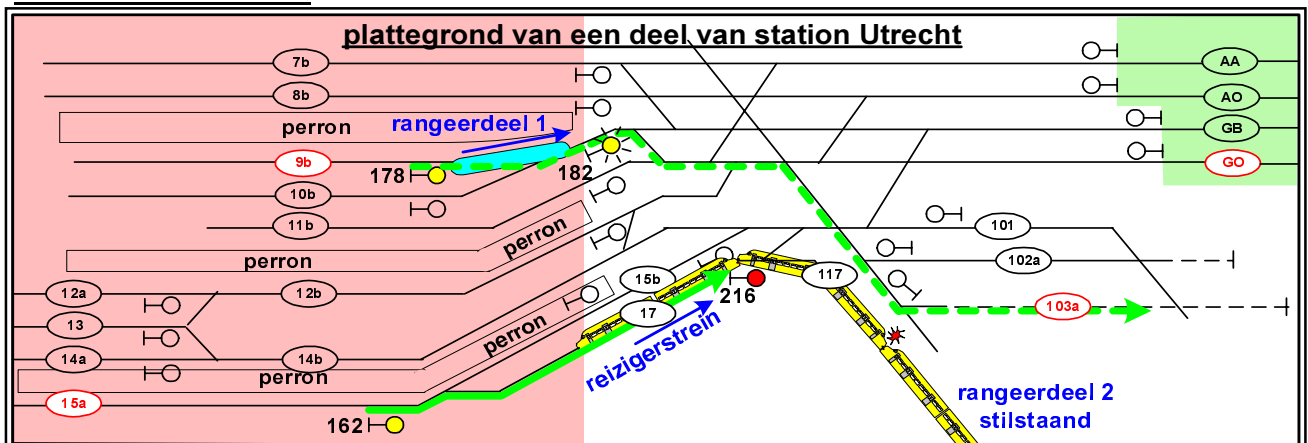
7. Utrecht 17 June 2003

Figure B14: Diagrammatic track situation. On 17 June 2003, a departing passenger train passed stop signal 216. For the passenger train, a route was set from track 15a to track 17. The train had to transfer to track GO. For a shunting unit (1), a route was set from track 9b to track 103a. On track 117, another shunting unit (2) was standing ready. The passenger train collided head on with the stationary shunting unit. **Assessment: This was a subroute which should have been avoided.**

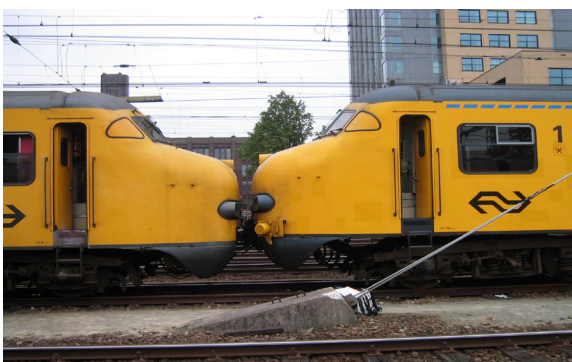
Figure B15.

Utrecht 17 June 2003. Passenger train 19645, after leaving track 15a, passed through stop signal 216 on track 17 and collided with a stationary shunting unit of the same stock, on track 117.

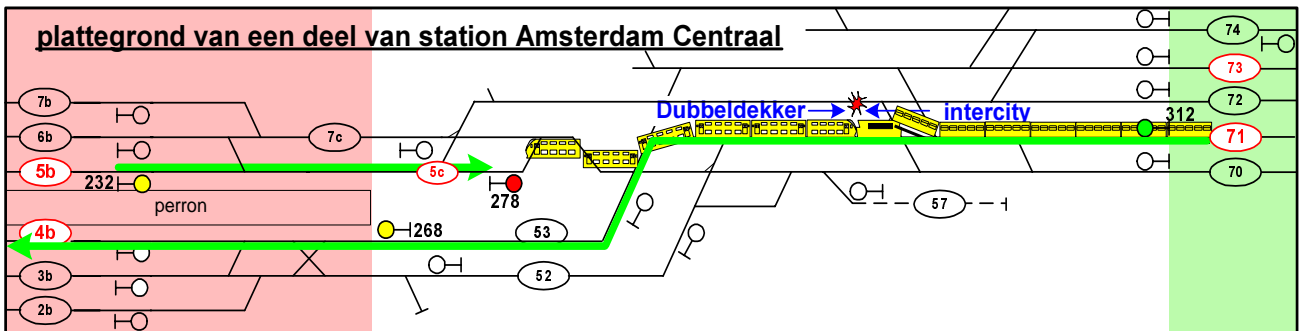
8. Amsterdam 21 May 2004

Figure B16: Diagrammatic track situation. On 21 May 2004, an empty double decker train, following departure, passed stop signal 278 and collided head on with the incoming intercity from Utrecht. For the intercity, a route was set from track 71 to track 4b. For the double decker train, a route was set from track 5b to track 5c as far as signal 278. The train had to transfer to track 73.
Assessment: This was a subroute which should have been avoided. For the double decker, an alternative route was available.

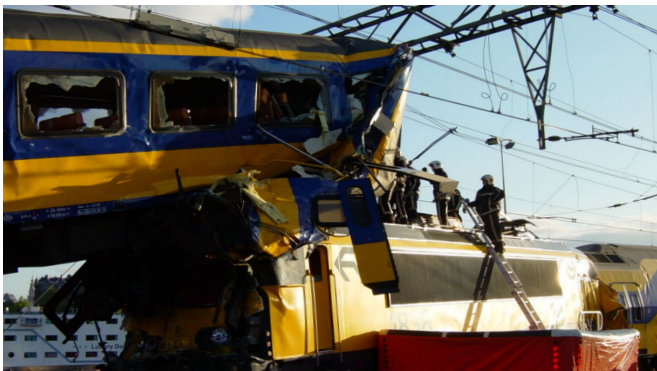
Figure B17.
 Amsterdam 21 May 2004. Train 80761 (empty double decker train VRM), following departure, passed stop signal 278. The double decker (right on the photograph) collided head on with the incoming intercity 960 from Utrecht. The first carriage of this passenger train was lifted up and folded double on the roof of the locomotive.

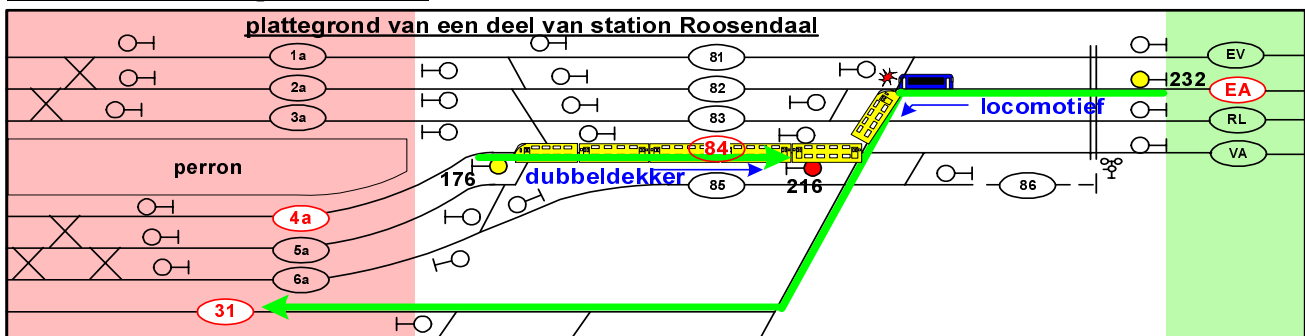
9. Roosendaal 30 September 2004

Figure B18: Diagrammatic track situation. On 30 September 2004, a double decker train, following departure, passed signal 216. For this train, a route had been set from track 4a to track 84. The train had to transfer to track VA. For a Belgian locomotive, a route was set from track EA to track 31. The two trains collided head on with one another. **Assessment: This is a subroute which should have been avoided.**

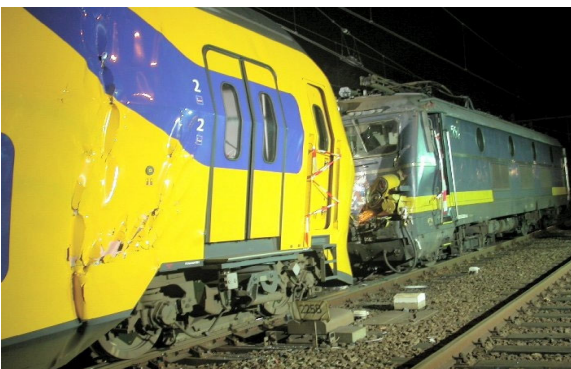
Figure B19. Roosendaal 30 September 2004. Following departure, passenger train 2163 passed stop signal 216 and collided head on with the incoming locomotive. On the left the passenger train with a kink in the crumple zone behind the platform. On the right the crumpled locomotive.

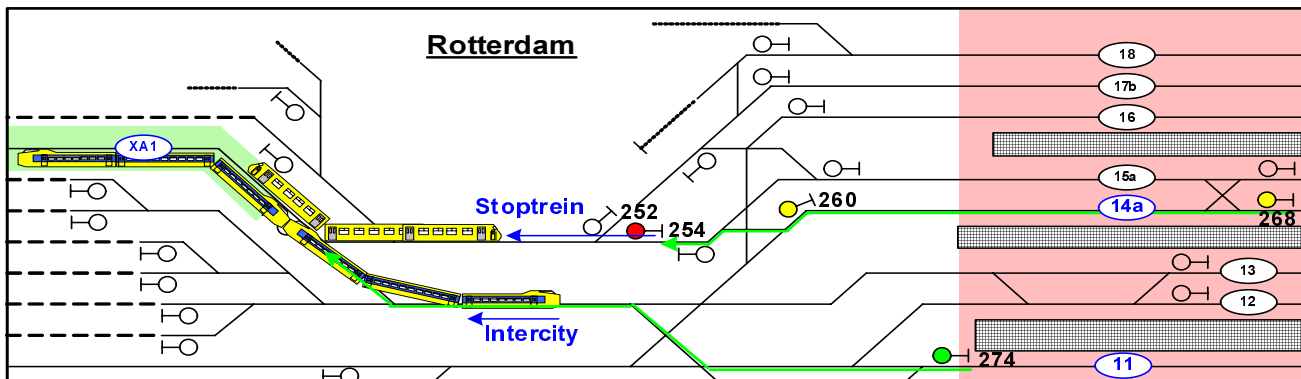
10. Rotterdam 11 February 2005

Figure B20: Diagrammatic track situation. On 11 February 2005, a stopping train (sprinter III) passed stop signal 254 and collided with the flank of an Intercity (2 train sets ICM-3). For the Intercity, a route was set from track 11 to track XA1. For the stopping train, a route was set from signal 268 to signal 254. **Accident assessment: This was a subroute which should have been avoided.**

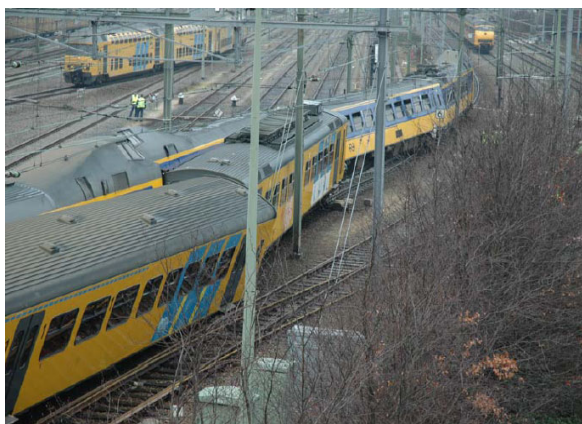
Figure B21.
Rotterdam 11 February 2005. On the right the front section of stopping train 9725 (sprinter), which passed stop signal 254 and collided with the right flank of intercity 21723 (ICM).
