# The Dutch Safety Board

**Occurrence #:** 2002086 **Classification:** Accident

## FACTUAL INFORMATION

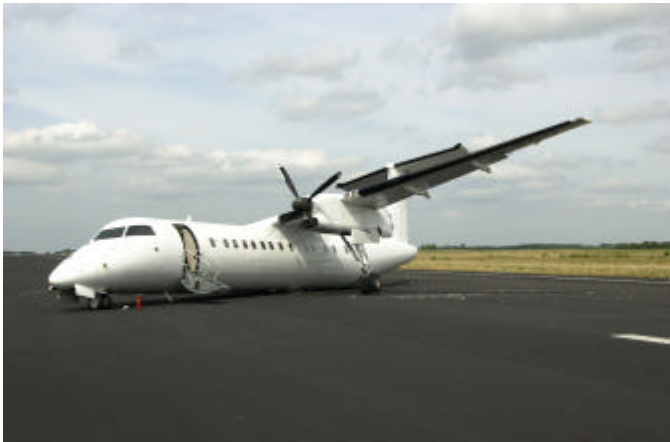
The PH-SDU after the accident

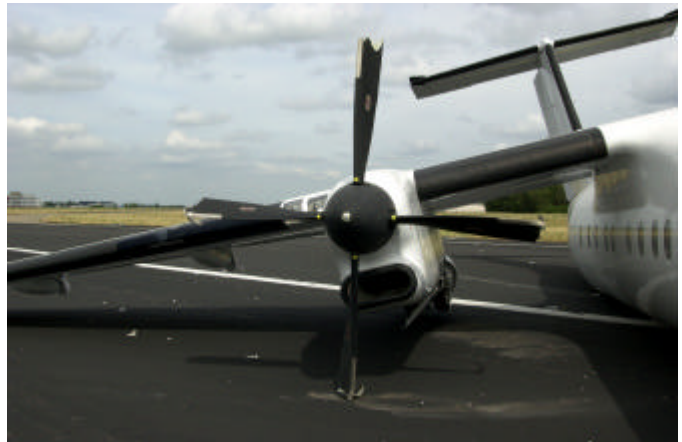
The damaged right-hand side

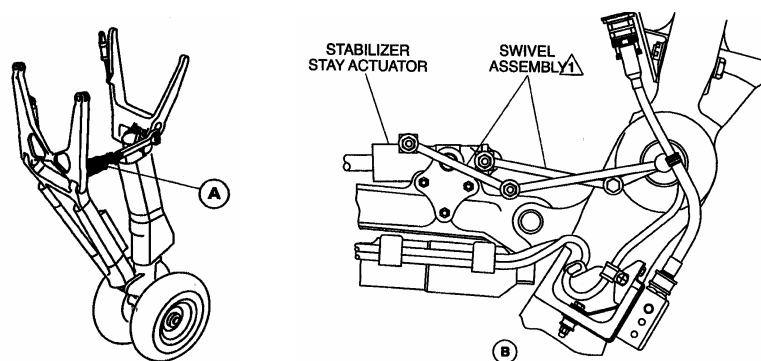
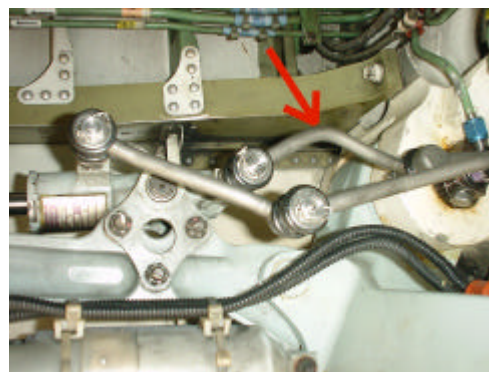
The incident flight was the first after right-hand landing gear change. Investigation revealed that the problem was caused by an upside down installed hydraulic swivel assembly.

The bent swivel tube (red arrow)

During gear retraction one of the swivel tubes was bent (see arrow in figure) as a result of which the landing gear could not get in the mechanical lock position. It is still unclear why the problem was revealed not until the test flight. After the gear change the wheels were retracted and extended a number of times in the hangar. All those times the mechanism functioned trouble-free.

A team of three experienced mechanics had carried out the gear change in which each others work was checked mutually. For the mechanic that installed the swivel tube it was the first gear change on this type of aircraft. It turned out that the swivel tube could be fitted in two ways, from which only one was correct. The inspection after the activities had concentrated primarily on general oil leakage and lock wiring, not on assembly direction of the swivel tube. None of both other mechanics was consequently aware of the reversed assembly. As far as known two more cases occurred worldwide of reversed assembly. The manufacturer of the aircraft has adapted the Aircraft Maintenance Manual as a result of the incident in Maastricht. A warning was entered in it and the installation was explained in more detail.
