De Onderzoeksraad voor veiligheid

Nummer voorval: 2002109

Ernstig incident

Datum voorval:	29-07-2002	Fase van de vlucht:	En Route
Plaats voorval:	Vliegveld Teuge	Bemanning:	1
Soort vlucht:	Overlandvlucht	Passagiers:	Geen
Registratienummer:	PH-SPC	Letsel:	Geen
Type luchtvaartuig:	Grob G 115	Schade aan luchtvaartuig:	Licht beschadigd
Soort luchtvaartuig:	Eenmotorig propellervliegtuig	Weerscondities:	Niet van invloed op voorval

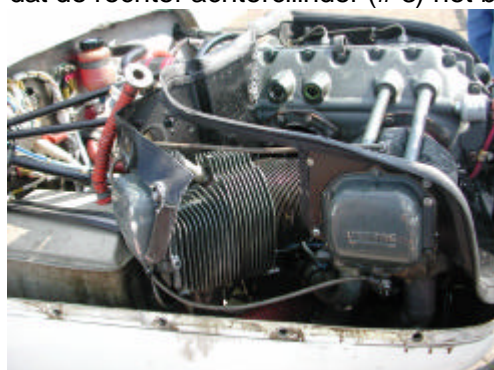
De PH-SPC beschikt over een viercilinder Lycoming O235-H2C motor met 110 PK. Nader onderzoek leerde dat de rechter achtercilinder (# 3) net boven de cilindervoet was afgebroken. De zuiger was vastgelopen in de cilinder en de drijfstang was ernstig vervormd. Verder waren de ophangrubbers van het motorblok ingescheurd door de hevige trillingen. Er was nog zo'n halve liter olie in het motorblok aanwezig van de ruim 4 liter die er in behoorde te zitten. De vlieger verklaarde dat hij op Hoogeveen de oliehoeveelheid had gecontroleerd en dat die binnen de limieten lag. Macroscopisch en microscopisch onderzoek wees uit dat de cilinder was afgebroken als gevolg van corrosie van buitenaf. Door verzwakking van het materiaal kon onder belasting scheurvorming optreden wat uiteindelijk resulteerde in het compleet afbreken van de cilinder. Waarschijnlijk is dit laatste gebeurd vlak voor de landing waarna de olie was weggelopen.
