Identification number:	2005134
Classification:	Accident
Date, time <sup>1</sup> of occurrence:	19 September 2005, 07.30 hours
Location of occurrence:	Rotterdam Airport (EHRD)
Aircraft registration:	PH-DYM
Aircraft model:	F-Swearing SA227-AC
Type of aircraft:	Twin-engined passenger aircraft
Type of flight:	Passenger flight
Phase of operation:	Take-off
Damage to aircraft:	Severe
Cockpit crew:	Two
Number of Passengers:	Seventeen
Injuries:	One passenger sustained minor injuries
Other damage:	None
Lighting conditions:	Daylight

During the take-off, the cockpit crew lost steering control and the aircraft came to a standstill alongside the runway. One passenger sustained minor injuries.

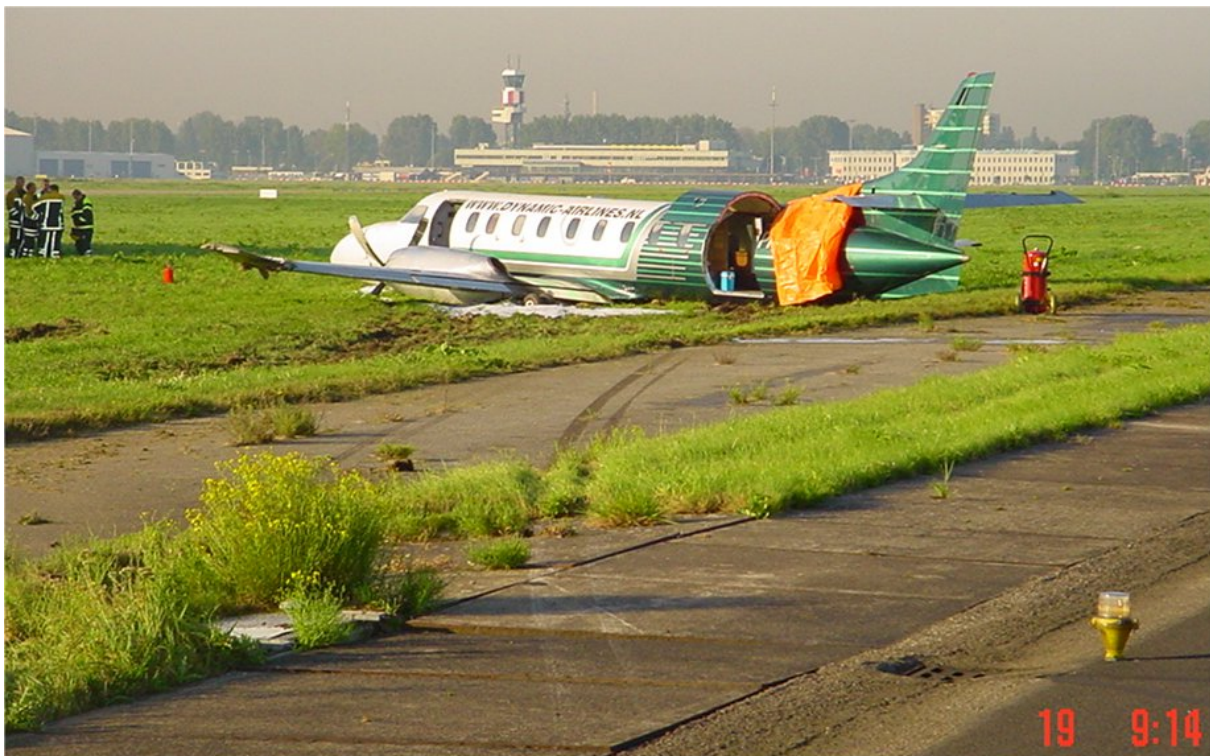
Figure 1: PH-DYM shortly after the accident

The grass area alongside the runway is lower than the runway and the ground was soft. The left landing gear sank in the soft ground first and, as a result, the aircraft decelerated heavily and the left landing gear broke off almost immediately. The tip of the left wing struck the ground. This caused a ground loop effect and turned the aircraft further left. As a consequence the right landing gear and the nose gear also broke off.

There was severe damage despite the relatively slow speed at which the aircraft left the runway.

The National Aerospace Laboratory investigated the effectiveness of the nose wheel steering system of PH-DYM in order to ascertain any defects. The study showed that a hydraulic leak in the nose wheel steering system meant that the system remained active after the nose wheel switch had been released. The system was, therefore, not being steered by commands via the rudder pedals and the leak resulted in an uncontrolled steering command to the left.

This accident was caused by an hydraulic leakage in the nose wheel steering system. The tyre tracks on the runway implied that the steering problem had occurred from the beginning of the take-off. The crew intervened as soon as after the nose wheel switch had been released and the nose wheel steering fault came on but were unable to prevent the aircraft leaving the runway.

It is noteworthy that a leak such as this will always lead to a rotation of the nose wheel. A nose wheel system must be designed as such that the nose wheel will remain in a neutral position or is 'free' to move when a defect like this occurs. This will enable pilots to steer the aircraft by varying the brake pressure on the right and left hand landing gear.

The original aircraft manufacturer of this aircraft no longer exists. The type certificate and technical support went over to another company. This company is aware of the problems with the nose wheel steering. It informed all users of this aircraft type about these problems in September 2009 and provided maintenance instructions that would prevent this type of problem from recurring. The main point of this instruction is that the manifold and arming valve must be replaced as an assembly. Replacement of the arming valve without changing the manifold can result in a leakage causing a slow uncommanded turning of the nose wheel.
