GENERAL INFORMATION

Identification number:	2005142
Classification:	Serious incident
Date, time ¹ of occurrence:	23 September 2005, 11.24 hours
Location of occurrence:	Amsterdam Schiphol Airport
Aircraft registration:	PH-KCG
Aircraft model:	Boeing MD-11
Type of aircraft:	Passenger aircraft
Type of flight:	Commercial air transport
Phase of operation:	Take-off
Damage to aircraft:	None
Cockpit crew:	Unknown
Passengers:	Unknown
Injuries:	None
Other damage:	None
Light conditions:	Daylight

SUMMARY

A MD-11 aircraft received take-off clearance for runway 24. During the take-off run a bird control vehicle got a clearance and crossed runway 24. Both the MD-11 and the vehicle continued their path uneventfully.

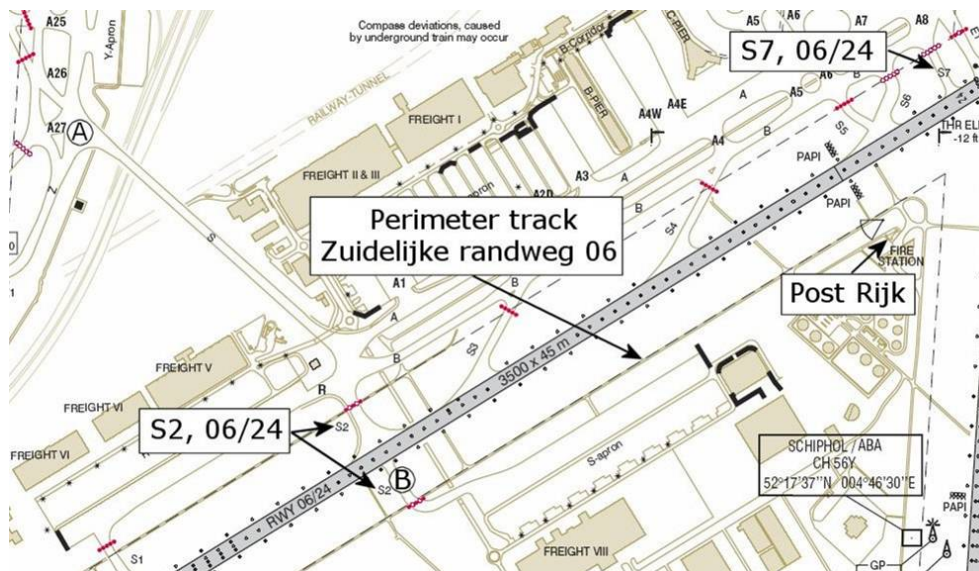
Figure 1: ground movement chart for EHAM as published in the Netherlands AIP

The bird controller (call sign 'Kievit 1') reported that he had driven from Post Rijk along the perimeter track, Zuidelijk Randweg 06, towards S2 with the intention to cross runway 06/24. During this timeframe the runway controller had cleared the MD-11 for take-off. Kievit 1 stopped his vehicle about three meters from the end of the perimeter track on the taxiway at S2 (south). At this position, he described the vehicle as being between the stop bar and the runway. This position is indicated as 'B' in figure 1.

The assistant 2 did not observe the Kievit 1 at position B as he checked the northern end of taxiway Sierra (towards position A) because in his view he expected to see Kievit 1 there. As taxiway Sierra was clear of traffic he approved the request of Kievit 1, which in his conviction was to drive along taxiway Sierra in a southerly direction.
