**Loss of steering on a
slippery taxiway**
of the Easyjet Boeing B737-700,
registration G-EZJM,
at Amsterdam Airport Schiphol
on 22 December 2003

The Hague, (investigation number 2003133)

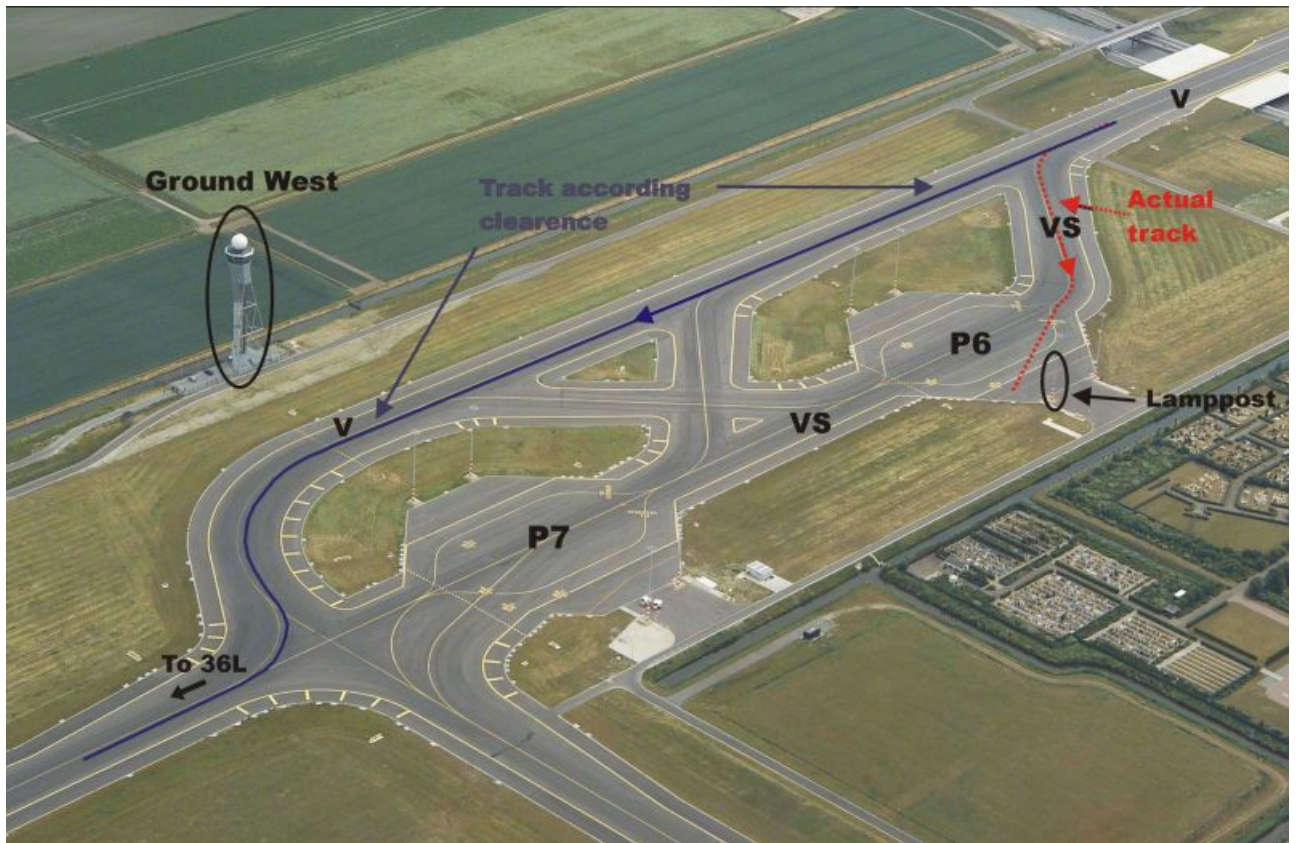
Figure 1: aerial photo of the route and the place of the accident (photo KLPD)

When the aircraft had made the turn towards taxiway VS, it appeared that the aircraft no longer responded to the steering and skidded towards the left side of the taxiway. There the aircraft collided with its left wing against a lamppost. Taxiway VS and the de-icing area P6 located there both turned out to be completely covered with ice. Both the aircraft and the lamppost were seriously damaged.

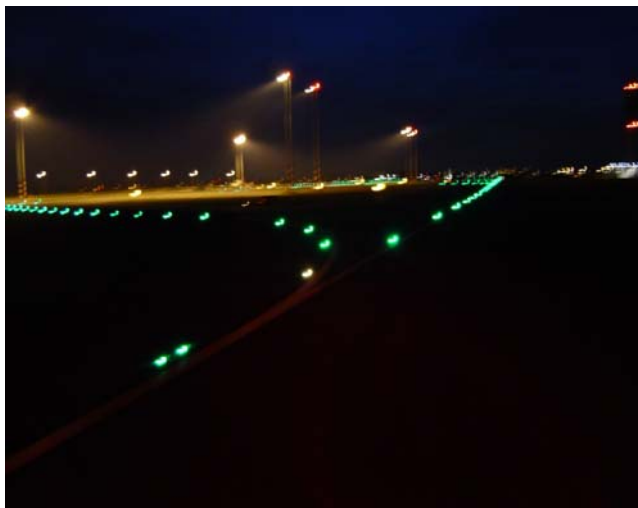
Figure 4: Fork of V and VS with P6 (left)

AAS has divided the airport into 13 service areas. The lighting is operated per service area. Taxiways V and VS are situated in service area T. It appears from the information of AAS that all the taxiway lighting in service area T was illuminated at the time of the accident and was burning with strength of 10%. According to the information of an employee of the airport that was a normal strength considering the prevailing visibility conditions.

Also the apron lighting of the de-icing aprons P6 and P7 were illuminated. No rules have been drafted with regard to the use of apron lighting.
