# The Dutch Safety Board

<b>Occurrence no:</b>	<b>2004078</b>	<b>Classification:</b>	<b>Accident</b>
-----------------------	----------------	------------------------	-----------------

Date of the occurrence:	24 May 2004	Cockpit crew:	1
Place of the occurrence:	Den Helder Airport	Flight experience:	8030 hours of which 357 hours on type
Aircraft registration:	ES-YLL	Passengers:	1
Aircraft model:	L-39 Albatros	Injuries:	None
Aircraft type:	Single engine jet	Lighting conditions:	Daylight
Type of flight:	Ferry		
Phase of operation:	Take-off		
Damage to aircraft:	Serious

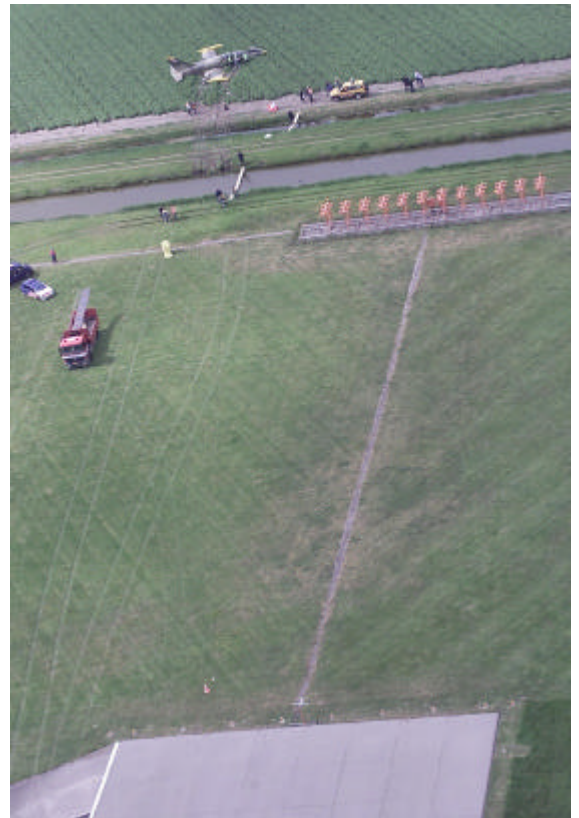
The pilot succeeded in getting the aircraft past two ditches located behind the runway, after which the aircraft came to a standstill in a field with flower bulbs outside the airfield. The pilot flying and the passenger were able to leave the aircraft uninjured. The aircraft was seriously damaged.

*The end of the runway with the ES-YLL after the accident*

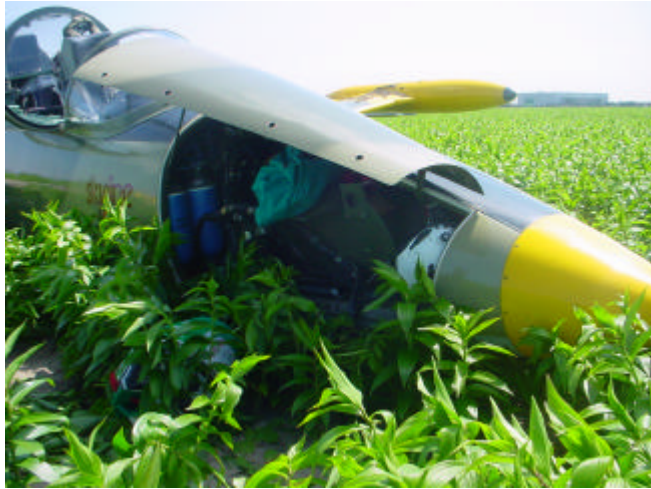
*The open hatch after the accident*

The pilot flying stated he had put the luggage in the nose and had closed the right-hand hatch after that. He stated he had turned the four locking screws with a quarter turn, until it was impossible to turn any more. For him, this was a sign that the hatch was closed well. He did not check this by feeling the hatch. Upon investigation after the accident it became apparent that the right-hand hatch was not shut. Moreover, it appeared that an item of clothing, a coat, had been sucked from the space into the engine through the right-hand air intake and partly closed the front side of the compressor. A second item from the compartment, a bag, was found on the runway. Upon further investigation in the hangar, it became apparent that the fastening functioned well. Provided the four locking screws fell in the recesses and were

turned with a quarter turn, the latch could no longer be opened. It took a certain degree of force and dexterity to make sure the screws fell into the recesses and to subsequently turn them. It is possible to turn these locking screws with a quarter turn without them falling in the fastening and therefore not closing the hatch. This only becomes apparent upon a manual verification to check whether the hatch has indeed been closed.

The accident occurred because the right-hand hatch was not shut, because of which after the start a coat was sucked into the luggage space and got into the right-hand air intake at the compressor's front side. This prevented the engine from supplying enough power. After the emergency landing it became apparent that the remaining runway length was insufficient to bring the aircraft to standstill in time.

It appeared that it had already happened twice that the company carried out a flight while one of the hatches was not closed. However, this had had no consequences for those flights. In the meantime the company has installed a warning system that indicates when a hatch has not been closed (well). In 2003, a similar accident occurred in the USA, and the pilot died in it.
