**Den Helder, chlorine gas intoxication in the  
"Bever" damage simulator on 4 July 2005**

The Hague, 16 May 2006, reference number: M2005DF0705 01  
The reports of the Dutch Safety Board are public. All reports are also available on the website of the Dutch Safety Board: [www.onderzoeksraad.nl](http://www.onderzoeksraad.nl)

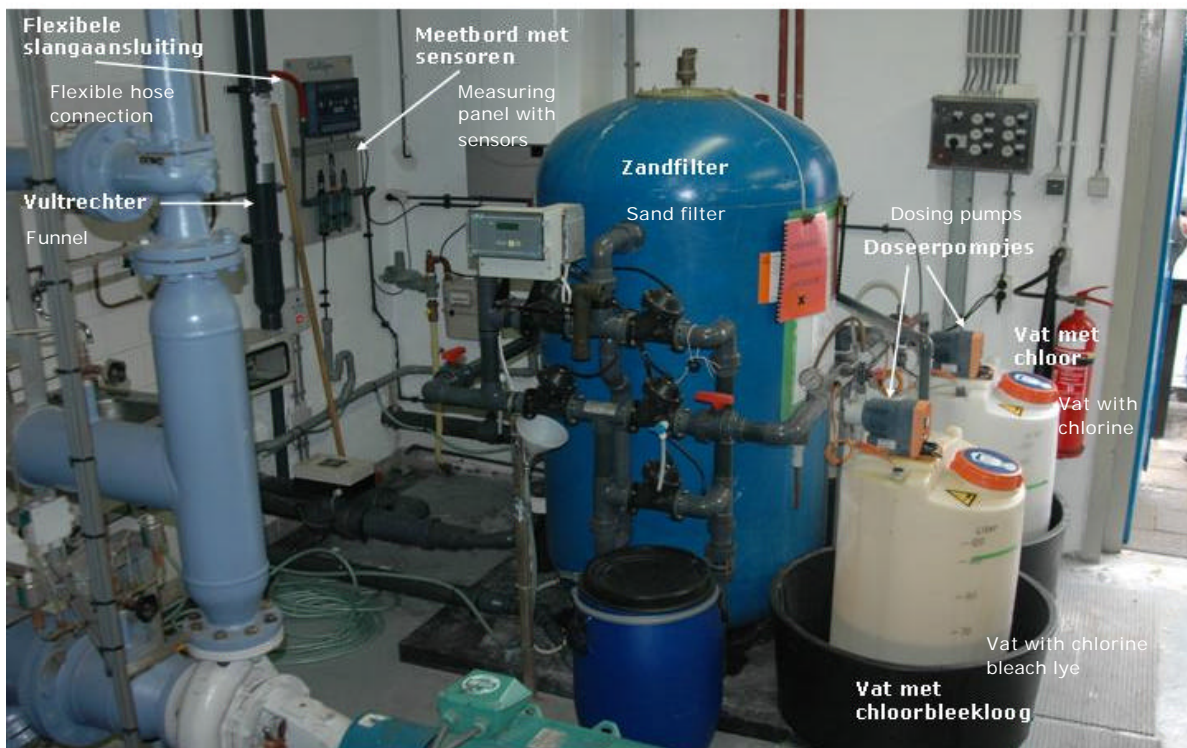
Illustration 5. The water treatment installation<sup>8</sup>

the buffer capacity had decreased such that chlorine gas was present in the water. The chlorine gas was released from the water when water flowed from the cracks and holes in the simulator.

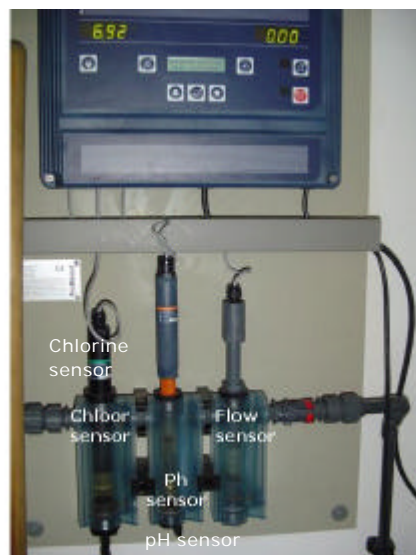
Illustration 6. The measuring plate with sensors

The flow sensor of the measuring and regulating system was jammed. This meant that a flow was constantly being signalled, which led to excessive amounts of acid and chlorine bleach lye being dosed. How the flow sensor came to be in the state it was found in could not be discovered. An inspection of the flow sensor revealed that it had been in this position for several weeks. If maintenance work had been planned and executed on the installation using a correct methodology, then the fact that the flow sensor was sending out the wrong signal would have been detected at any moment.

The measuring and regulating system serves to disinfect the water and continue to provide a disinfecting effect after the treatment by dosing the right quantity of chemicals. The addition of the two chemicals is supposed to be implemented in such a way that there is no build-up of chemicals in the water.

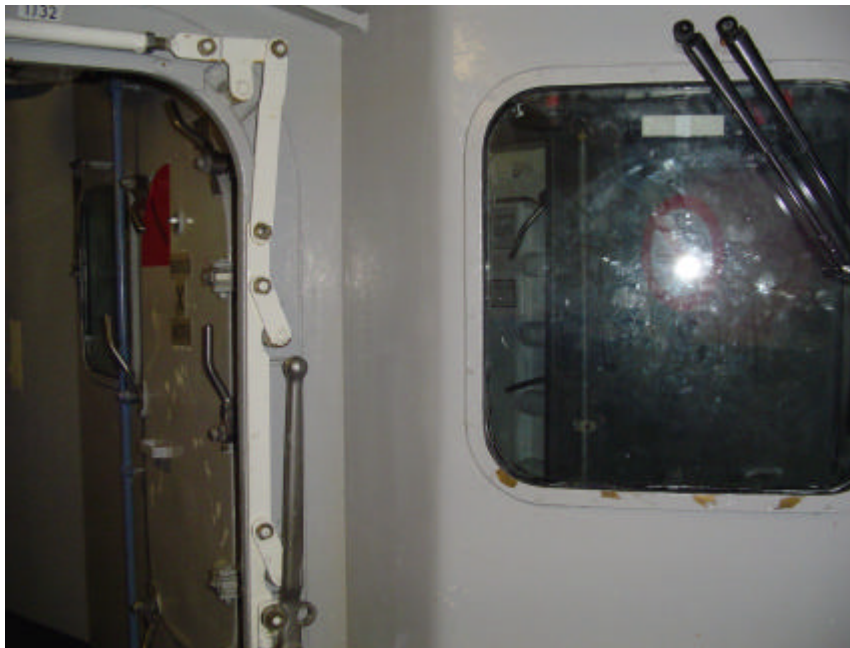
*Illustration 7. A control room seen from the training compartment*

The control rooms in the damage simulator where the instructors were, have their own ventilation system. The instructors in the control rooms cannot detect the presence of chlorine gas. The students were inexperienced and unfamiliar with the effects of chlorine gas. Since the instructors had no immediate clue as to the presence of chlorine gas in the training compartments, and given the inexperience of the students, there was a delay in recognising the problems and carrying out the evacuation.

There are two control rooms in the simulator (one per deck), from where the instructors coach the students and from where water can be transported to a number of specially installed "leaks" by means of a training water system or a mock fire extinguishing system. The ventilation for the control rooms is separate from that of the training compartments. The instructors cannot detect the chlorinated air experienced by the students. Two instructors were exposed to the chlorine gas during the evacuation of the "Bever".

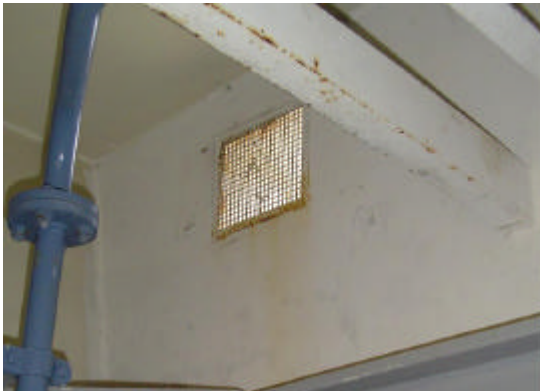
Illustration 8a. A ventilation grate

The simulator had only been equipped with a mechanical supply system. The air had to escape naturally through a number of grates in the walls of a number of compartments. With this particular ventilation system it is not possible to create triggered ventilation that would have been sufficient to remove the chlorine gas outside quickly.

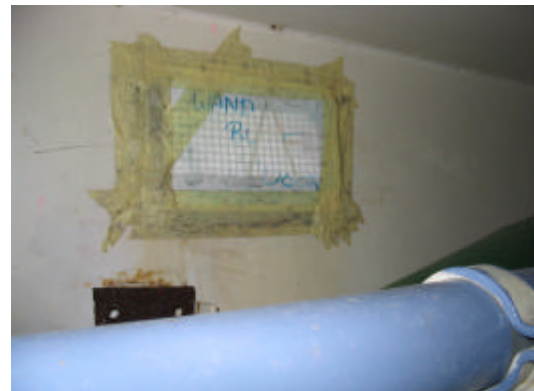
Illustration 8b. The taped-up grate<sup>13</sup>

Furthermore, in one of the simulator's compartments where students were working, a ventilation grate had been taped up as part of an earlier exercise involving divers. Since this grate was taped, the air supplied to the compartment could not be extracted adequately in the normal way. So, the air supplied and the chlorine gas present were being partly recycled through the simulator.

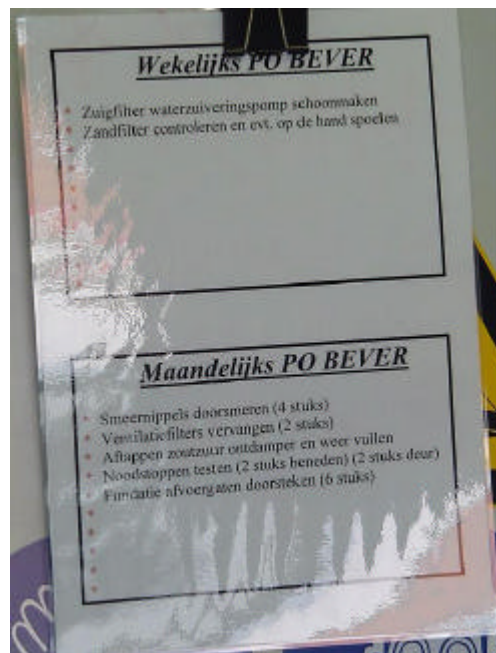
Illustration 8. A self-penned maintenance list

The maintenance to (the water treatment installation of) the "Bever" was not carried out using ILS but was performed with the help of lists drawn up over time by the personnel of the school themselves on the basis of merely general technical acumen.
