# The Dutch Safety Board

**Occurrence #:** 2003057

**Serious incident**

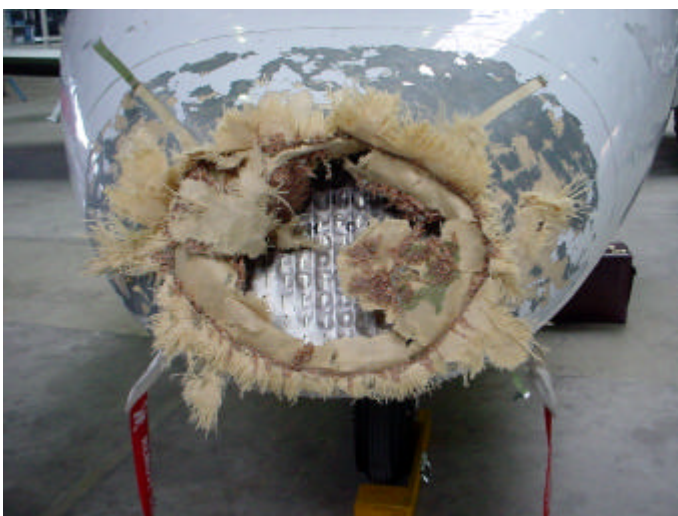
The destroyed fiberglass radome

Radar tapes showed that N18HJ flew straight through the center of a cumulonimbus resulting in the above mentioned damage.

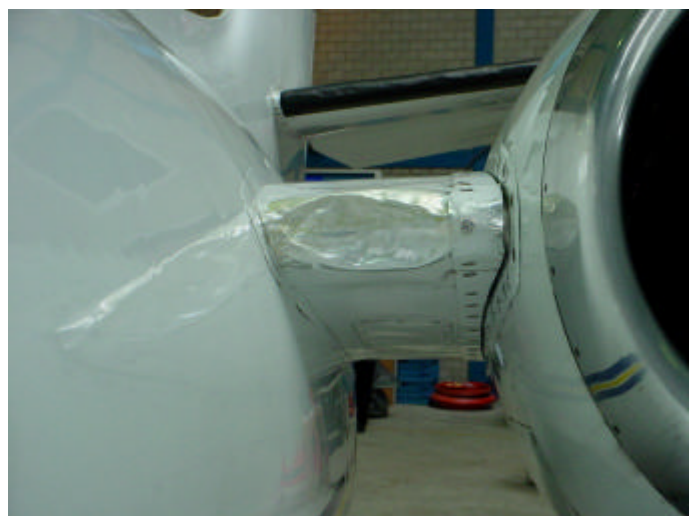
Dents in the aluminium sheet metal lining
