# The Dutch Safety Board

**Occurrence #:** 2005069                      **Classification:** Accident

Date of the occurrence:	20-05-2005	POB flight crew:	1
Place of the occurrence:	Kats	Flight experience:	Circa 650 hours total, circa 100 hours on type
Aircraft registration:	G-AJOE	POB passengers:	1
Aircraft model:	Miles M38 Messenger 2A	Injuries:	None
Aircraft type:	General Aviation Aircraft	Lighting conditions:	Daylight
Type of flight:	Cross-country		
Phase of operation:	En route		
Damage to aircraft:	Substantial

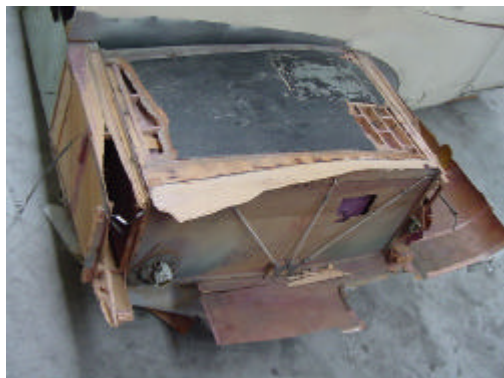
*Damaged right-hand fuselage*

with at that moment. According to the pilot he was flying at an altitude of 1,200 feet and was forced to make a tailwind landing. The field he had chosen was just planted with corn (mais). Due to the wind gusting to circa 25 knots, the planned touch-down point was over-shot. The aircraft landed fast, and on all 3 wheels in the selected field, but the pilot was unable to stop the aircraft before the end of the field. Adjacent to the landing field was a wide water dyke. In an attempt to try and skip over the dyke the pilot pull full stick at the last moment. This was partially successful, but unfortunately, the main wheels impacted against the opposing dyke bank side with full force, turning the right hand wing and undercarriage legs off.

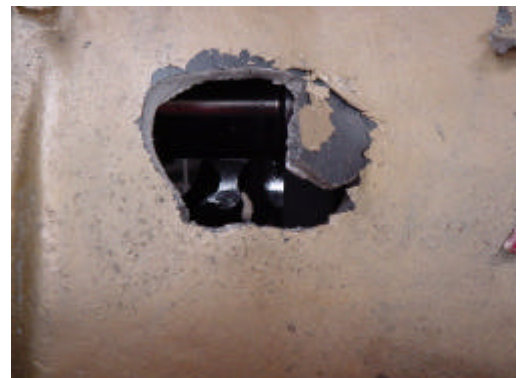
*Hole in engine casing*

Both occupants left the aircraft without injuries. The emergency services attended the scene within a few minutes. The aircraft was substantially damaged (insurance write-off). Removal of the upper engine cowling, revealed two holes in the engine casing.

The amount of flying hours of the airframe and engine after respectively restoration and overhaul were approximately 100. Investigation revealed that the engine most likely stopped as a result of a broken bolt of one of the connecting rods. No further effort was performed to find the cause of the bolt failure, during the investigation the engine has not been dismantled.
