The Dutch Safety Board

Occurrence #: 2005135 **Classification:** Serious incident

The flight and the incident

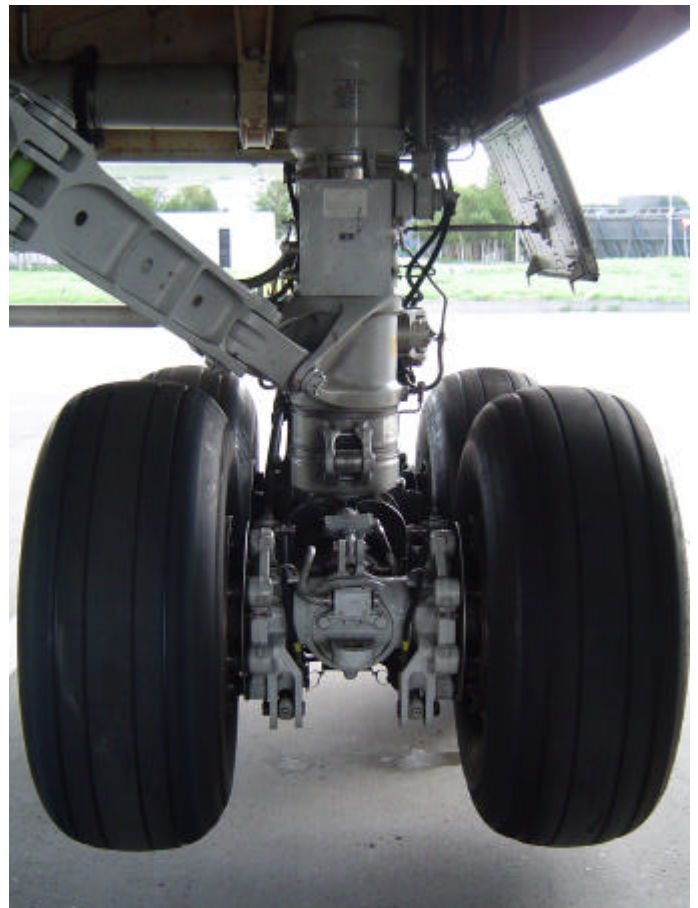
The flight crew performed the items on the non-normal checklist for "GEAR TILT" and "GEAR DISAGREE" but the situation did not change. An attempt to lower the gear and raise it again was not successful, the EICAS messages did not disappear. The flight crew decided to return to Amsterdam where an uneventful landing was made. At the platform broken seals were visible on the left-hand body gear, with damage to the landing gear doors and linkage corresponding to the gear/structure interface point. The shock strut was found fully compressed (inflation pressure was zero) and the tires did not contact the ground.

Fully compressed shock strut with tires off the ground

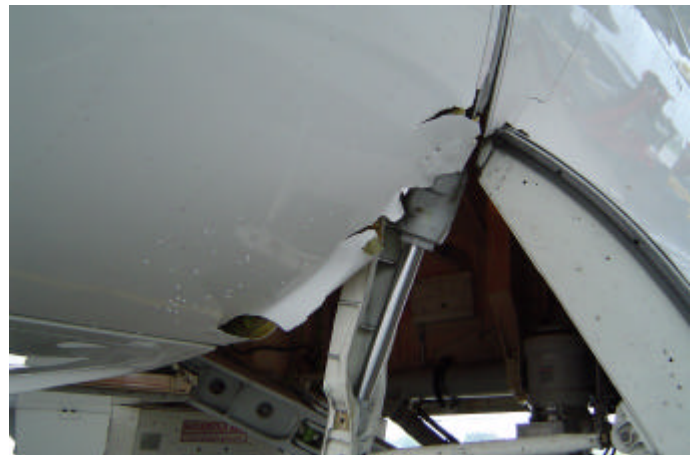
Boeing launched a repair team and a service engineer to support the operator with troubleshooting of the landing gear. The Boeing team reported that the damage was caused by over-extension of the left-hand body landing gear. During gear retraction, the tires of the over-extended left main body gear contacted and damaged the structure. During the incident landing the shock strut was fully compressed and the strut remained in the fully compressed situation.

Disassembly of the shock strut revealed that the following internal components were fractured/cracked:

- Upper Bearing Carrier;
- Snubber Valve;
- Follower Tube.

Damaged structure

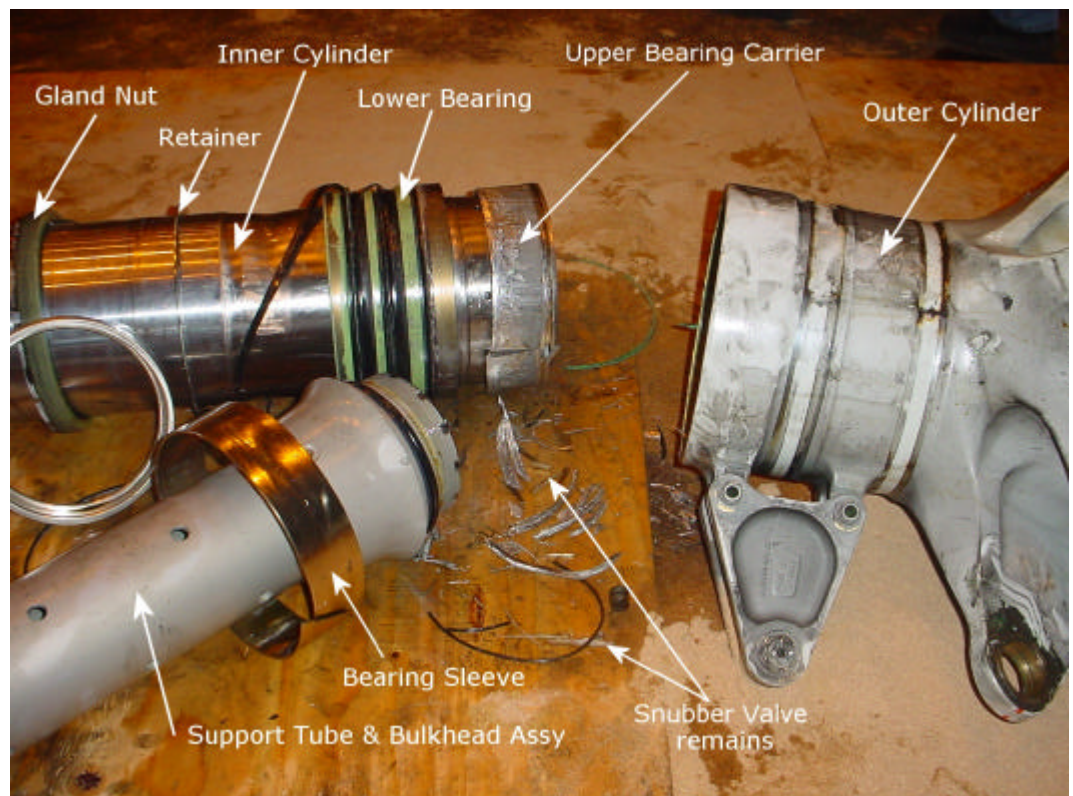
The upper bearing carrier, upper bearing sleeve, and snubber valve were found loose in the outer cylinder. The snubber valve was completely fractured in at least eight locations with the horizontal flange completely severed; the upper bearing carrier halves both were fractured near the lower relief; the follower tube had multiple cracks.

In addition, the inner cylinder was bent, and the upper bearing sleeve was damaged at multiple locations. The deformation to the inner cylinder was a result of the over-extension and was caused by short coupling of the cylinder upper barrel by the lower bearing during the incident landing.

Damaged Parts

Over-extension of the shock strut occurred when the upper (bearing) carrier dislodged from the inner cylinder. Evidence of contact between the steering yoke assy and the outer cylinder indicates that the

shock strut extension was limited by the steering mechanism assy. Limited only by the steering mechanism assy the shock strut extended approximately 12 inches beyond maximum design extension.

Disassembly and investigation of the shock strut revealed that failure of the upper bearing carrier initiated the failure sequence of the shock strut internal component damage and subsequent over-extension.

Subsequent to the disassembly of the shock strut Boeing received a Notice Of Escapement (NOE) from the landing gear manufacturer advising that their supplier disclosed that a number of upper bearing carriers had not been properly heat treated and were delivered in the annealed condition. An electrical conductivity inspection was performed by Boeing on the two upper bearing carriers removed from aircraft JA01KZ. The inspection confirmed that both upper bearing carriers were annealed 2024 aluminum which agrees with the NOE from the part supplier. All upper bearing carriers with improper heat treatment were traced and the affected operators were informed by Boeing and were offered support to replace the parts.
