**The derailments at Amsterdam Central Station
on 6 and 10 June 2005**

The Hague, 30 November (project numbers M2005RV0606-04 en M2005RV0610-02)

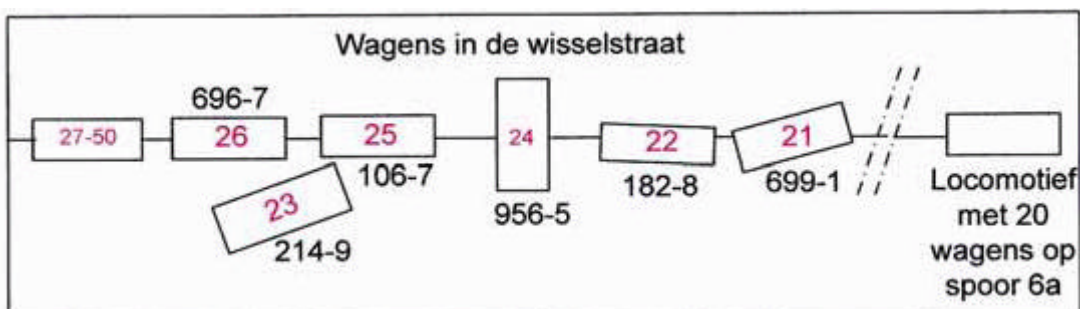
The derailment did not cause any casualties or injuries. However, there was considerable damage to both equipment and infrastructure. Wagon 23 collided with a post carrying an overhead wire causing the gantry which extended across six tracks to collapse, as a result of which a large section of the emplacement was no longer usable.

Illustration 1 Illustration showing the position of the wagons after the derailment (source: Inspectorate for Transport, Public Works and Water Management)

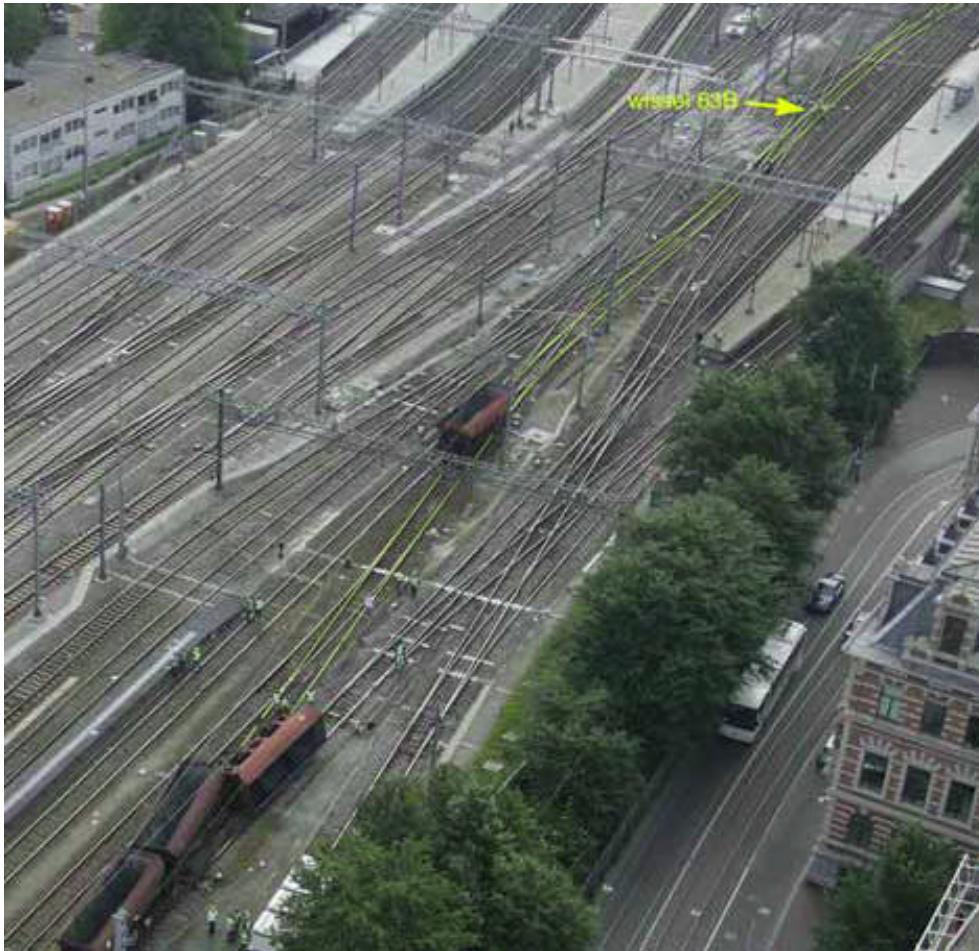
At twelve minutes past three in the morning of Friday 10 June 2005, an empty coal train derailed on the damaged set of points. The train consisted of an engine and 36 empty coal wagons. The rear three wagons derailed and one tipped over on its side. There were no casualties. However, there was damage to the equipment and the infrastructure. A number of points were also damaged.

Illustration 2 Defective set of points 63, track and final position of the derailed wagons

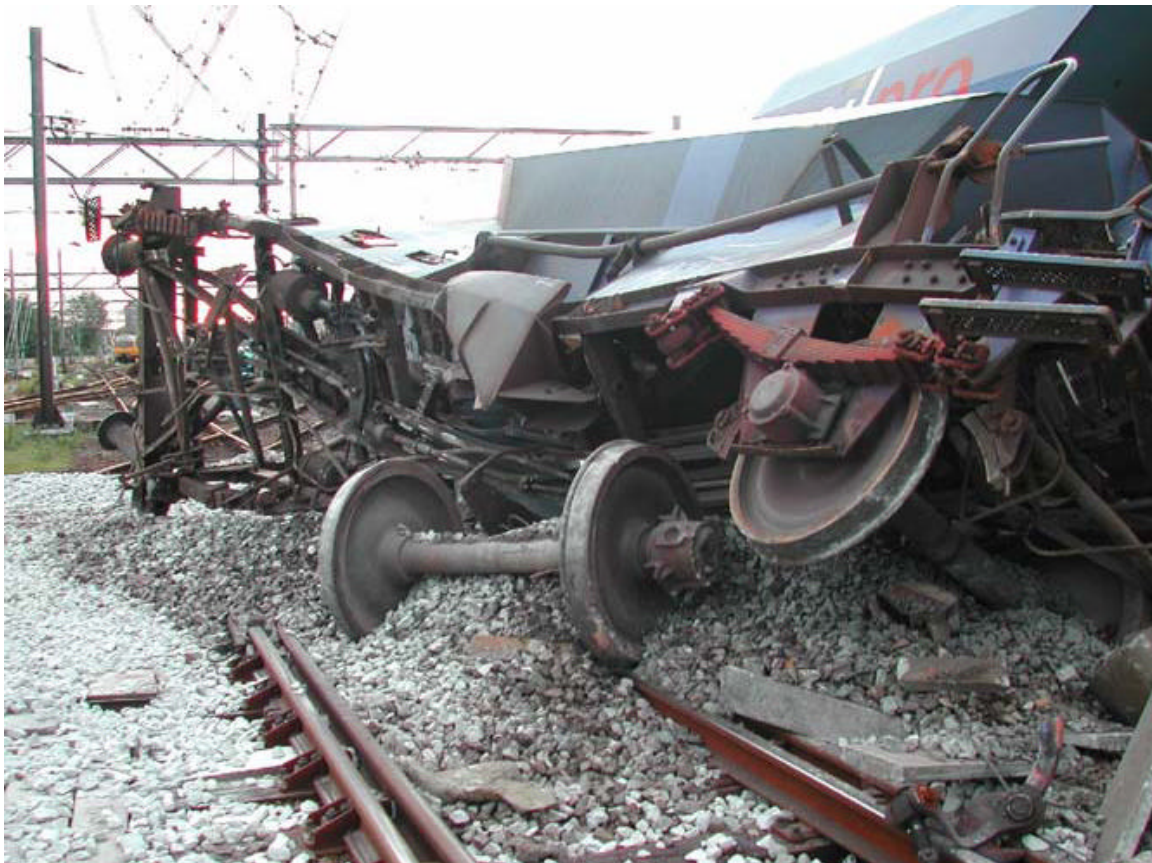
Illustration 3 Photo of the debris

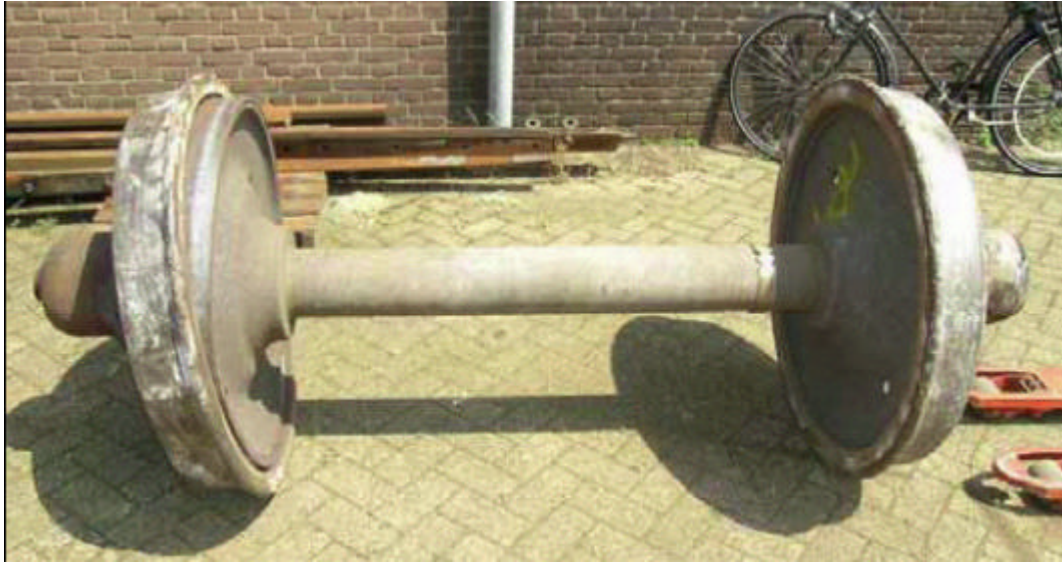
The Inspectorate for Transport, Public Works and Water Management concludes in its report that the derailment was the direct consequence of the loose and displaced tyre of the left wheel of the rear wheel set of wagon 22. The Inspectorate did not determine the underlying cause of the sudden loosening of the tyre. The other damage observed to the equipment and the infrastructure can be designated as consequential damage. According to the Inspectorate, a check of the data from measurements taken shortly after the derailment and data from the maintenance database show that no evidence has been found in the infrastructure which could have been the cause of the derailment.

Illustration 4 The rear axle of wagon 22 (Source: Inspectorate for Transport, Public Works and Water Management)

The Inspectorate for Transport, Public Works and Water Management investigated the possible cause of the derailment⁴. This investigation focused on, among other things, the equipment. The investigation into wagon 22 revealed that the tyre of the left wheel of the rear wheel set had moved away from the inner wheel. The tyre had partly come loose from the inner wheel. Closer inspection of the wheel in question revealed that the tyre clip (see paragraph 2.2 for an explanation of this term) was missing and that part of the tyre on the side of the tyre clip had disappeared. Part of what is known as the lip of the tyre was also missing. The fracture area of the tyre where the lip had disappeared was very rusty which would seem to indicate that the lip material had been missing for some considerable time (although it is not known how long). The tyre clip was not recovered from the scene of the derailment nor from the section of track the train had travelled along. However, part of a tyre clip was found on an entirely different track at the emplacement at Amsterdam Central Station. Investigations by AEA Technology showed that it was probably part of the wheel in question. If this is the case it means the tyre clip had become loose and had broken during an earlier trip.

On the basis of its investigation, AEAT concluded that the tyre had come loose due to a combination of factors. Both tyres of the bogie were found to be slightly concave. The tyre thickness was 33 mm, while the thickness for Fccpps wagons (120 km/h empty and 100 km/h full) has to be at least 35 mm⁶.

A concave tyre may be caused by an excessively high wheel load⁷, an excessively thin tyre and a substantially increased temperature caused by the brakes on the tyre. Usually, a combination of these factors is involved. The increased temperature decreases the resistance to distortion. According to AEAT, it is plausible that this resulted in the so-called rolling out of the tyre in the hottest part. The rolling out of the steel near the wheel tread caused the tyre to become concave. The shrinking stress would then increase in the middle and decrease at the sides. Incidentally, it is well known that the shrinking stress decreases as the tyre becomes thinner⁸.

1. Voestalpine Railpro is advised to develop the maintenance system for its railway equipment in such a way as to guarantee that the equipment continues to fulfil the applicable requirements. This includes a complete and clear registration of the state of repair of each vehicle.
2. The Inspectorate for Transport, Public Works and Water Management is advised to implement, as a priority, the plan described in the Second Framework Policy Document on Rail Safety in the Netherlands to maintain strict supervision of the maintenance and maintenance processes for goods equipment. In particular, the Safety Board recommends an improvement in the system of technical checks and regular maintenance which ensures that deficiencies such as the lack of wheel markings can no longer occur.

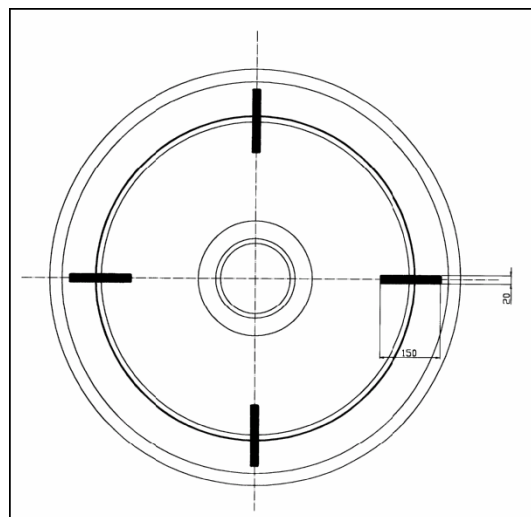
The wagon master stated that he walked along the right side of the entire train, while the brakes were on and along the left side of the entire train while the brakes were off. According to the wagon master, his check did not reveal any irregularities¹⁶. Further investigation by the Inspectorate for Transport, Public Works and Water Management revealed that, in the case of a number of different wagons of the derailed train, the control markings (four stripes on the wheel flanks, painted at 90°) of the tyred wheels were missing or were unclear. These stripes are prescribed as being necessary and serve as a means of checking for movement or loosening of the tyre¹⁷. The control markings clearly show when the tyre has moved, and when rust has formed between the tyre and the inner wheel (an indication that something is wrong).

Position of the white check marks on tyres, Length 150 mm, width 20 mm.

It has been established that the control markings on the wheels were missing. These markings (four white painted stripes on the tyre and wheel) allow a loose tyre to be detected. The missing control markings, the excessively thin tyre and the missing tyre clip must have gone unnoticed during technical checks before departure and during earlier checks because the defects in question do not occur overnight. The system of technical checks before departure and the supervision thereof is evidently arranged in such a way that such aspects may structurally go unnoticed.

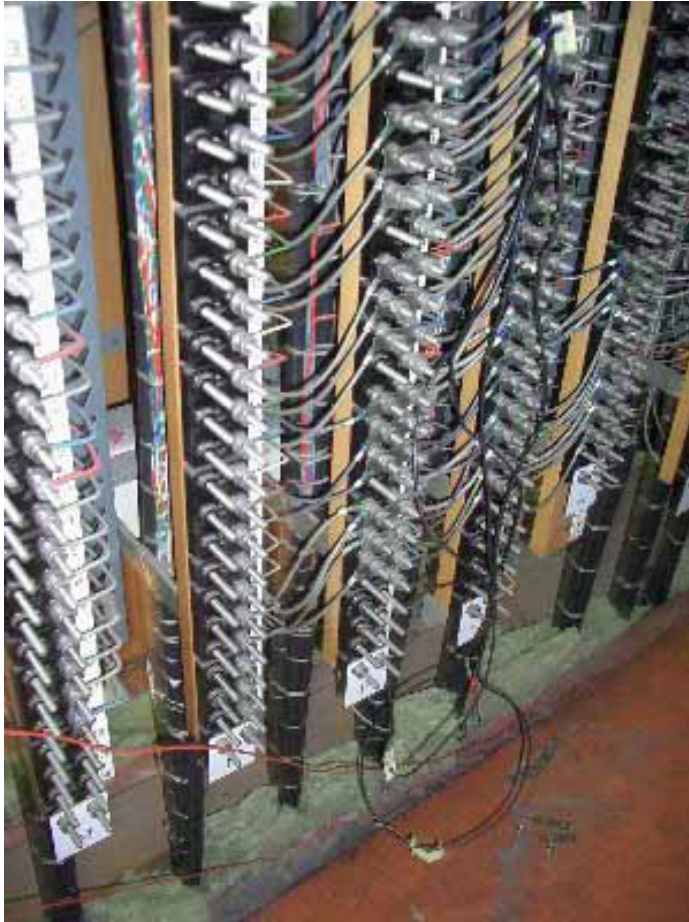
Nonetheless, in order to allow a set of points to be used in such a situation, it can be physically jammed in a position that allows them to be used safely. However, because the signs for the track in question cannot be turned to green as a consequence of the broken cable, either the train traffic controller must order each individual train to pass through a red light (which is a time-consuming process), or the warning signal in the operating system must be 'artificially' removed. The latter is done by installing a bridging element. The safety installation is then adapted in such a way (by attaching wires between the relay) that the system signals that the set of points are controlled to a certain side. However, this signal is no longer linked to the actual position of the set of points outside, but is an 'artificially' generated signal. If, for example, the set of points is manually placed in a different position, the system will continue to indicate the position chosen when fitting the bridging element. The train traffic controller only sees the signal that the set of points is in control (the signal that s/he would also see normally), and does not see that the signal is a result of a bridging element.

Illustration 2 The temporary connections are fitted in the relay housing using long black wires (Source of photo: Inspectorate for Transport, Public Works and Water Management).

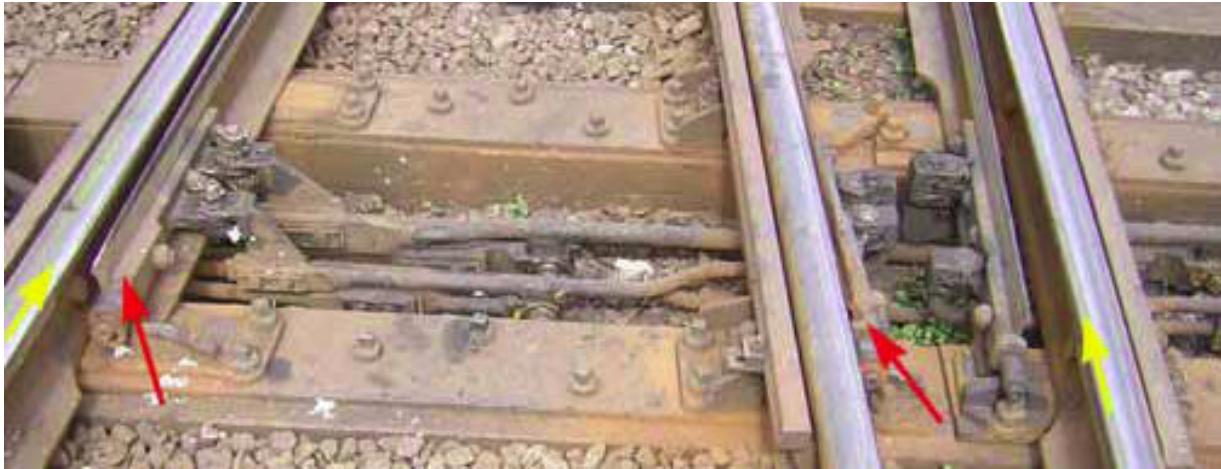
The train traffic controller allowed a number of trains to pass over this set of points on the assumption that these were in the right-hand position (as indicated by the system) while the set of points was actually in the left-hand position. As a result, the set of points was opened and damaged by the passing trains (see the following illustration).

Illustration 3 Set of points 63B in the position found directly after the derailment. The open tongues can be clearly seen.
