The Dutch Safety Board

Occurrence #: 2004106 **Classification:** Serious incident

FACTUAL INFORMATION

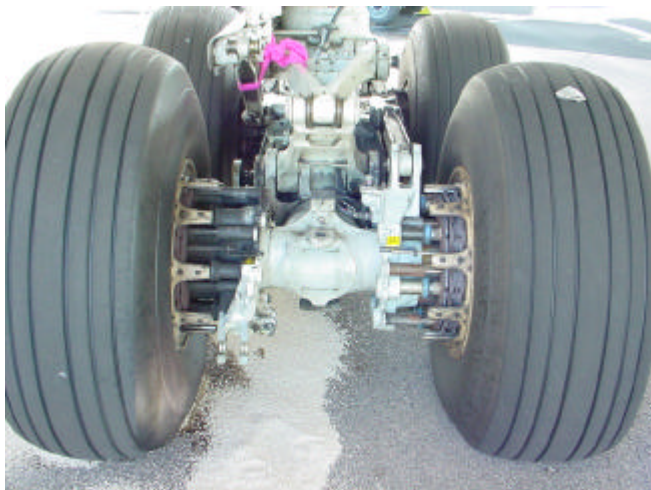
The broken lug (bottom left) of the right MLG

It was found that the right MLG had sustained serious damage during the rejected take-off. The brake link connection lug on its right front brake unit (see left picture) and a number of electronic and hydraulic lines of the brake- and anti-skid system of the right MLG were found broken. No other evidence of cracking was observed at that time. The four tires of the left MLG had deflated of which two tires showed large scouring spots. Three tires (two aft and one left front) of the right MLG had deflated partially. Several small parts of the right MLG were found on the runway. Subsequent to being towed from the runway, a very large crack was observed in the front part of the right MLG bogie beam (see right picture).

- Investigation of fractures surfaces of the broken brake unit lug showed signs of overloading.
- At the edges some mechanical damage was present. Its cause could not be determined.

2. The lugs on the brake unit broke first. This could be a result of some pre existing deficiency in it. Too much play in the bearing, existing damage, material or processing discrepancies.

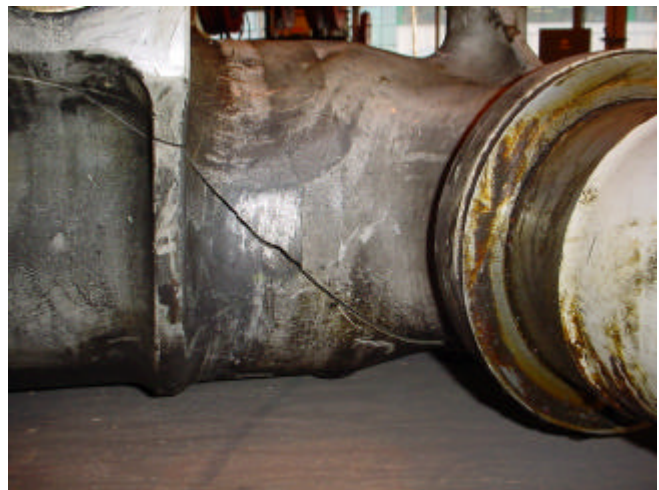
The crack in the right MLG bogie beam

- Fracture of the right main landing gear bogie beam occurred due to stress corrosion cracking, which emanated from an area of mechanical damage on the right (outboard) side of the part, approximately seven inches aft of the centreline of the forward axle lug hole.
- Evidence of bubbling in the paint along the inner surface and softening of the base material along the outer surface in the area of mechanical damage, indicated that this region reached an elevated temperature.
- No material or processing defects were observed.

1. The area with mechanical damage on the bogie beam already existed before the occurrence. This damage had caused internal residual stresses in this area. The material of the bogie beam is susceptible for stress corrosion cracking. The loads on the bogie beam applied during the rejected take-off were above the stress corrosion cracking limit, causing the beam to crack.

A small aluminium part bolted to it scrapped along the beam, smearing the soft metal on it. This process caused the damage and the heating of the damaged area. The heating reduced locally the strength of the material. Under the loads on the beam during the rejected take-off it fractured.
