GENERAL INFORMATION

Occurrence:	2006060
Classification:	Accident
Date and time ¹ :	19 May 2006, 20.41 hours
Location of occurrence:	Amstelveen
Aircraft registration:	PH-RPX
Aircraft model:	MBB BO 105 CBS-4
Type of aircraft:	Helicopter
Type of flight:	Test flight
Phase of operation:	En route
Damage to aircraft:	Serious
Flight crew:	Two
Passengers:	None
Injuries:	None
Other damage:	None
Lighting conditions:	Daylight

SUMMARY

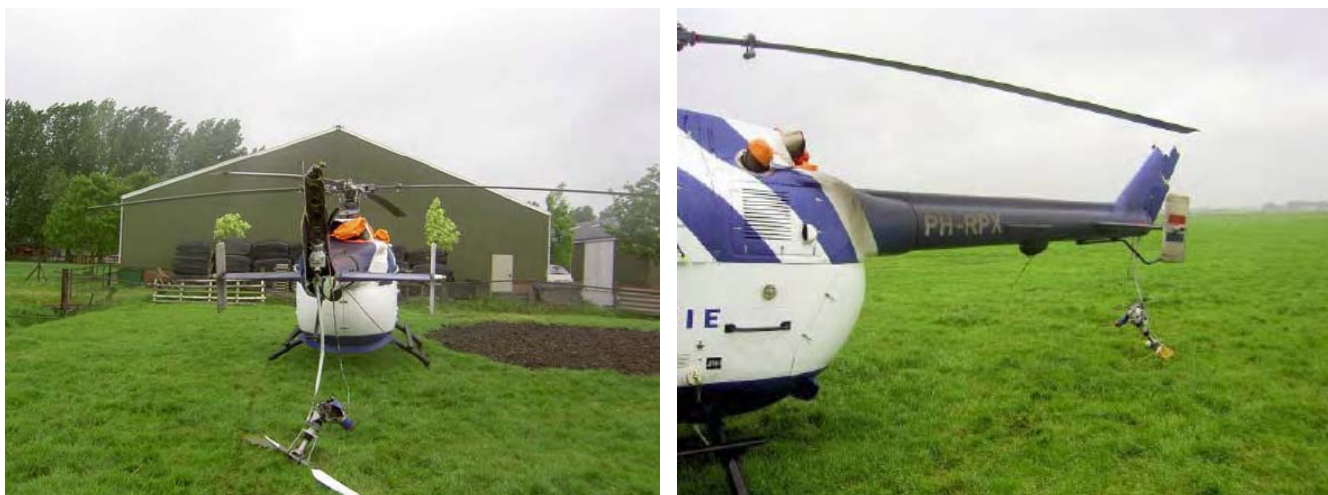
Post accident inspection revealed the reason for the sudden lack of directional control. The complete tail rotor unit was ripped out of the vertical fin of the helicopter.

Illustration 1: PH-RPX after the accident

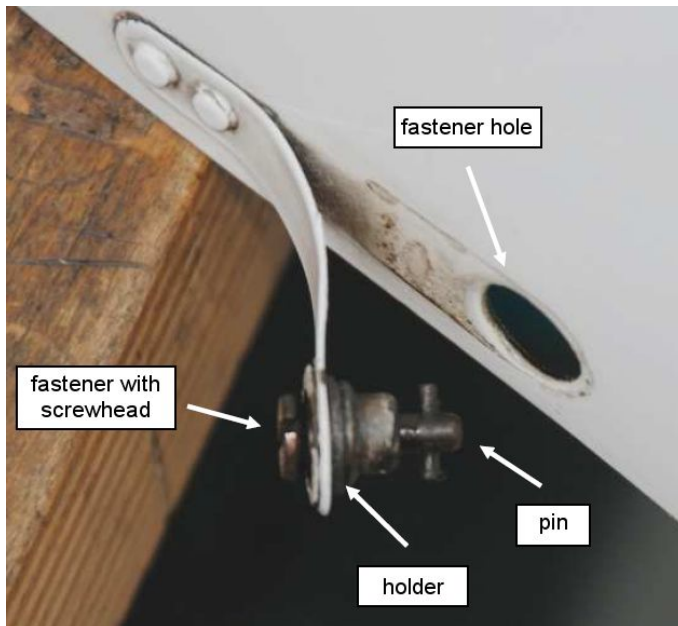
At the day of the accident the aircraft engineer involved performed a 50 hours inspection on the helicopter PH-RPX. To get access to the inspection items the vertical fin cowling was removed. The cowling is made of composite material and is connected to the structure by quick access fasteners. To close a fastener the pin is pushed through the fastener hole and turned a quarter turn with a screwdriver to secure it. The vertical fin cowling contains twenty-two fasteners, eleven on either side. The installation procedure for the vertical fin cowling is to lift the cowling, keep it into position and secure two lower fasteners on either side to prevent the cowling from dropping down. Next the remaining fasteners need to be secured. Because of the high location above the ground, a platform is required to reach the remaining fasteners. During the investigation the aircraft engineer declared that all fasteners of the vertical fin cowling were secured. Following the 50 hours inspection the aircraft engineer performed a walk-around inspection while the pilot performed a pre-flight inspection. No abnormalities were reported whereupon the helicopter was moved from the hangar to the platform for a post inspection test flight.

Illustration 2: quick access fastener (source: NLR)

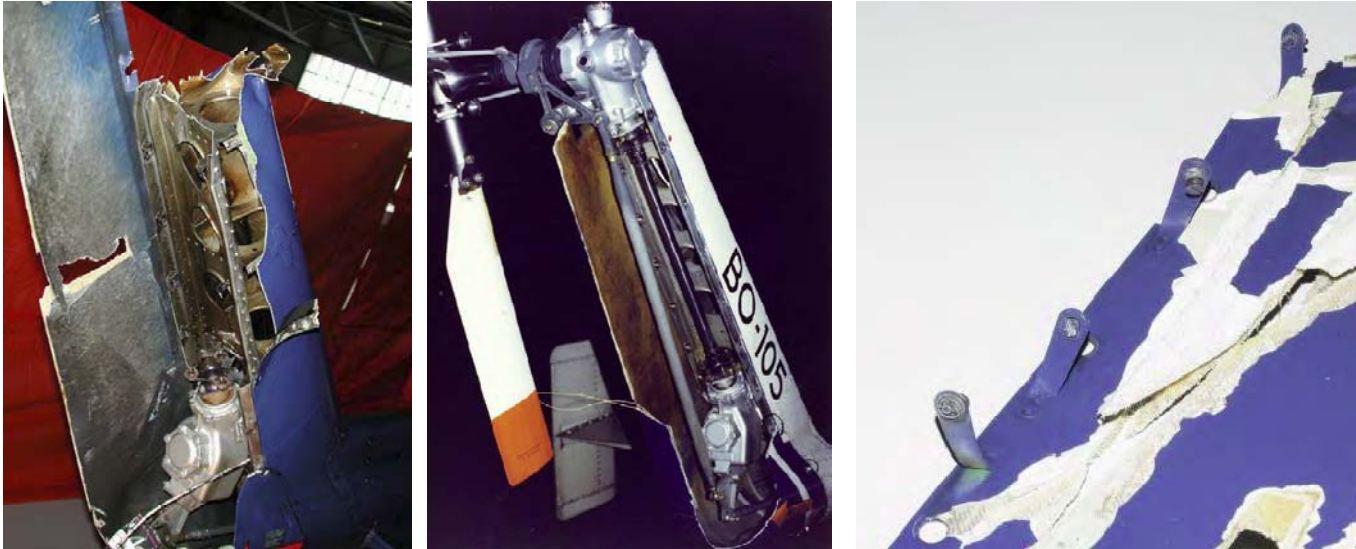
Illustration 3:

- There are no indications that the tail rotor drive mechanism was not fully operational at the time of the initial failure.
- Most likely the separation of the tail rotor assembly was initiated by a failure of the vertical fin cowling. The first seven quick access fasteners (counted from top to bottom) of the eleven fasteners on the right-hand side of the vertical fin cowling were not secured or in a locked position when the tail rotor assembly separated from the fin. All fasteners on the left-hand side appeared to be in a secured and locked position when the cowling failed. The break-up damage of the cowling showed further much resemblance to that with a BO 105 helicopter incident in Spain where it was known that seven fasteners on the right-hand side were not secured (source: Eurocopter).

- It is most likely that during cruise flight the cowling lifted on the right-hand side due to the dynamic pressure of the air stream and vibrations. During the power reduction prior to the intended power check on engine #1 the air stream changed due to a rudder pedal input causing the cowling to fail along the left-hand trailing edge.

Left: fasteners on left-hand side PH-RPX still attached

Middle: similar fin cowling damage with Spanish helicopter

Right: fasteners on right-hand side PH-RPX in 'open' position (source: Eurocopter)

- Both walk-around and pre-flight inspection took place in the hangar with artificial lighting.
- Both fin cowling and fasteners were painted in the same (dark blue) colour which reduced the difference in perceptibility between an open and a closed fastener. As a precautionary measure after the accident the areas of the cowling underneath the fastener lips were painted orange to make an open fastener more noticeable.
