## FACTUAL INFORMATION

Identification number: 2006082  
Classification: Accident  
Date and time: 18 July 2006, 09.47 hours<sup>1</sup>  
Location: Rotterdam Airport (EHRD)  
Aircraft registration: TC-OAN  
Aircraft model: Airbus A321  
Type of aircraft: Passenger aircraft  
Type of flight: Commercial air transport  
Phase of operation: Landing  
Damage to aircraft: Substantial damage  
Crew members: 2/5  
Passengers: 146  
Injuries: None  
Other damage: None  
Lighting conditions: Daylight

During the landing at Rotterdam Airport the aircraft experienced a tail strike.

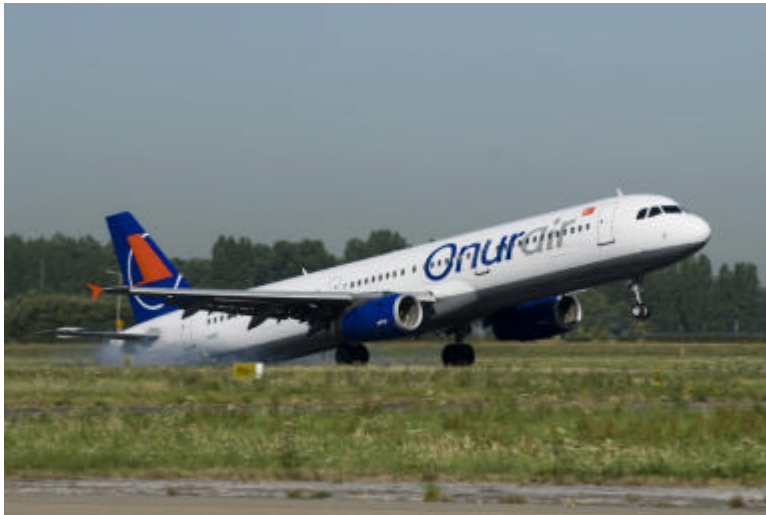
At Rotterdam Airport the aircraft made a VOR-DME approach to runway 06. During this approach the aircraft was flown manually and the engine thrust was dictated by the auto thrust system. At 09.47 hours the aircraft touched down short of the runway threshold. During this touch down the aircraft's tail struck a paved surface, resulting in substantial damage to the empennage.

*Figure 1: TC-OAN experiencing the tail strike  
(source: Rotterdam Airport authorities)*

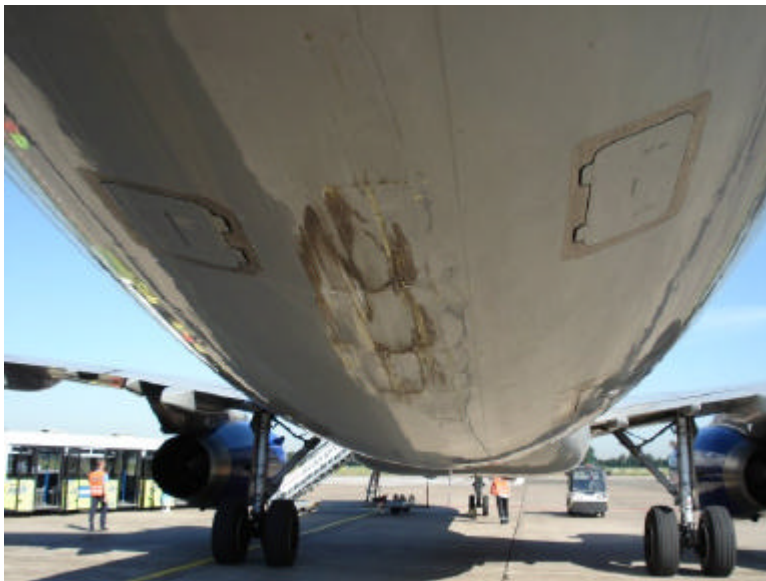
*Figure 2: view on the aircraft's empennage with scrape marks*

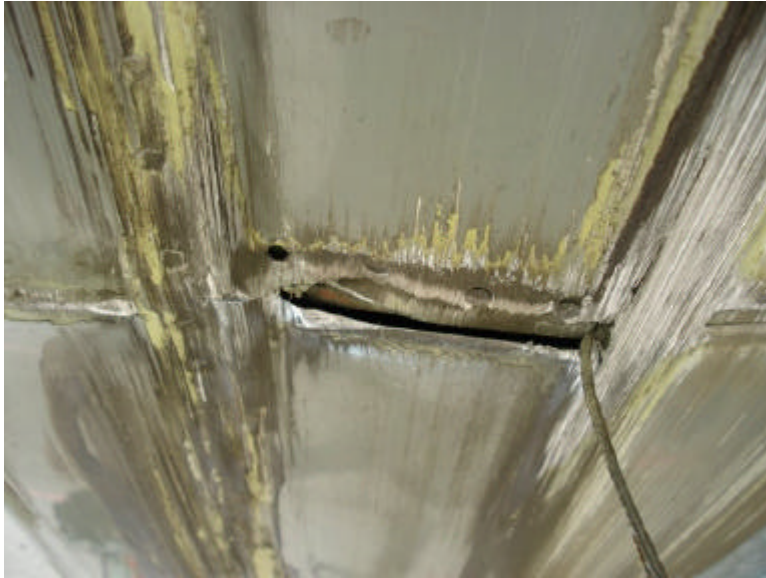
Figure 3: close up of the damaged area

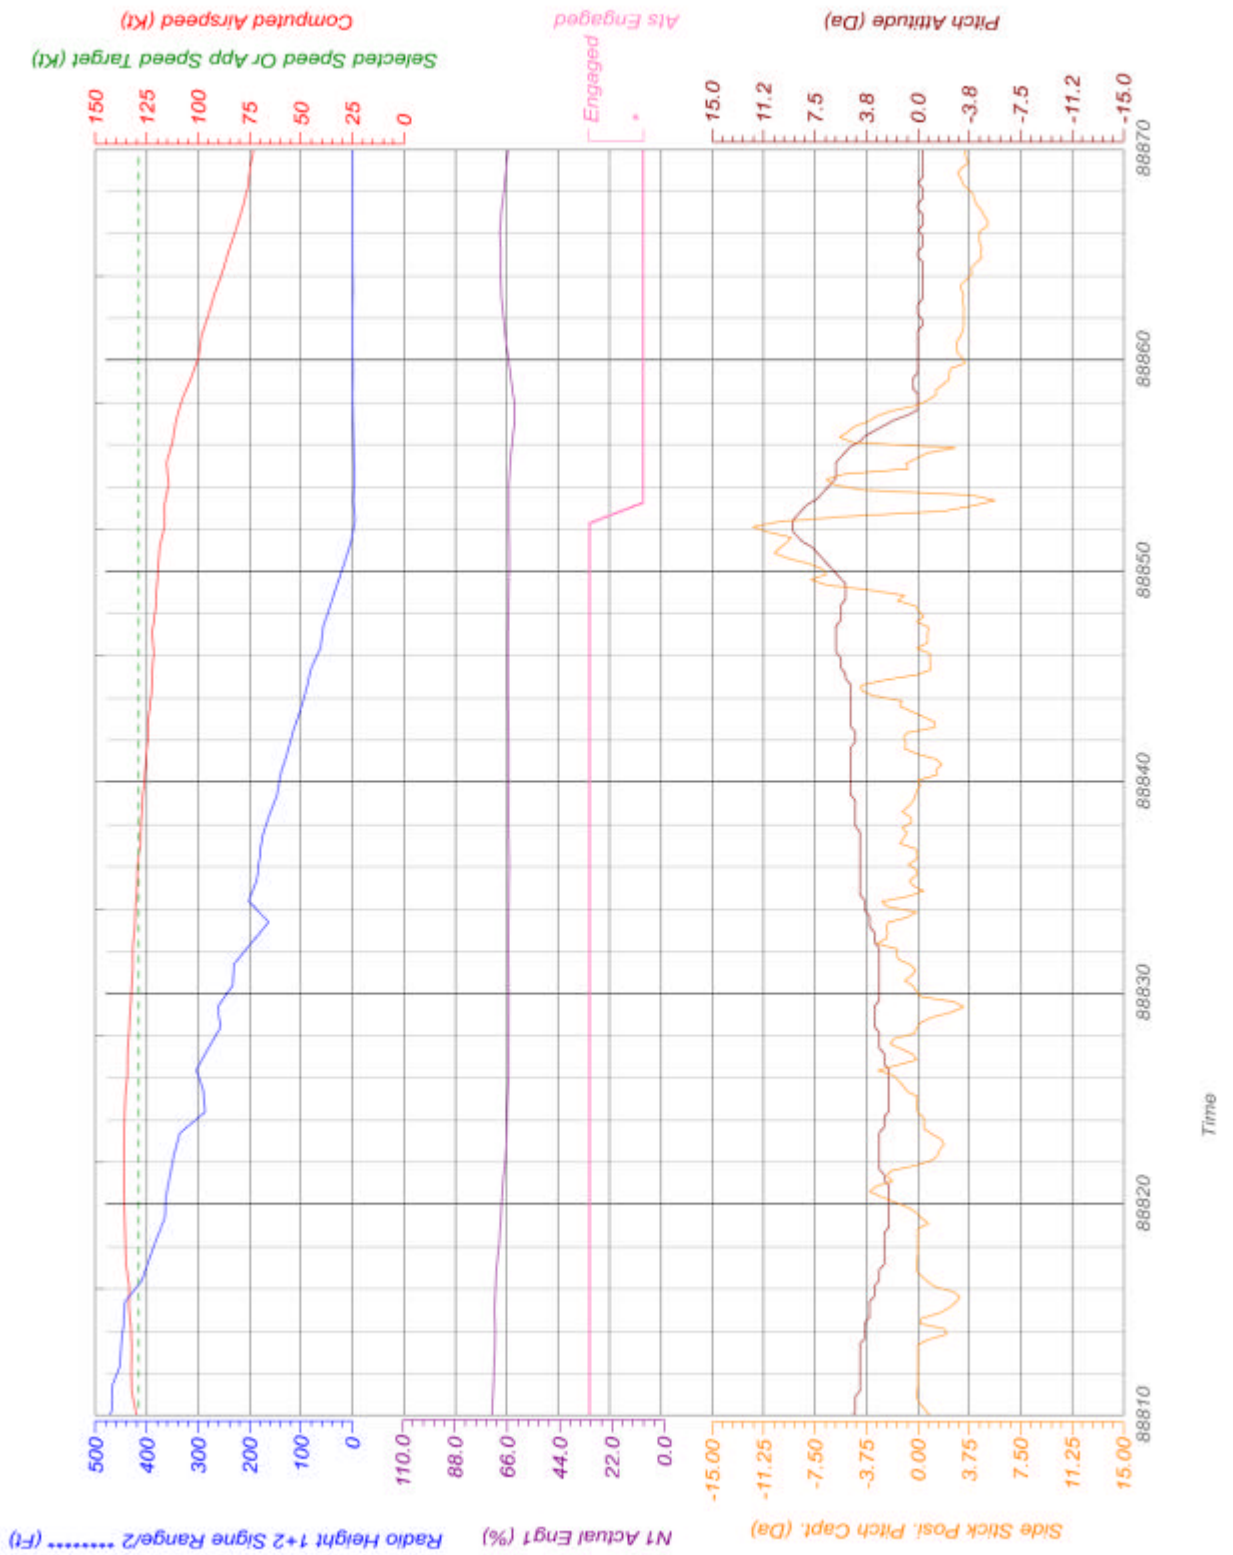
Figure 6: flight data recorder plot

During the accident flight the target speed during the approach was 129 knots. At approximately 180 feet radio altitude the aircraft's speed dropped below this target speed. At the moment of touch down the speed had dropped to 120 knots and the pitch attitude reached 9 degrees aircraft nose up. During this last part of the approach there was no reaction from the auto thrust system to correct the speed. Figure 6 depicts the aircraft's radio altitude, approach speed target, the computed airspeed, engine thrust, auto thrust system status, pitch attitude and side stick pitch inputs.
