## FACTUAL INFORMATION

Occurrence:	2006092
Classification:	Serious incident
Date and time:	12 August 2006, 11:27 hrs <sup>1</sup>
Place:	Amsterdam Airport Schiphol (EHAM)
Aircraft registration:	PH-BXP
Aircraft model:	Boeing 737-900
Aircraft type:	Passenger aircraft
Type of flight:	Public transport
Phase of operation:	Landing
Damage to aircraft:	Minor damage
Flight crew:	2
Passengers:	193
Injuries:	None
Lighting conditions:	Daylight

## SYNOPSIS

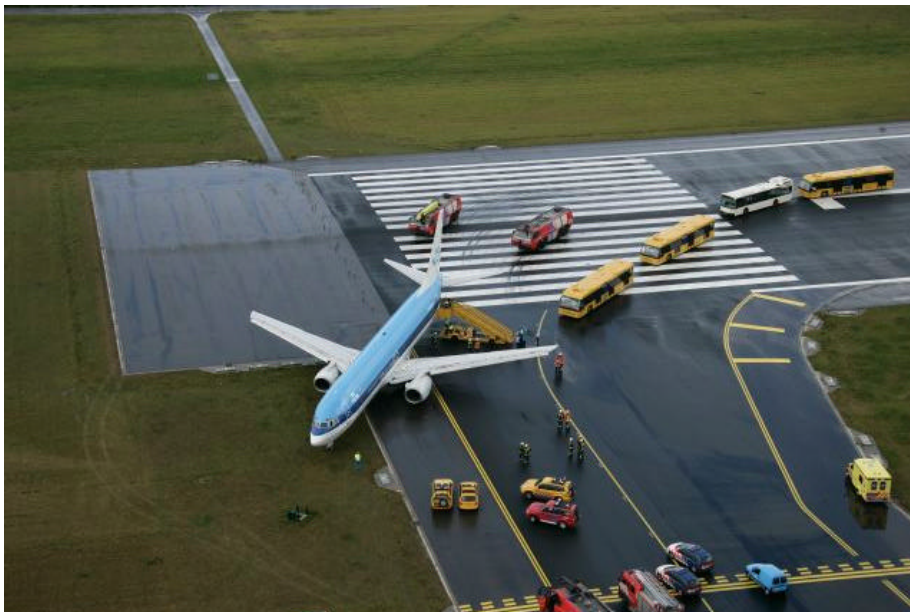
Picture 2: the aircraft after the incident (source Aviation police)

paved surface. The crew decided not to execute an emergency evacuation as the aircraft appeared to be intact. The tower controller informed the crew that the fire brigade had been alerted. Eventually the passengers could disembark the aircraft via stairs at the rear entry door and were transported to the terminal in busses.

Immediately after the incident the aircraft has been inspected by the airline's technical department. Apart from minor damage to the nose gear rims this did not reveal malfunctions. The aircraft was released for flight the following day. The aircraft technical log did not contain complaints regarding the brake system neither before nor after the incident. The deceleration values as recorded by the DFDR and ACMS indicate deceleration values consistent with the use of auto brake setting 2 until the auto brake system is disarmed by the pilot. Deceleration values during the remainder of the roll-out are consistent with the recorded brake pressure.

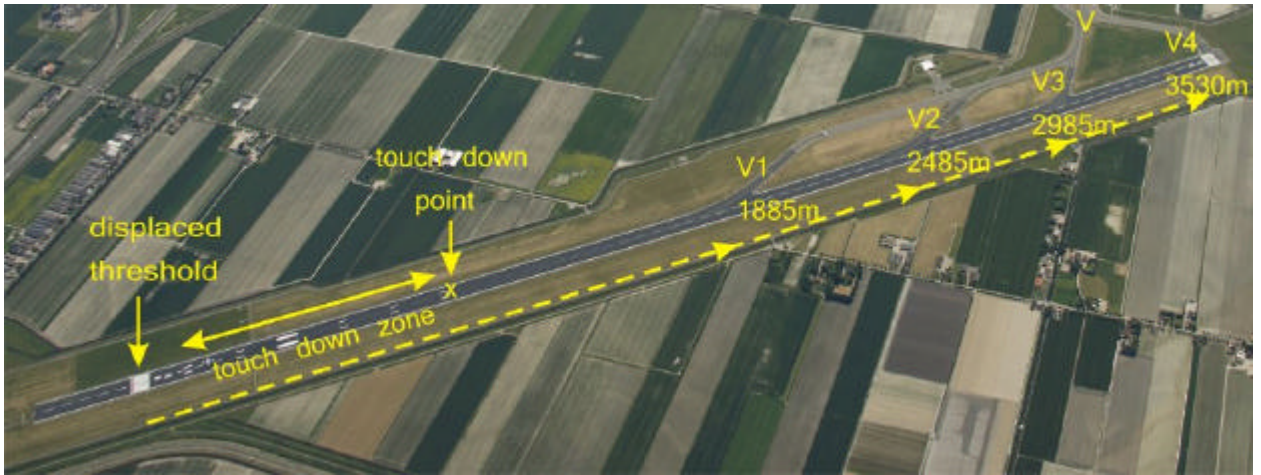
Picture 3: runway 18R/36L with the exits (source Aviation Police)

The runway is equipped with four exits, V1 through V4. V1 is a high speed exit located 1,885 m from the displaced threshold of runway 18R (remaining runway length: 1,645 m).

V2 is a high speed exit located 2,485 m from the displaced threshold of runway 18R (remaining runway length: 1,045 m).

V3 is located 2,985 m from the displaced threshold of runway 18R (remaining runway length: 545 m) and is placed at a 50 degree angle to the runway.

V4 is located at a 90 degree angle to the runway and is located at the far end of the runway.

Investigation turned out that the runway surface occasionally can be slippery locally during damp or wet conditions. Especially the white painted markings provide reduced friction, as the runway friction measurements show. Because these paintings consist of layers of paint, which are filling the open structure of the concrete completely, they can be slippery, particularly when wet. The low friction on the threshold marking of runway 36L in wet conditions forms a potential risk for aircraft landing on runway 18R. Normally the turn off the runway will be made before exit V4. However in incidental cases where the full length of the runway is needed, the considerably lower friction of the last part (30 m) takes the crew by surprise.

As a result of this recommendation Amsterdam Airport Schiphol made a new work instruction that during heavy rainfall a "diminished braking action" would be announced. Investigations were started how to improve the roughness of painted markings on runways.

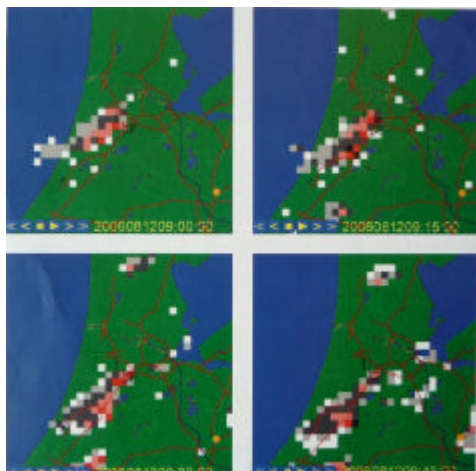
Picture 4: images of the weather radar between 11.00 – 11.45

*According to the weather radar image at 11:20, rain intensity near runway 18R reached a peak of 49 mm/hour, resulting in an amount of precipitation of 4,1 mm in 5 minutes.*

ratio of 2 can be deduced. When applied to the situation at 11:20, this would result in a maximum value of 8 mm rain in 5 minutes.

The KNMI further remarked that a value of 8 mm rain in 5 minutes at a given place is equalled or exceeded only once in every three years in the Netherlands.

The KNMI report concluded that an exceptionally heavy shower had passed runway 18R only minutes before landing of KL1002. Neither the crews of preceding aircraft nor the air traffic controller nor the crew of KL1002 were informed about the intensity of this shower. This is explicable because the heavy shower was very local and very difficult to see on the radar screen. The shower caused a different colour of one or two pixels on the radar screen of the meteorologist. It is impossible to detect one or two different coloured pixels during normal operational activities. These pixels were only detected after a thorough examination of the radar pictures. On the other hand the shower area was visible on the radar screens of the observer as well as the meteorologist in De Bilt. However the intensity of the shower was not noticed.

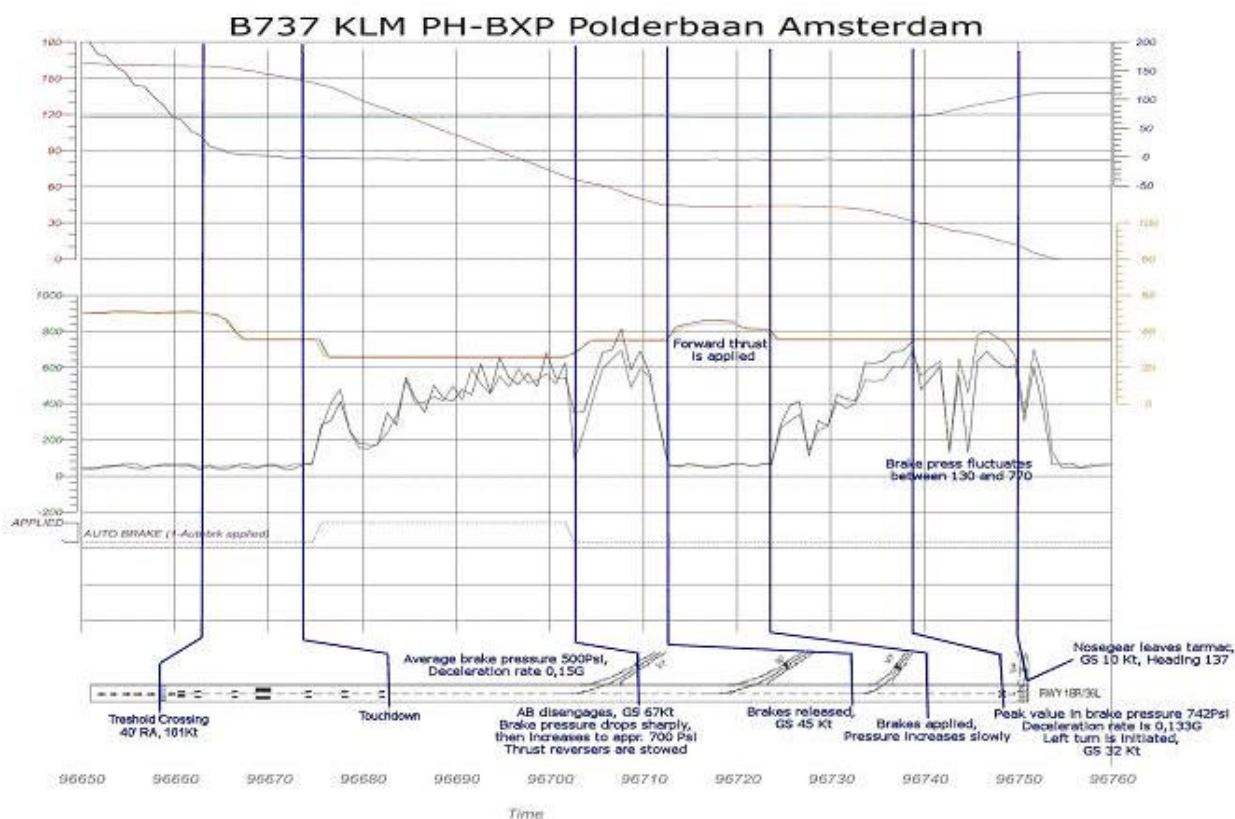
Picture 5: Important events plotted on a picture of the runway

The aircraft continued decelerating normally until 2,750 m past the displaced threshold. At this point (26 seconds after touch down) the crew disengaged the auto brake system and applied manual braking in order to increase the deceleration rate to vacate the runway via exit V3. At this moment the aircraft had a groundspeed of 70 kt.

After passing exit V3 the brake pressure showed fluctuation. As mentioned before the intervention of the anti skid system is not registered but the fluctuation is probably caused by the intervention of the anti skid system.

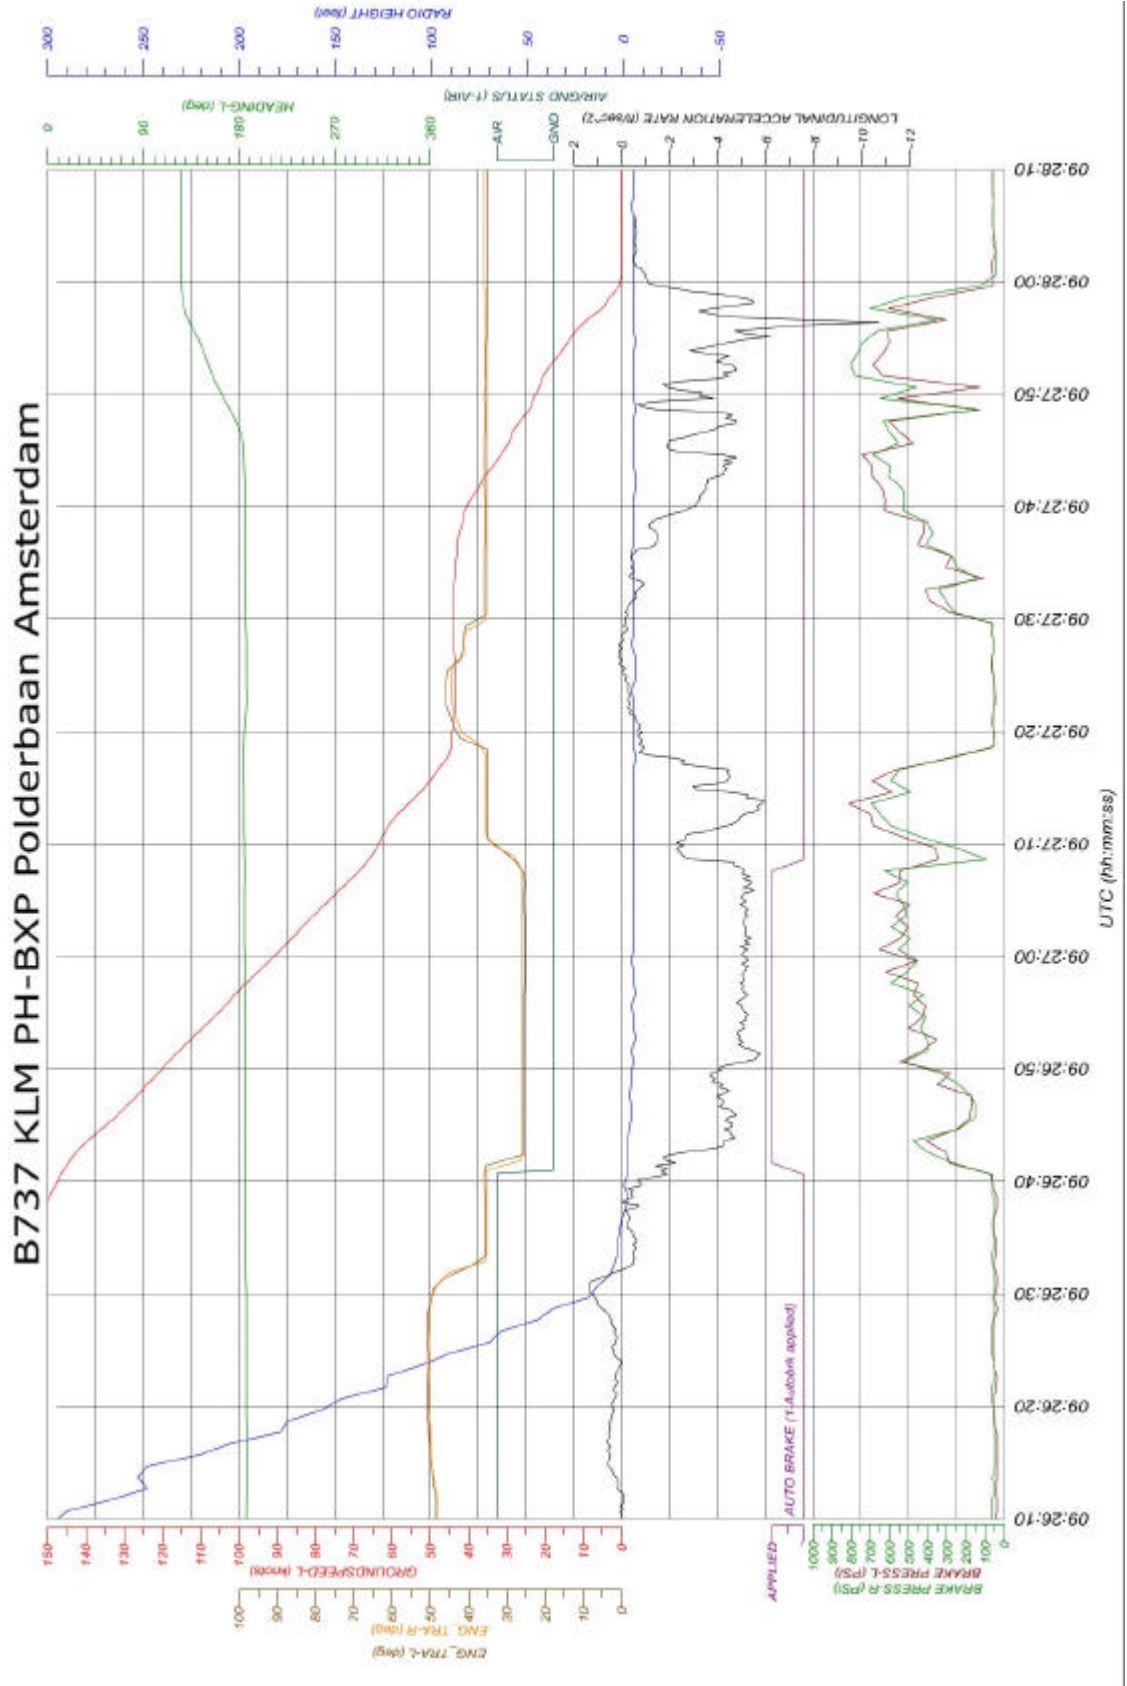
APPENDIX A: Extensive plot of DFDR data

The DFDR registered a nominal flight path until the flare phase of the flight. At 50 ft RA the indicated air speed (IAS) was 161 kt. According to the flight management system (FMS) position data the aircraft main gear touched the runway at time 11:26:41. At the same time the ground spoilers extended and the auto brake system level 2 engaged. Two seconds later the thrust reversers were deployed. At time 11:26:52 nose gear touch down occurred. From that time the data showed a steady deceleration of approximately 0,15G with a brake pressure which varied between approximately between 400 and 700 Psi, until a ground speed of 70 kt was reached at time 11:27:07. At that time the auto brake system was disengaged. The data showed a drop of the brake pressure and a drop of the deceleration to approximately 0,08G. After 3 seconds the brake pressure showed an increase to a maximum of 814 Psi resulting in an increase of the deceleration to a maximum of 0,18G. The thrust reversers were retracted at a speed of 60 kt. From time 11:27:19 to 11:27:30 zero brake pressure was measured. During that time frame data indicate that some thrust was applied. The ground speed which had decreased until 44 kt, remained steady. From 11:27:30 until the incident the brake pressure fluctuated, reaching a maximum of 742 Psi. When the heading of the aircraft started to change from 182° to 126° the ground speed was approximately 30 kt. At time 11:28:00 the ground speed had decreased to 0 kt.
