GENERAL INFORMATION

Identification number: 2006133
Classification: Serious incident
Date, time¹ of occurrence: 14 November 2006, 09.03 hrs
Location of occurrence: Rotterdam TMA

SUMMARY

A Cessna Citation departing from Rotterdam Airport (EHRD) and an approaching Boeing 737 had a traffic conflict due to the misconception of ATC that the Cessna Citation followed a different standard instrument departure procedure than it had actually been cleared for.

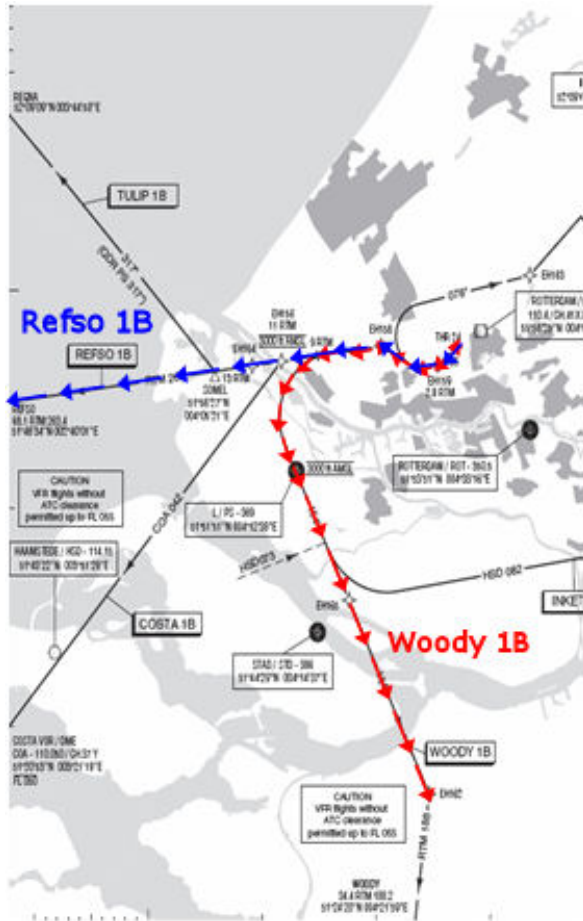
Illustration 1: standard instrument departures of EHRD

After takeoff N666MX followed the "Woody1B" departure as it was cleared for. At 3000 feet the crew contacted Approach with the words "FYG391E 3000 on the Woody 1 bravo". N666MX was cleared to climb to 5000 feet. This attitude was reached around navigation point (RNAV) EH164 where the aircraft turned left to follow the "Woody1B" departure. When the crew was asked to confirm that they were flying heading 270 degrees by Approach, they simultaneously received the TCAS RA "descend" which was immediately followed up. N666MX stopped turning and at approximately 4500 feet the crew had visual contact with PH-XRV that was flying above N666MX.

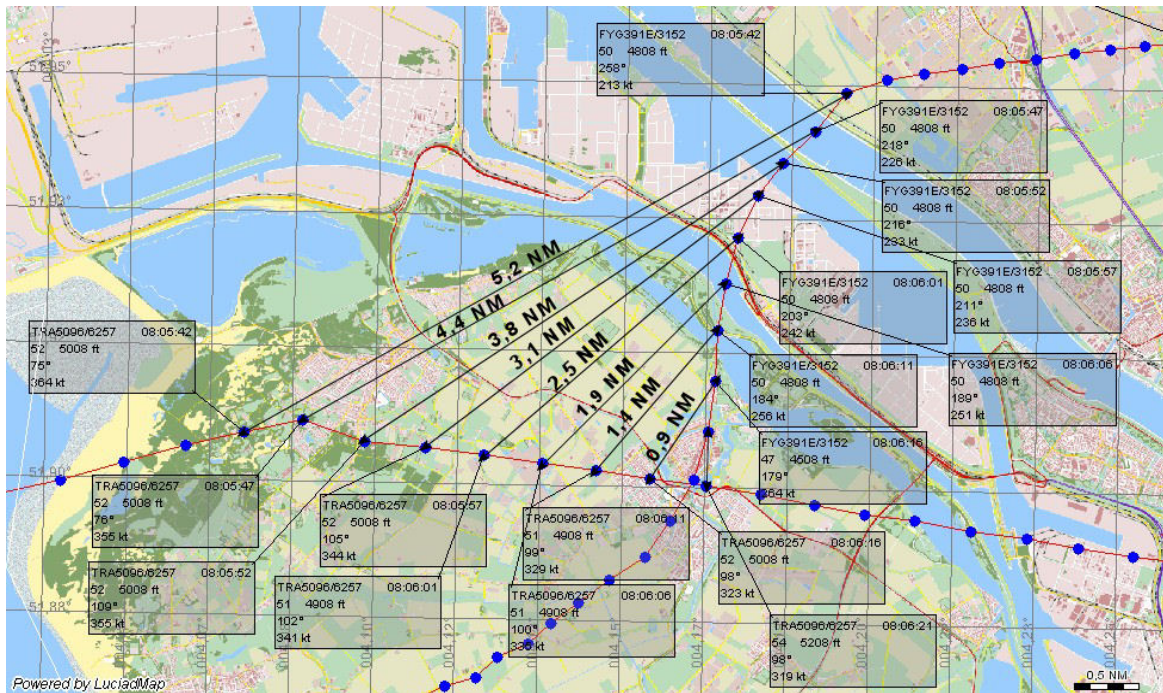
As a result of all instructions, (TCAS RA and the instructions of the approach controller) the conflict was solved and both aircraft continued the flight without problems. The closest distance between both aircraft was 0.4 nm horizontally and 900 feet vertically. The crew of both aircraft had visual contact with the other aircraft during the conflict.

Illustration 2: plot with the positions of both aircraft with the positions in-between (source LVNL)

The most probable cause of this serious incident was the misconception of approach control about the standard instrument departure flown by N666MX. A possible mid air collision was prevented by TCAS and the instructions of approach control.
