GENERAL INFORMATION

Identification number:	2006138
Classification:	Serious incident
Date, time ¹ of occurrence:	12 December 2006, 09.45 hours
Location of occurrence:	30 NM north of Spijkerboor VOR
Aircraft registration:	N840PN
Aircraft model:	Gulfstream American 690C Jetprop 840
Type of aircraft:	Fixed wing
Type of flight:	Non-scheduled commercial
Phase of operation:	Descent
Damage to aircraft:	None
Cockpit crew:	One
Passengers:	Four
Injuries:	None
Other damage:	None
Lighting conditions:	Daylight

SUMMARY

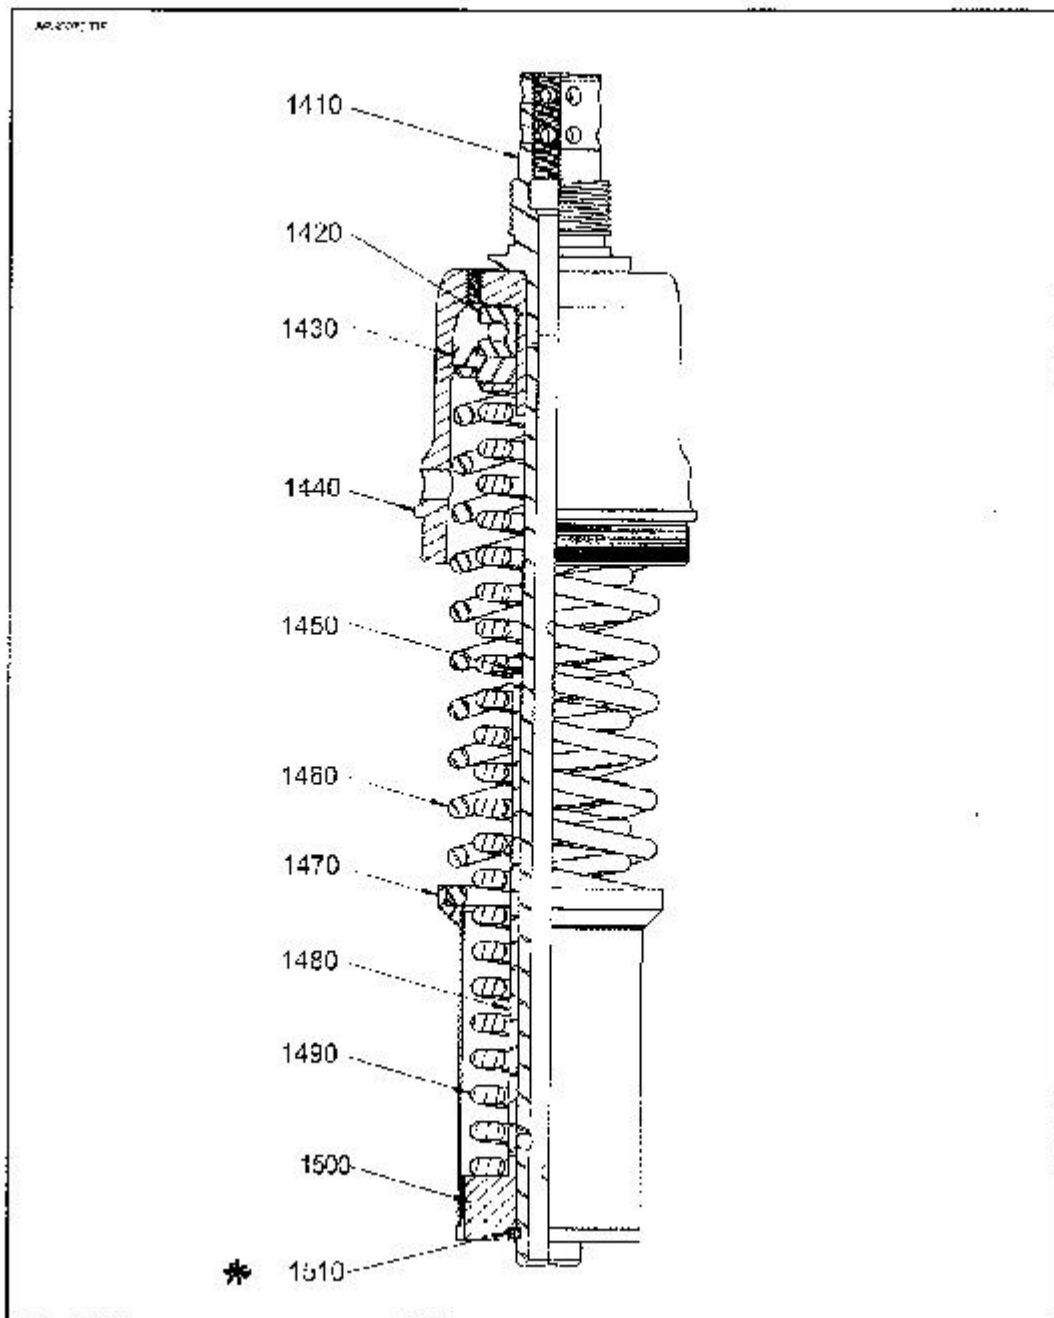
Figure 1 shows the propeller spring assembly components. On this propeller, feather is accomplished by use of blade counterweights and a feathering spring in the prop dome. During normal operations, engine oil pressure is used to drive the propeller pitch change piston. When the propeller is feathered, a valve opens and dumps the oil in the prop dome back to the engine gear case. This allows the counterweights, plus the feathering spring in the prop dome, to drive the blades to the feathered position.

Both parts of the split retainer were missing. All the components present were in good condition, the unit was 300 hour old.

Figure 1: Propeller feathering mechanism spring assembly. The split retainer is component number 1510, indicated with a '*'.

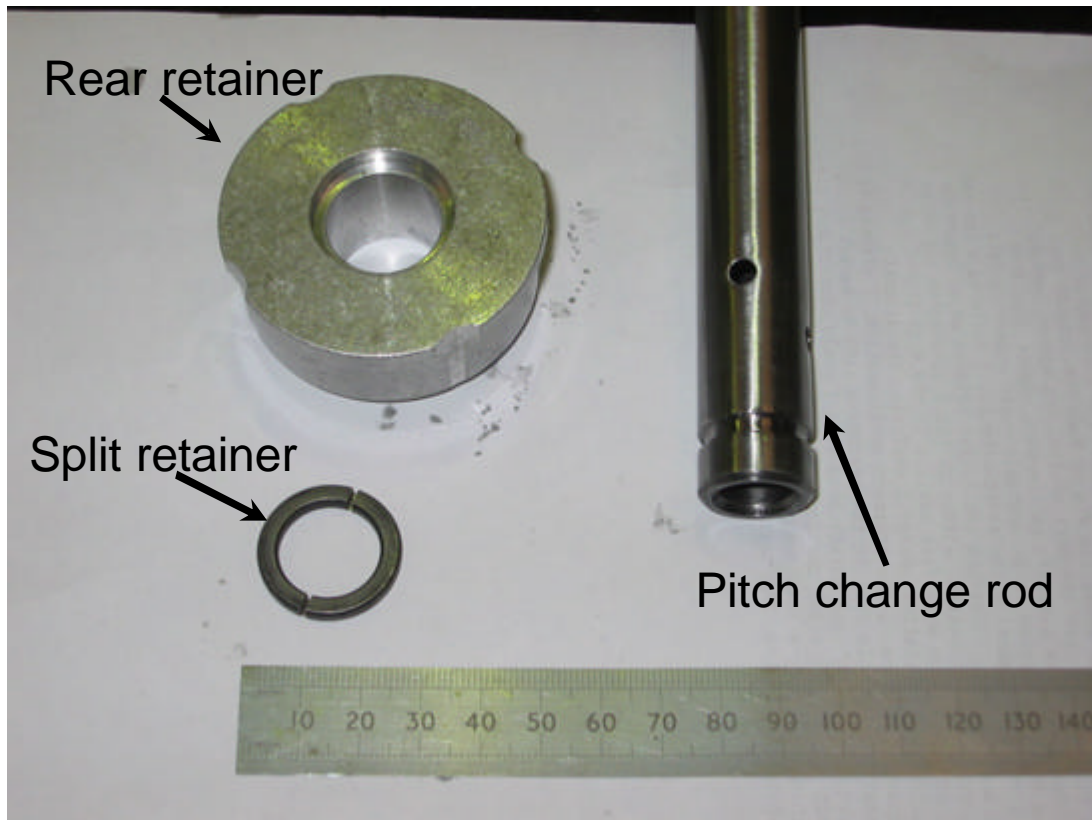
The investigation concluded that the feathering problem was caused by the spring kit split retainer becoming somehow detached from the groove in the rear of the piston rod, see

figures 2 and 3. In this condition, the feathering spring does not apply any force on the piston rod. Without the spring kit assistance the only aid to feather the propeller would be the blade clamp counterweights.

The reason why the split retainer was missing could not be determined.

With the split retainer missing, the propeller can be moved throughout its operational range by hand. Checking this is not part of the pre-flight checklist however and would normally not be detected. The pilot declared that he had feathered the propeller on a training flight some three weeks before the occurrence of the incident, and the mechanism then seemed to be functioning correctly. This makes it unlikely that the split retainer was not originally installed.

Figure 2: Rear retainer, pitch change rod and split retainer (new). Split retainer from N840PN was not found.

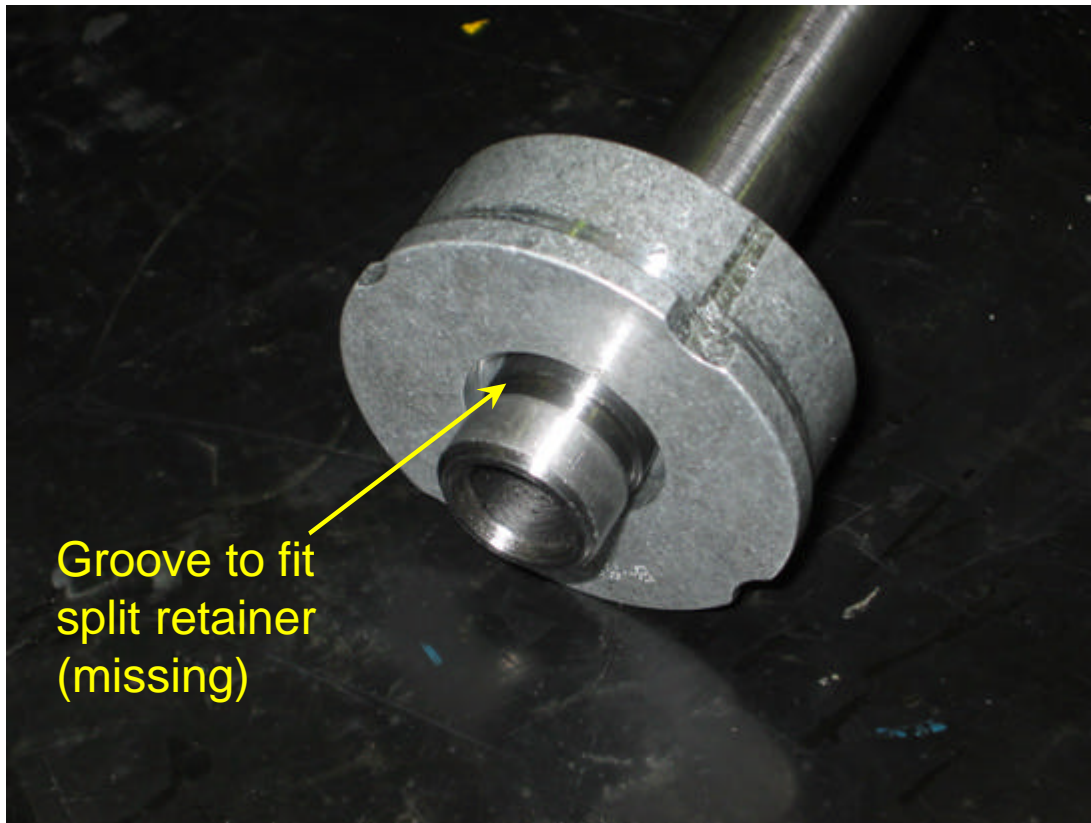
Figure 3: Rear retainer and pitch change rod (assembled).
