The Dutch Safety Board

Occurrence #:	2004003	Classification:	Accident
----------------------	----------------	------------------------	-----------------

Date of the occurrence:	12-01-2004	POB flight crew:	2
Place of occurrence:	Rotterdam Airport	Flight experience captain:	Circa 4000 hours of which circa 1300 hours on type
Aircraft registration:	PH-DYN	POB passengers:	6
Aircraft model:	Cessna 550 Citation II	Injuries:	3 passengers with neck complaints
Type of aircraft:	Twin-engine business jet	Lighting conditions:	Daylight
Type of flight:	Commercial flight		
Phase of operation:	Taxiing		
Damage to aircraft:	Severely damaged

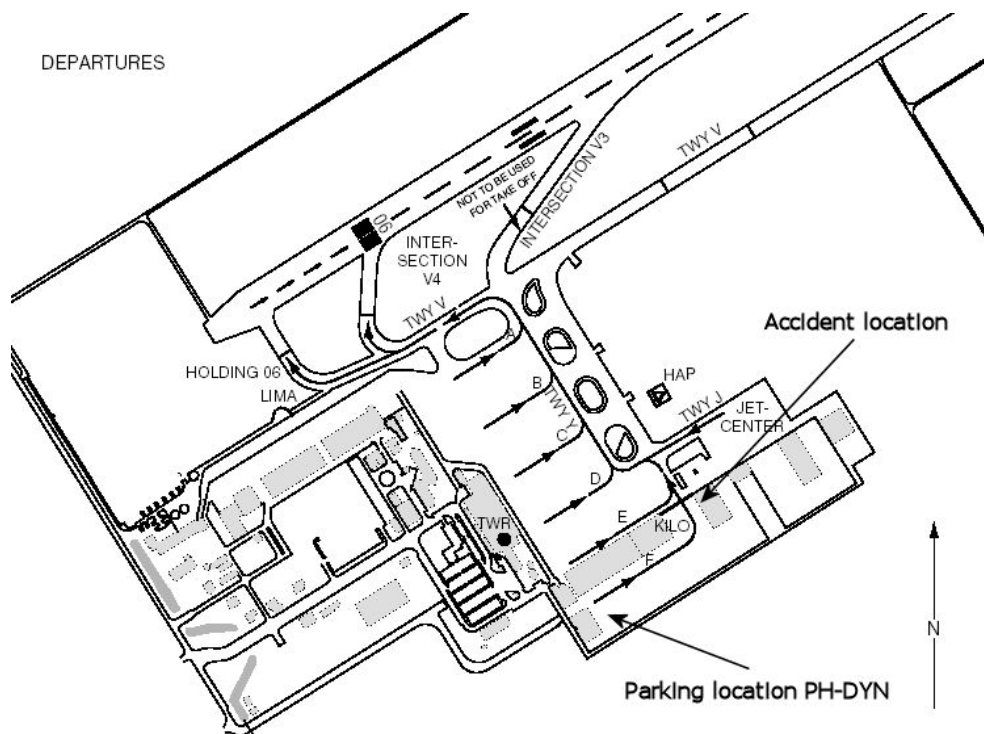
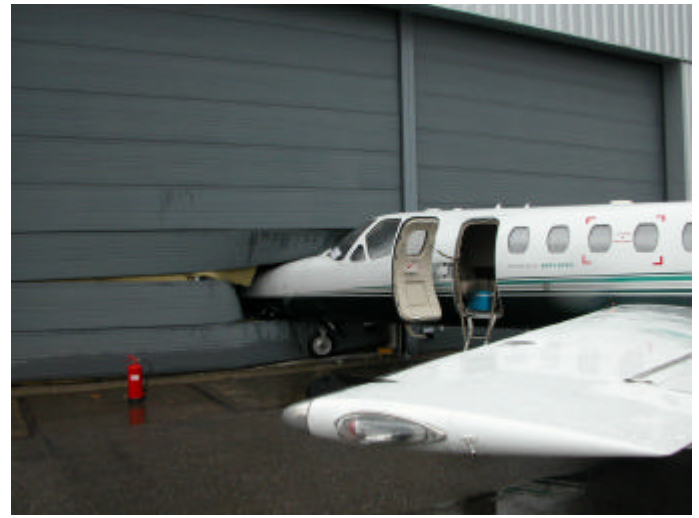
The Cessna 550 Citation II is a business aircraft with two jet engines. On board of the PH-DYN were two pilots and six passengers. Purpose was a commercial flight from Rotterdam (NL) to Strassbourg (F). The captain was pilot flying en was sitting in the left-hand seat. The aircraft was parked at the "F-apron" and the flight crew had received permission from air traffic control (ATC) to taxi to runway 24. The platform was damp after recent rain/drizzle conditions that same day. After performing the "before taxi checklist" the PH-DYN started to move. First a right-hand turn was made to intercept the yellow marker line on the "F-apron". At the end of the "F-apron" the pilot used nosewheel steering to make a left-hand turn. To make the turn sharper and keep the nose wheel on the marker line the pilot was forced to use the left-hand wheel brake. When a gentle pressure on the brake pedal did not give the desired result he declared that he pushed the brake pedal to the maximum limit. The deceleration was minimal whereupon he asked the co-pilot to assist braking. This had no result whereupon the aircraft made the turn too wide and the right-hand wing came in contact with the post of a hangar door. The aircraft levered to the right after which the nose ran through a hangar door and the aircraft came to rest. All occupants left the aircraft. Three passengers suffered from neck complaints. The aircraft was severely damaged. During this occurrence the emergency brake system has not been used.

The PH-DYN after the accident
