# The Dutch Safety Board

**Occurrence #:** 2004172 **Classification:** Serious incident

Date of the occurrence:	18-09-2004	POB flight crew:	2
Place of occurrence:	Amsterdam Airport Schiphol	Flight experience captain:	1340 hours of which
Aircraft registration:	G- BMDK		513 hours on type
Aircraft model:	Piper PA-34 Seneca	POB passengers:	None
Type of aircraft:	Twin engine propeller aircraft	Injuries:	None
Type of flight:	Freight operation	Lighting conditions:	Daylight
Phase of operation:	Taxi		
Damage:	Substantial

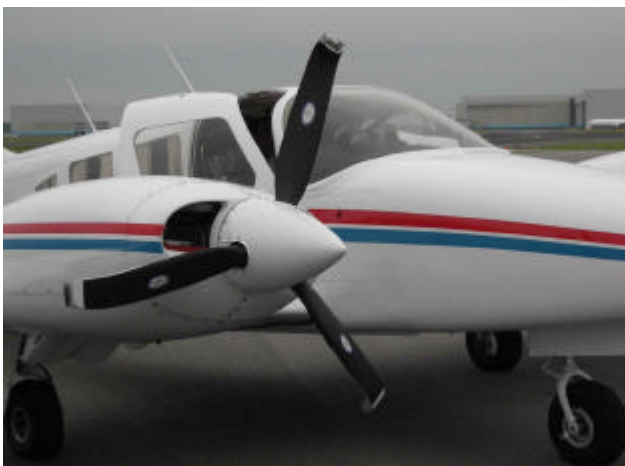
*Damage to the right-hand engine propeller blades*

In consultation with the ground controller the tower controller requested the crew of the B737 to move a bit forward in order to make more clearance for the PA-34. The PA-34 then received permission to pass behind the B737 and in front of an Airbus A320. While the PA-34 continued taxiing both the B747 as well as the B737 received clearance to line up in sequence on runway 24. When the PA-34 passed behind the B737 it was struck by 'jet blast' from the B737. As a consequence the right-hand wingtip and the right-hand propeller of the PA-34 touched the ground which caused substantial damage to the PA-34.

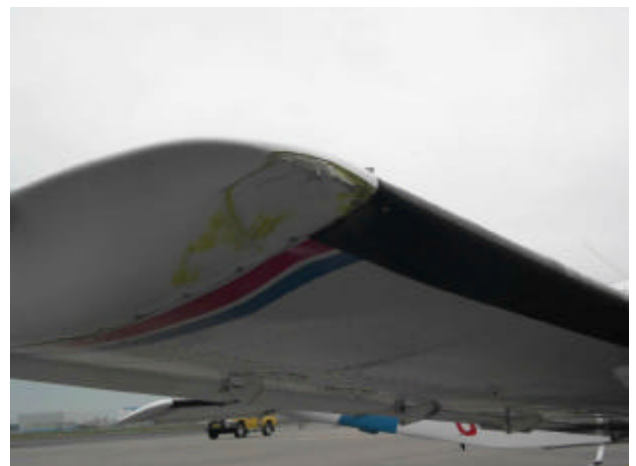
*Damage to the right-hand wingtip*
